Flight below lowest safe altitude involving ERJ-190, VH-IKJ

About 11 km north-north-east of Napier Airport, New Zealand, on 24 May 2023

ATSB Transport Safety Report

Aviation Occurrence Investigation (Short) AO-2023-038 Final – 5 March 2024 Cover photo: ADS-B Exchange flight data overlay on Google Earth

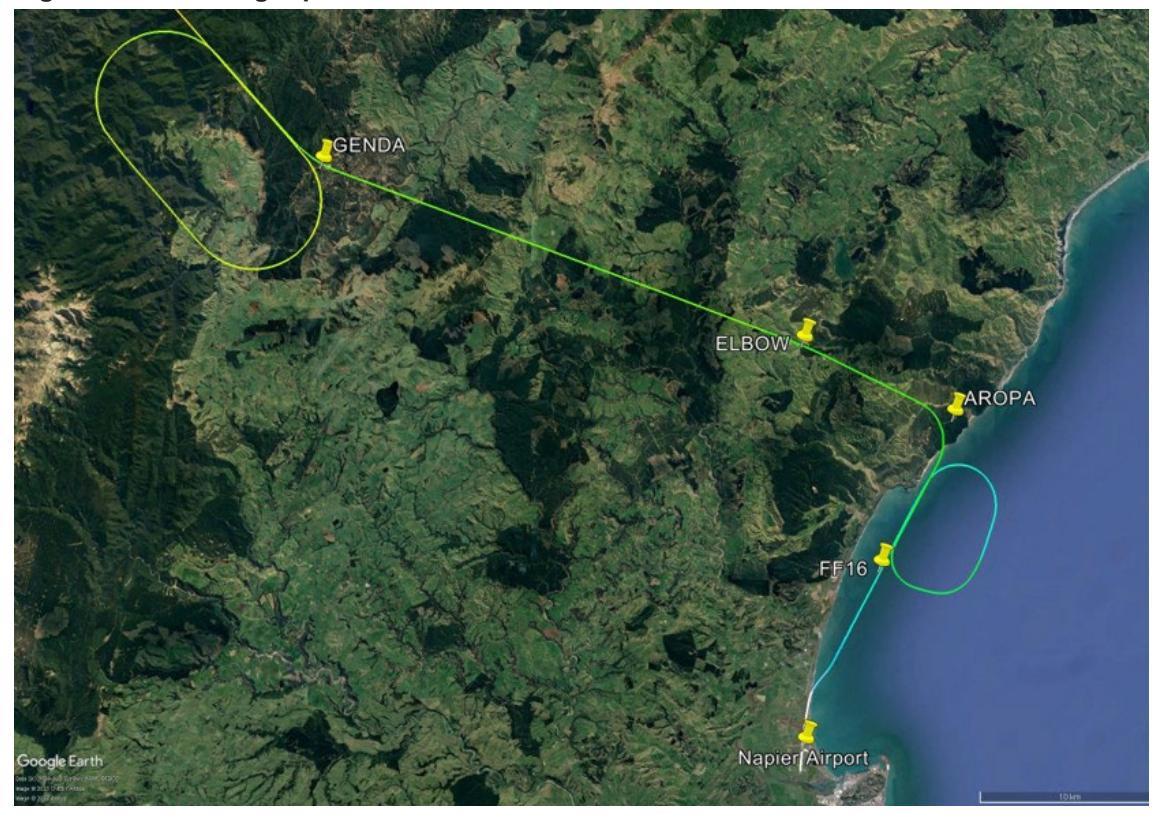
Figure 1: VH-IKJ flight path

During descent, approaching the waypoint² GENDA (Figure 1), the crew determined that due to the reduced track miles and extra fuel uplifted in Auckland, the aircraft would be approaching its maximum landing weight on arrival at Napier. To reduce the aircraft weight, they conducted a holding pattern and started the auxiliary power unit (APU) to increase the fuel burn. After the holding pattern, a descent toward the Napier RNP 16 initial approach fix, waypoint ELBOW, (see section titled *Napier RNP 16 instrument approach*) was conducted and the crew completed the required checklists.

Near waypoint ELBOW, the aircraft flew through a thin layer of stratus cloud resulting in an ice detection system advisory alert. This required the crew to conduct the Stall Protection Ice Speed checklist, and to recomplete the Approach checklist. Passing the intermediate approach fix at AROPA, the crew observed that the aircraft was now high on the approach and increased the descent rate in an attempt to capture the vertical profile from above.

Just prior to reaching the final approach fix at FF16, the captain, who was the pilot flying,³ engaged altitude hold along with heading mode on the autopilot, and commanded the aircraft to conduct a left orbit over the ocean. This took the aircraft beyond the inbound approach track tolerance for the approach segment and below the minimum safe altitude (see section titled Minimum altitude for flight). The crew completed the Stall Protection Ice Speed checklist and after re-intercepting the final approach track, re-commenced the descent, before continuing the procedure and landing at Napier Airport.

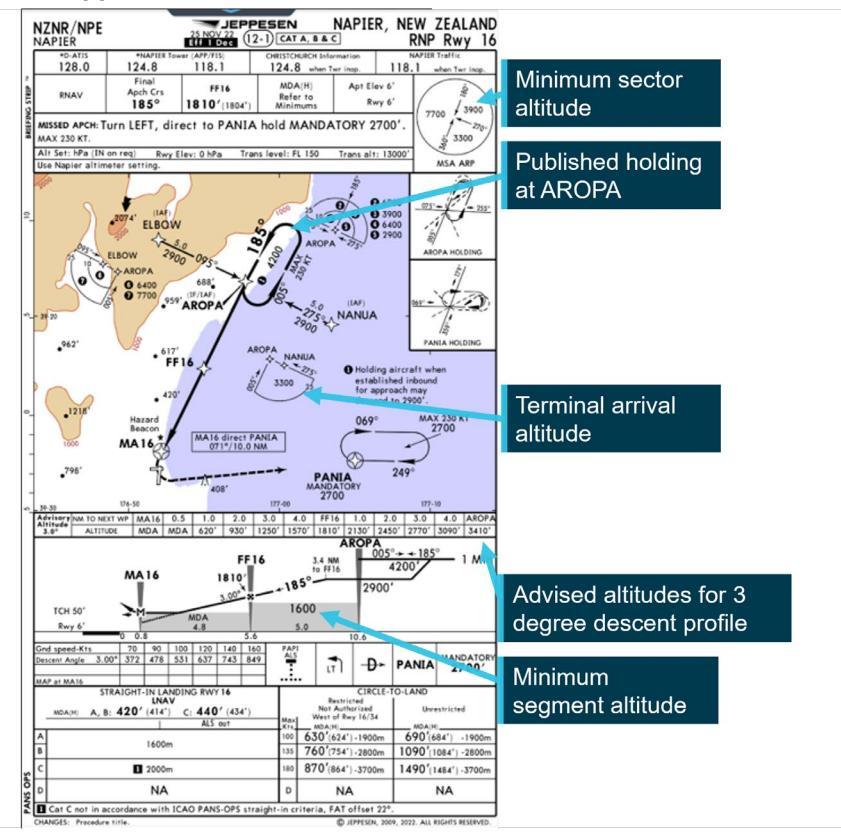
A minimum sector altitude is provided for different areas centred on the airport reference point and defined on the approach plate. They define the minimum altitude an aircraft may descend to unless established on a published approach track with a lower altitude. The minimum sector altitude for the area northeast of Napier was 3,900 ft (Figure 3).

The terminal arrival altitude (TAA) provides a minimum safe altitude from an approach reference point providing a minimum terrain clearance of 1,000 ft at the TAA altitude. The instrument approach has a TAA referenced to AROPA of 3,300 ft (Figure 3).

When flying the RNP approach, the inbound track has a minimum segment altitude which applies to a lateral tracking tolerance¹¹ on the inbound track. This is often lower than the minimum sector and terminal arrival altitudes. The minimum segment altitude for the inbound track between AROPA and FF16 was 1,600 ft.

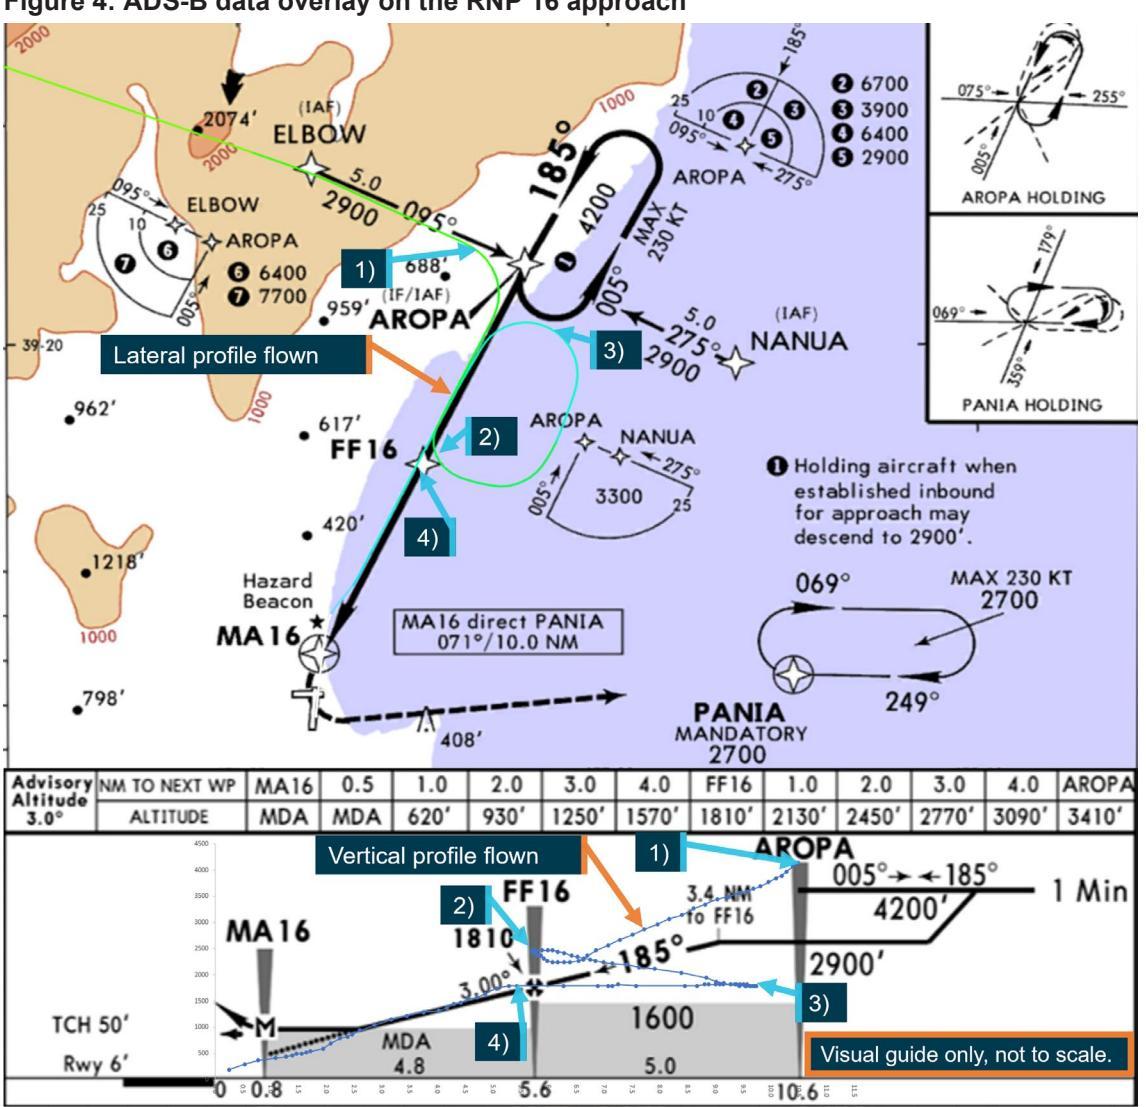
Figure 4: ADS-B data overlay on the RNP 16 approach

ADS-B data was transmitted by the aircraft and was obtained by the ATSB from a third-party website to analyse the aircraft's lateral and vertical flight path (Figure 4). The ADS-B data also provided information on the selected autopilot modes at the time of the approach (*Table 1*).

The approach track is labelled to show the altitude the aircraft was at against the vertical profile. Source: ADS-B data overlay on Jeppesen NZNR RNP 16 annotated by the ATSB

ADS-B data confirmed that the aircraft became high on the vertical approach profile prior to joining the Napier RNP 16 instrument procedure. It also confirmed that the crew did not enter the published holding pattern at AROPA to complete the preparations and instead, continued descending to join the vertical profile. At this time, the pilot monitoring was still completing the checklist and was unable to give full attention to monitoring the aircraft's flight path.

The captain decided that they needed to reduce the workload in the cockpit prior to continuing through the final approach fix. Due to the perceived time pressure and a desire to minimise further delay they decided to do this by conducting an orbit rather than a missed approach which would take significantly longer. They believed the visual approach criteria could be complied with and without further discussion, a left turn was commanded via the autopilot descending to 1,800 ft. The left turn took the aircraft beyond the lateral tolerance of the intermediate approach segment and below the minimum safe altitude of 3,300 ft.

- the aircraft's quick access recorder card was replaced and data is now being captured and analysed
- a simulator exercise was developed to replicate the Napier event and how to manage a 2D approach should the aircraft become high on the approach; the simulator exercise commenced on 6 June 2023 as part of the E190 recurrent simulator program
- a notice to staff (NTS) has been issued reiterating their obligations to check the operational flight plan is correct and they have received all the NOTAMS and weather forecasts required for the flight
- the decision-making events that occurred on the ground in Auckland, during flight and approach to Napier Airport will be included in the human factors and non-technical skills training.
