# Collision with terrain involving Gulfstream 695A, VH-HPY

30 NM south-east of Cloncurry, Queensland on 4 November 2023

Aviation Occurrence Investigation AO-2023-053 Preliminary – 7 February 2024 Released in accordance with section 25 of the Transport Safety Investigation Act 2003

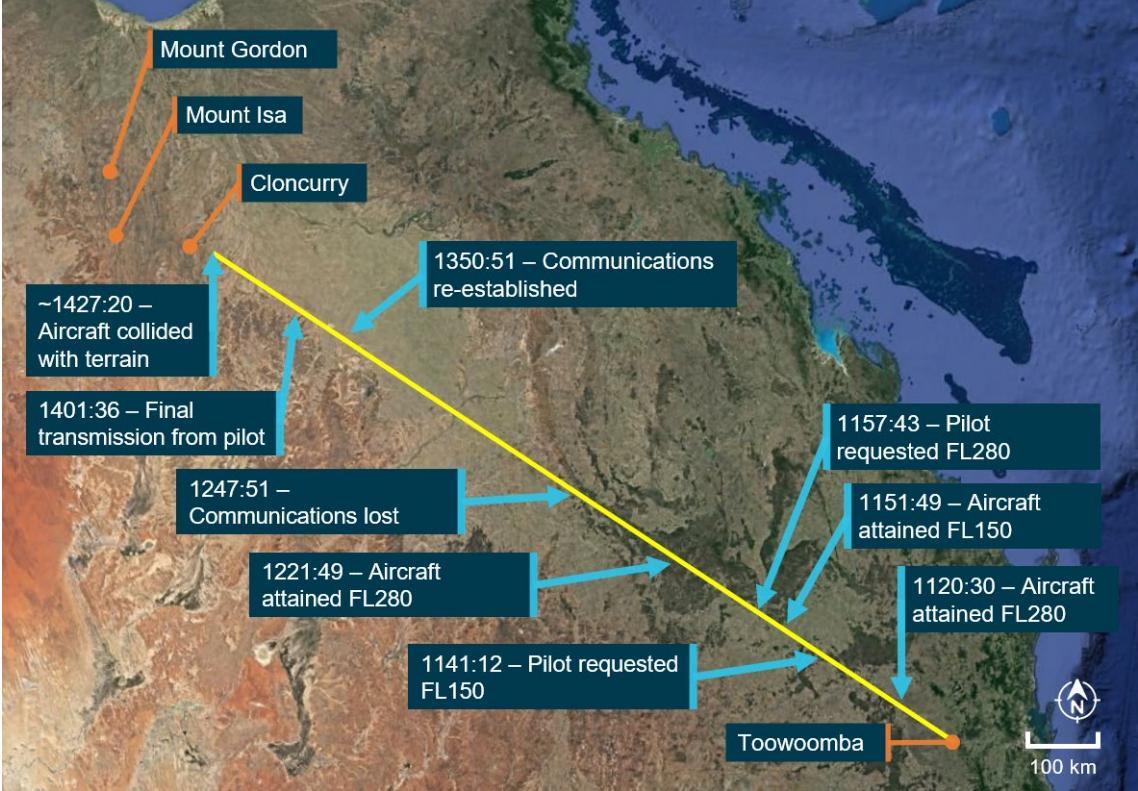
#### Figure 1: Flight path overview

At about 1055 local time, the aircraft departed Toowoomba Airport. The pilot was provided with an air traffic control clearance to track to Mount Isa. They were initially cleared to climb to flight level<sup>2</sup> (FL) 160, and then were issued further instructions to continue the climb to the planned cruise of FL 280. The pilot made a brief personal phone call at about 1106, and the aircraft reached FL 280 at 1120:30 (Figure 1).

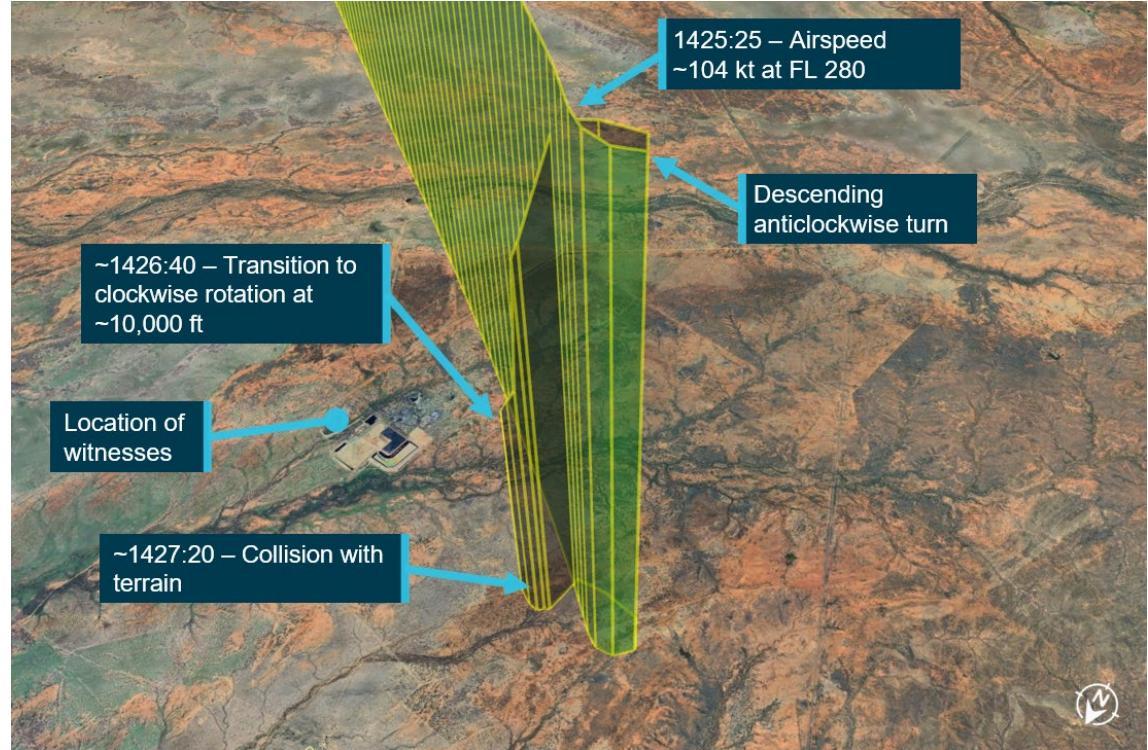
#### Figure 2: Oblique view of the aircraft's flight path during the descent from FL 280

The aircraft was not fitted with a cockpit voice recorder or flight data recorder. However, flight data was transmitted to ground stations by aircraft/navigational equipment (see *Recorded information*). This data indicated that at 1420:50 the aircraft's groundspeed began to reduce from a cruise groundspeed of about 225 kt (417 km/h), while heading and altitude remained steady. At 1425:25, the groundspeed had decreased to about 104 kt (193 km/h) and the aircraft departed controlled flight. The aircraft initially entered a descending anticlockwise<sup>5</sup> turn with an increasing rate of descent. At an altitude of about 10,000 ft, the aircraft transitioned into a tight clockwise helical descent, likely an aerodynamic spin,<sup>6</sup> with a subsequent average rate of descent of about 13,500 ft/m (Figure 2).

Two witnesses at a nearby mining facility observed the aircraft's descent and described hearing a 'whirring' noise and seeing it descending in a nose-down clockwise corkscrew motion. The witnesses recalled the aircraft's motion momentarily abated partway down, before it re-entered the nose-down corkscrew descent.

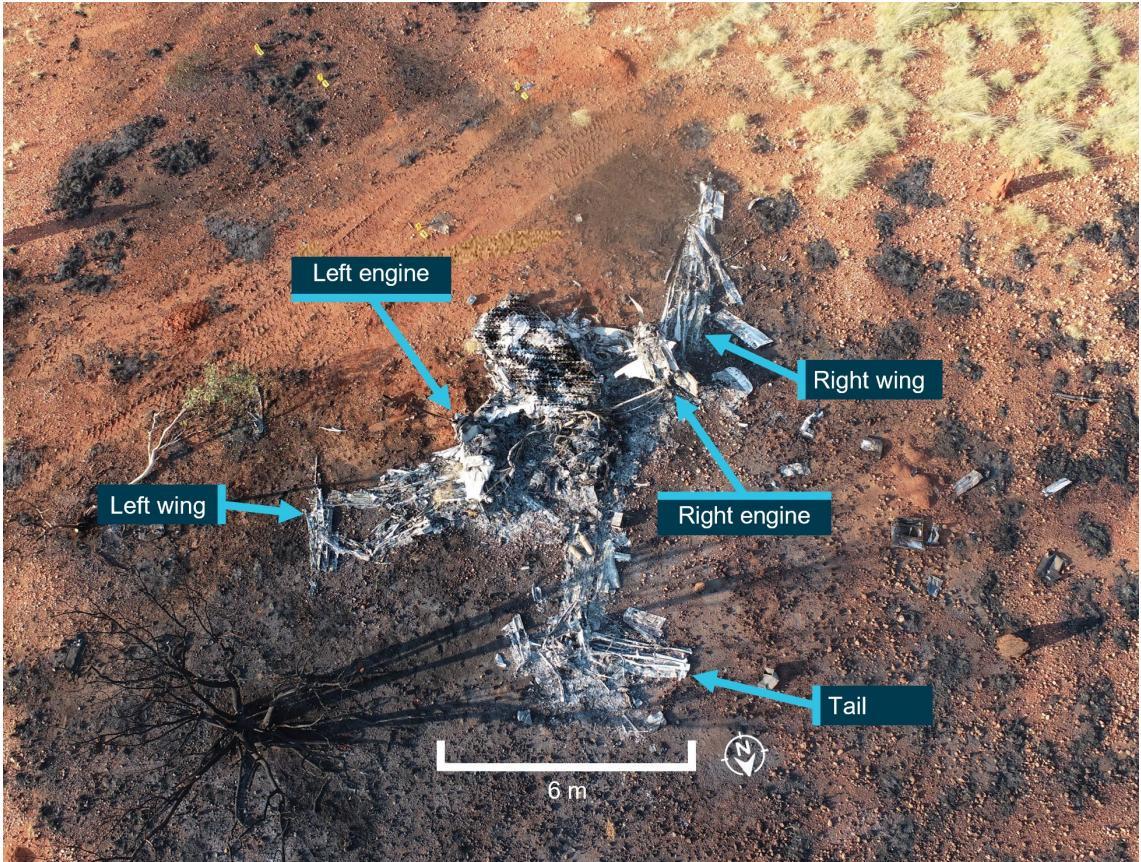
Figure 3: Overview of the accident site

The ATSB conducted an on-site examination of the aircraft wreckage. The aircraft came to rest in flat, open bushland and was destroyed by a significant post-impact fire (Figure 3). The post-impact fire damage limited the extent to which pre-impact defects could be identified, however from the evidence available:

- all major aircraft components were accounted for at the point of impact
- the impact marks and wreckage position indicated that the aircraft impacted terrain upright with a shallow, nose down attitude and with little forward momentum, indicative of a spin
- both engines and propellers had indications that the engines were running at impact.

It was not possible to determine the operability of the aircraft's pressurisation and oxygen systems.
