# Derailment of freight train 9305

Katunga, Victoria | 30 May 2016

ATSB Transport Safety Report Rail Occurrence Investigation RO-2016-007

Final – 30 May 2017

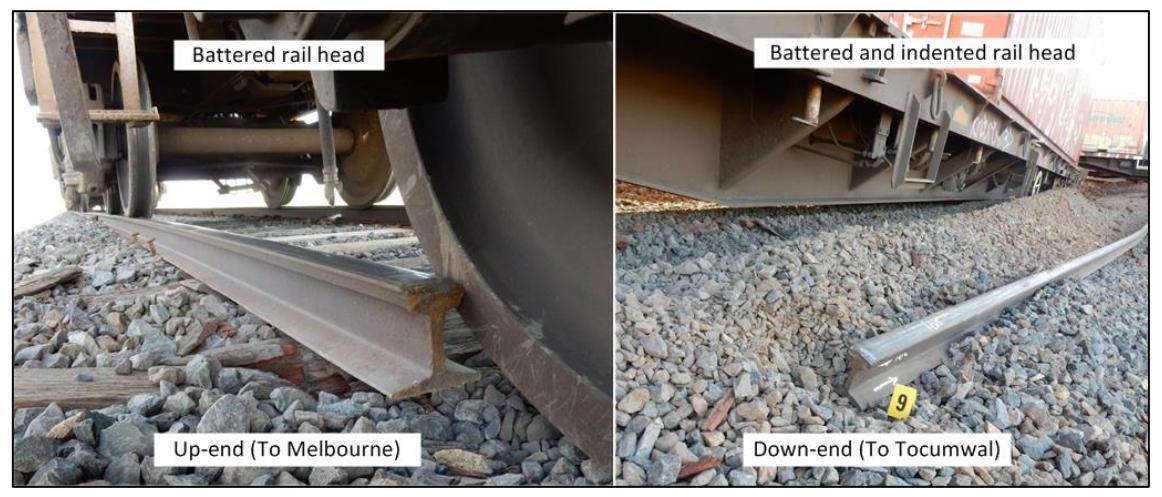
#### Figure 2: Fractured rail

The train had derailed at a fractured flash butt welded rail joint in the east rail at about the 227.8 km mark (Figure 2).

The rail head at the fractured weld had been battered on both sides of the break. Both ends were battered to a depth of about 10 mm. Mechanical damage to this depth indicated the passage of bidirectional rail traffic over the broken joint after fracture. There was also significant mechanical damage to the fracture surfaces and corrosion. At the intersection of the web and the foot, the fracture surface exhibited a region of predominantly intergranular fracture where significant grain boundary oxidation was observed (Figure 6).

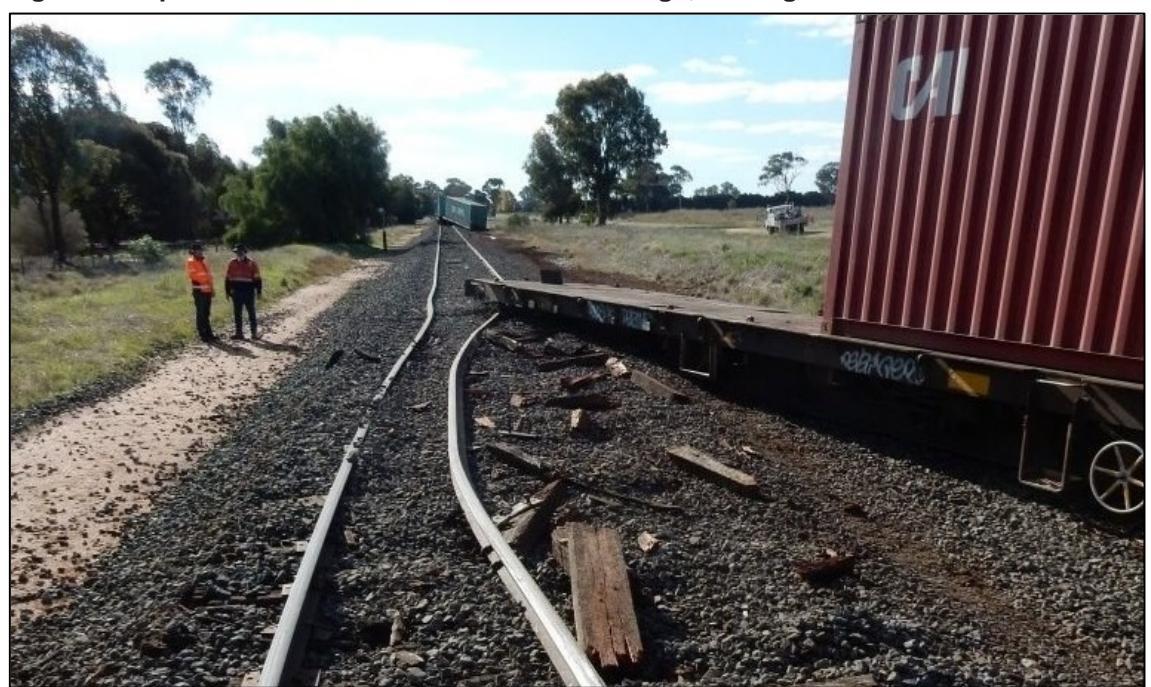
Of the twelve wagons that derailed, wagon six, seven and eight stayed upright and generally followed the track alignment, while the rear bogie of wagon nine veered to the east of the track. The tenth wagon and the following eight wagons veered to the east of the line causing a separation between the ninth and tenth wagons. The separation caused the loss of brake pipe pressure and the subsequent application of the train brakes. The locomotive and the first nine wagons travelled about 137 m from the separated section of the train (Figure 3).

Figure 3: Separated section of train and track damage, looking towards Tocumwal

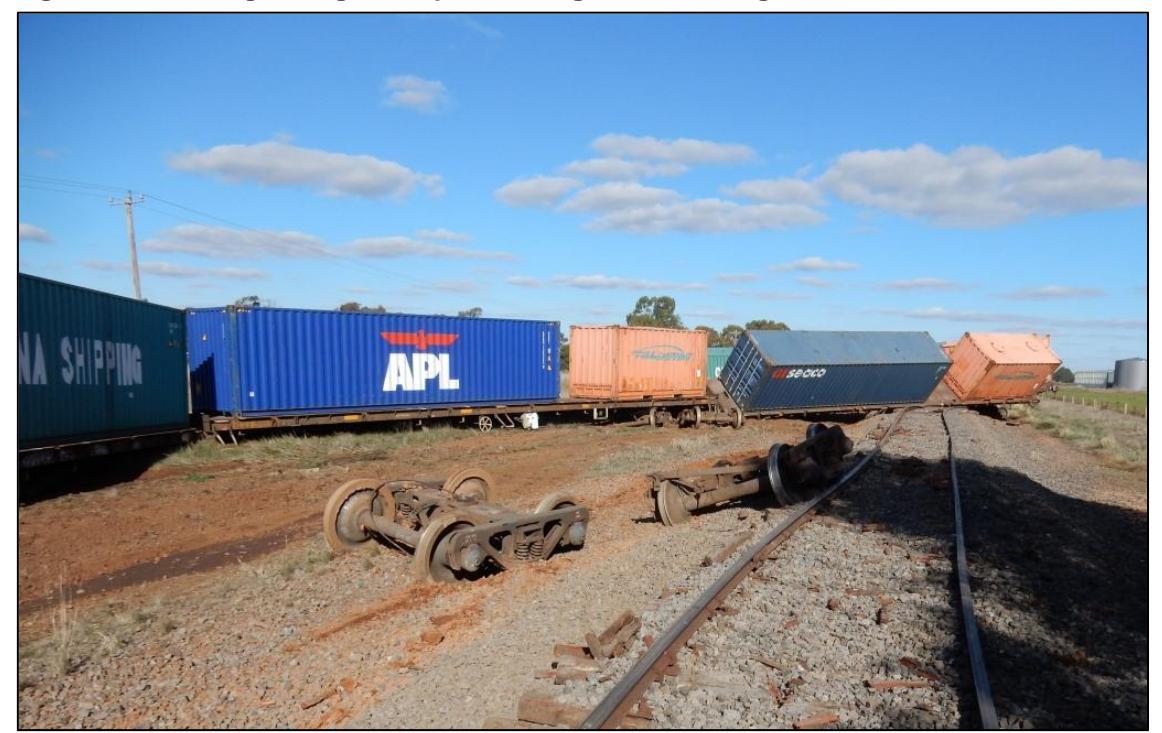
Wagons 10 to 17 ended in various states of disarrangement (Figure 4). The leading end of wagon 18 had lifted off the bogie centre bowl while the last nineteen wagons remained on the track. The derailment resulted in about 350 m of track damage.

Figure 4: Disarranged wagons separated bogies and damaged track

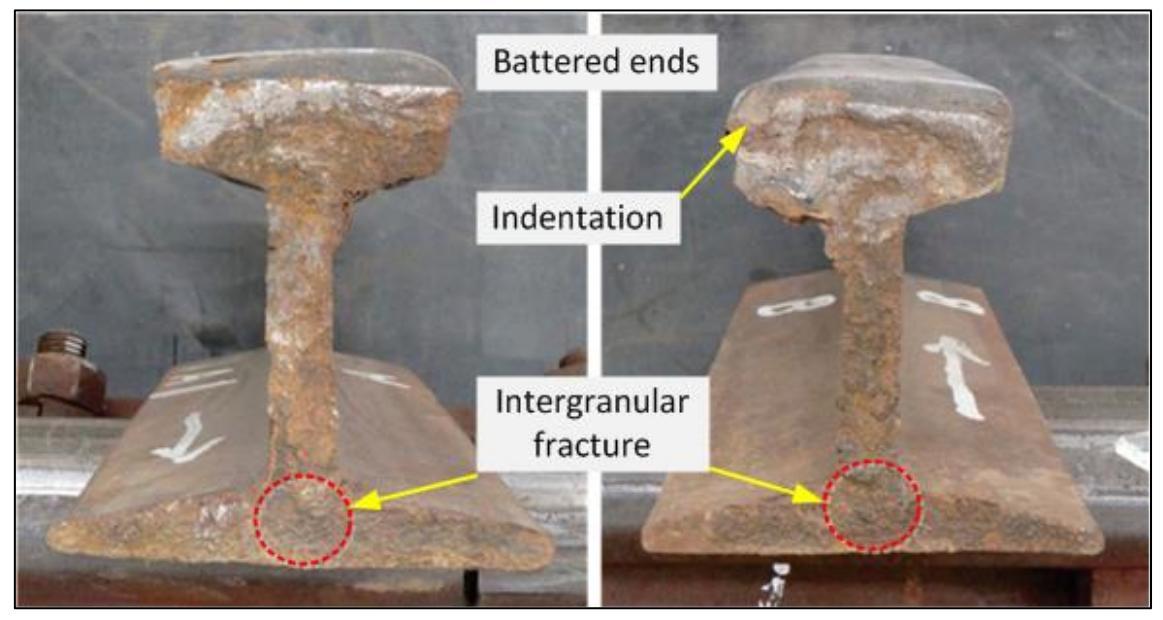
Figure 6: Fractured weld ends, the Up-side rail is on the left and the Down-side rail on the right. The area of intergranular fracture is identified.

The damage to the fracture surfaces had destroyed a significant amount of the fracture detail. The undamaged fracture surfaces of the rail head and web exhibited a coarse dimpled appearance consistent with instantaneous overload fracture. These features were indicative of ductile-fast fracture.

The derailment occurred as a result of a fracture at a flash butt welded rail joint. The condition of the fracture surfaces indicated that the fracture had occurred prior to the passage of train 9305. Battering of the fractured rail indicated bi-directional traffic across the fracture, and corrosion and fracture surface damage suggested the fracture had been present for several days.

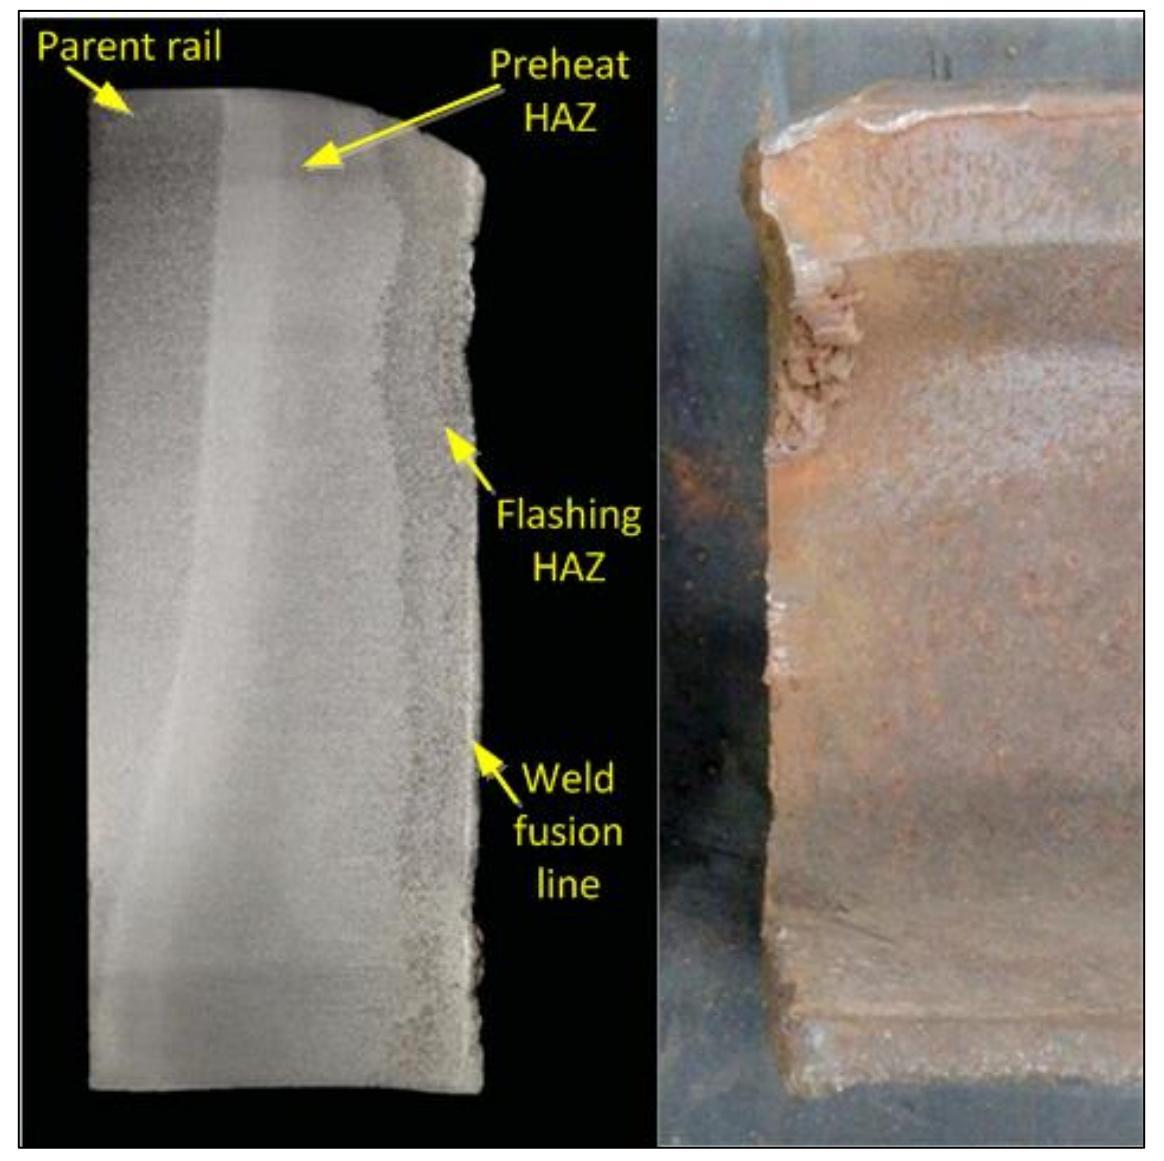
In addition to the parent material, the evaluation revealed three distinct areas; a weld fusion line, a weld flash Heat Affected Zone (HAZ) and a HAZ produced during pre-heating prior to welding (Figure 7). The two Heat Affected Zones are consistent with in-plant flash butt welding processes. The fusion line hardness of the subject rail was consistent with the parent-rail material hardness. The peak HAZ hardness was 264HV (Vickers), 2.5 mm from the break and is not excessive for the application.

Figure 7: Macro etched longitudinal section of rail on the left showing that the fracture had occurred predominantly in the HAZ adjacent to the weld fusion line. The rail prior to sectioning is shown on the right.

The fracture occurred predominantly in the Heat Affected Zone adjacent to the weld fusion line and fracture surfaces were consistent with instantaneous overload fracture.

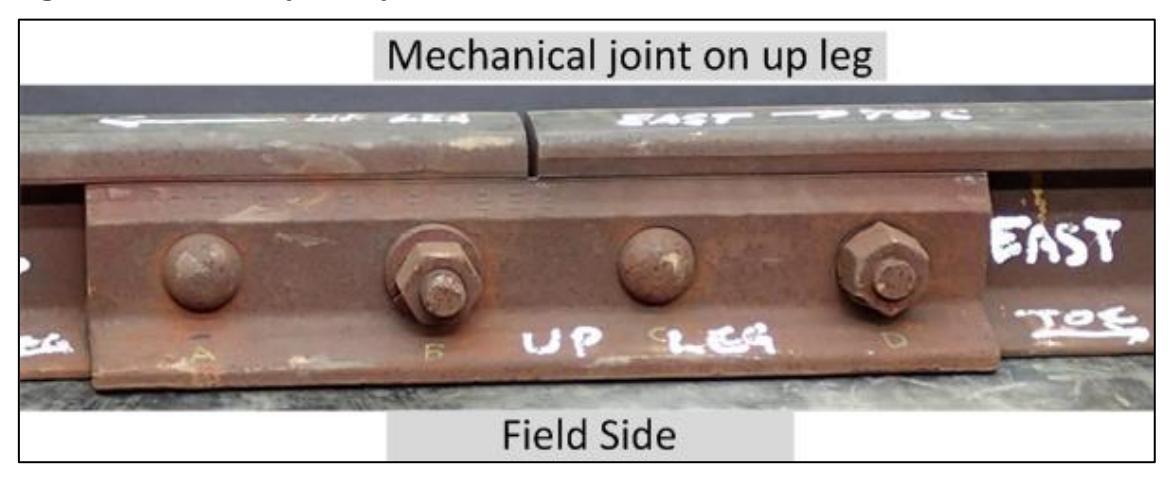
A mechanical joint adjacent to the fractured weld on the east rail was visually and mechanically examined (Figure 8). Based on bolt torques and wear on the fishing surfaces, the examination concluded that the rail had been expanding and contracting at the mechanical joint.

Figure 8: Mechanical joint adjacent to fractured weld on the East rail

V/Line has advised that, since the derailment of freight train 9305, a joint servicing program has been completed, with all mechanical joints lubricated, bolts repaired, and fishing surfaces lubricated. V/Line has also redeveloped its ultrasonic inspection and assessment standard to include more specific instructions and requirements for ultrasonic testing, including a requirement to report non-sizable defects in more detail. Further, it has conducted ultrasonic inspections of an additional 100 flash butt welds and 50 thermit welds on the Tocumwal line. They reported that no defects were detected during these inspections.

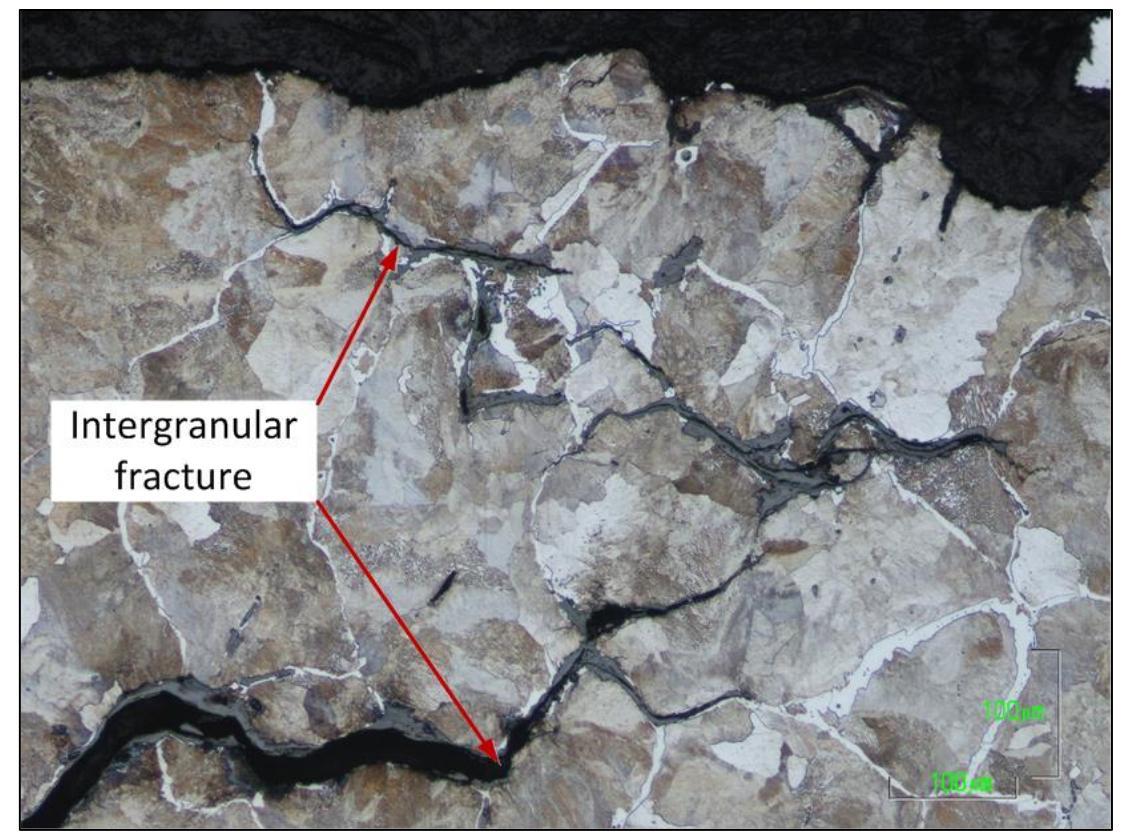
Metallographic examination of the fracture exhibited a mixed mode (transgranular and intergranular) cracking mechanism. The fracture surface at the foot-web intersection of the fractured weld exhibited a predominantly intergranular brittle fracture mode (Figures 6 and 9).

# Figure 9: Photomicrograph of the etched microstructure of the rail fracture surface. The foot-web intersection of fractured weld exhibited an intergranular fracture mode.

Intergranular brittle fracture occurs by separation at or adjacent to the grain boundaries (where significant oxidation was observed). This type of fracture is indicative of improper material processing during flash butt welding.

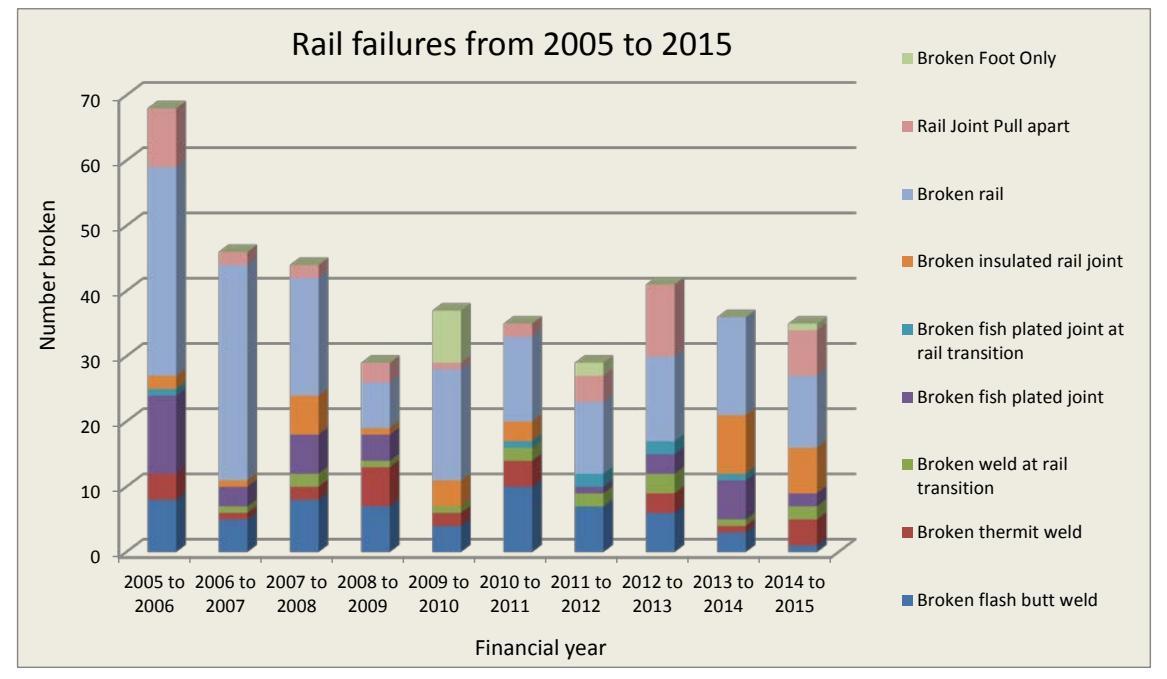
V/Line advised that there were about 330,000 flash butt welds and about 180,000 thermit welds<sup>13</sup> on their operating network. From 2005 to 2015, there were 59 flash butt weld failures, 27 thermit weld failures and a range of other fractures (Figure 10). The flash butt failures represented 15 per cent of the total annual rail failures and the failure rate is similar to other welded connections on the network.

Figure 10: Rail failures from 2005 to 2015.
