# Drive shaft failure and loss of control involving Garlick Helicopters UH-1H, VH-UHX

36 km north of Launceston, Tasmania on 14 February 2022

ATSB Transport Safety Report Aviation Occurrence Investigation (Defined) AO-2022-006 Final – 12 March 2024 Cover photo: Jamie Davis

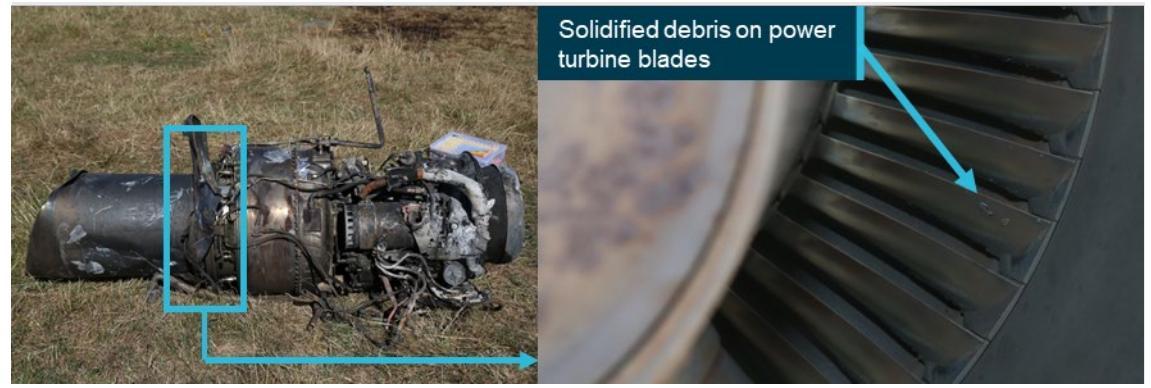
Figure 8: Solidified metallic deposits were identified on the surfaces of the second stage power turbine

The power turbine was unable to be rotated. However, metallic material had solidified at numerous locations on the second-stage power turbine aerofoil surfaces indicating that metallic debris had passed through the combustion chamber while the engine was operating. Although absolute engine power levels were not able to be assessed the extent of internal compressor damage in combination with the ingested debris provided evidence that the engine was rotating at high speed during the impact sequence (Figure 8).

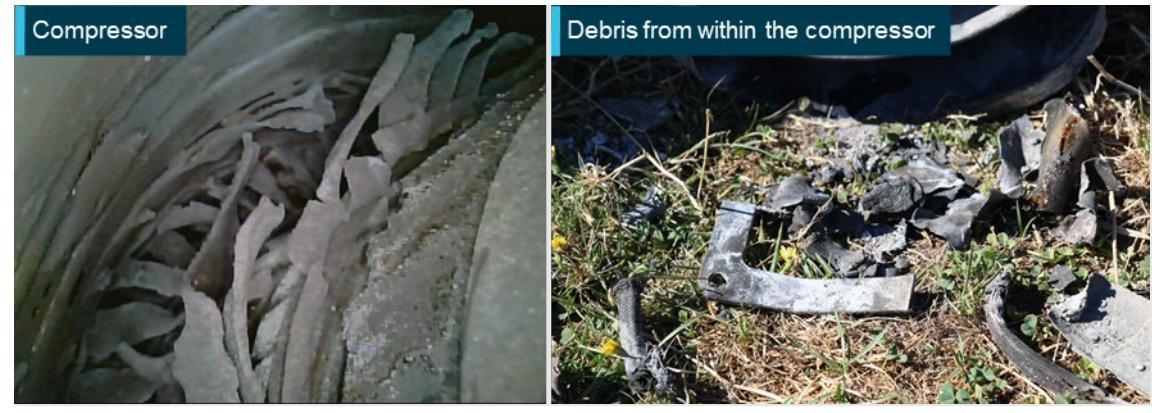
Figure 9: Severe disruption occurred to all internal stages of the compressor (left) and the debris that was recovered from within the compressor (right)

Internal inspection<sup>4</sup> of the compressor section identified that the compressor blades had been dislodged and bent against their normal direction of rotation. Debris was found throughout the compressor, including a piece of the main transmission drive shaft (KAflex coupling), multiple blade segments, inlet guide vanes and pieces of airframe structure (Figure 9).

The rectangular item in the right image is a piece from the main transmission drive shaft (KAflex) Source: ATSB

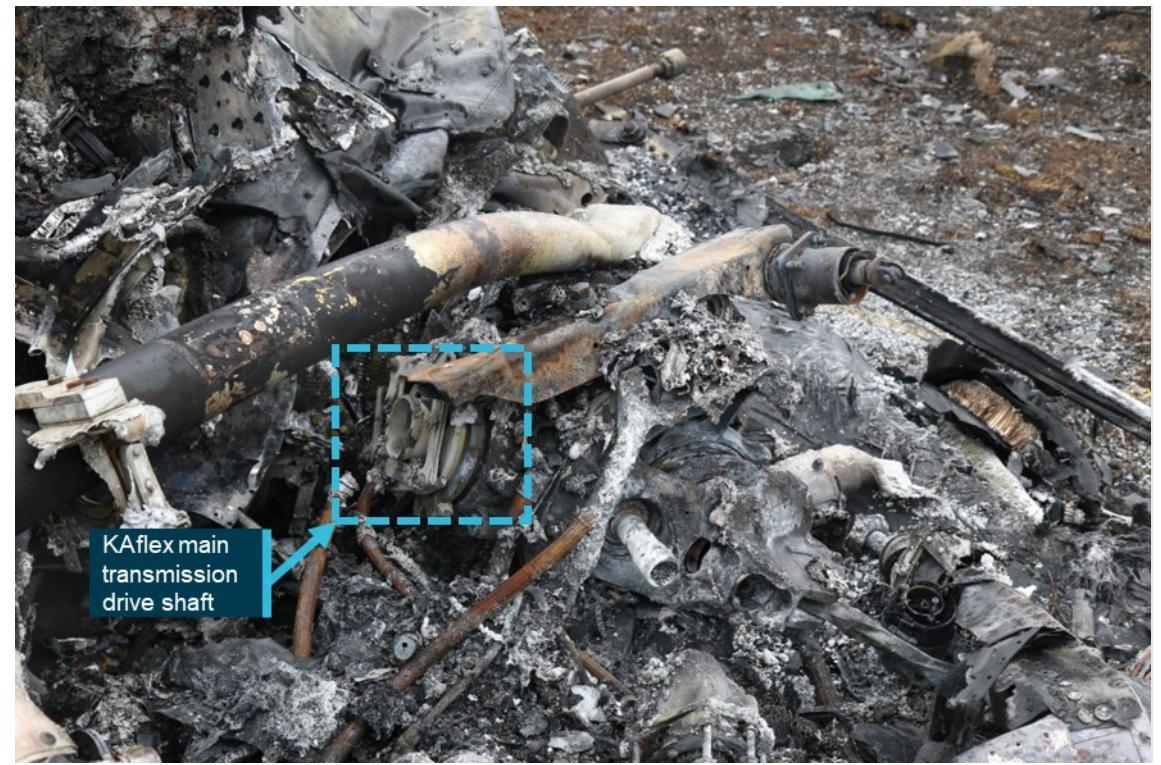
Figure 10: Burnt wreckage noting the forward section of the fragmented KAflex main transmission drive shaft

The main transmission drive shaft (KAflex) was identified at the accident site to have fractured into multiple pieces (Figure 10). One of those pieces was found within the compressor section of the engine. Due to the extent of impact and fire damage, several attachment bolts and portions of flexible frame elements from the coupling were unrecoverable. The KAflex components were retained for subsequent examination at the ATSB's technical facilities in Canberra.

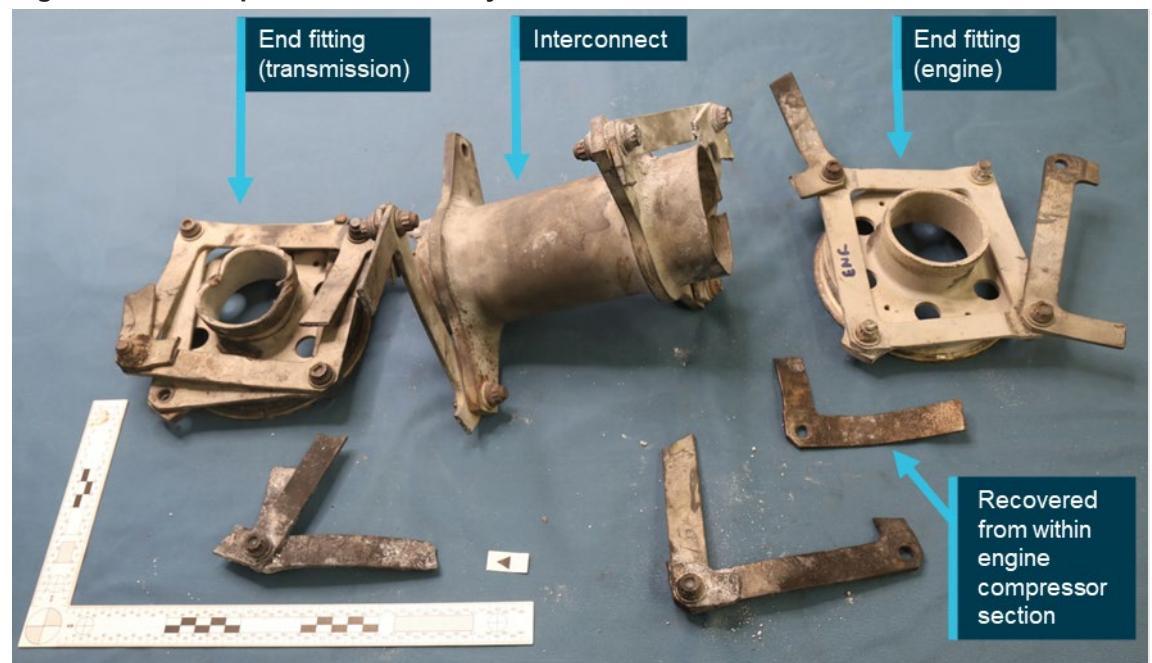
Figure 18: KAflex prior to disassembly at the ATSB's technical facilities

Not all flex frame fragments or their attachment hardware were recovered at the accident site. One flex frame fragment was found in the compressor section of the engine. Source: ATSB

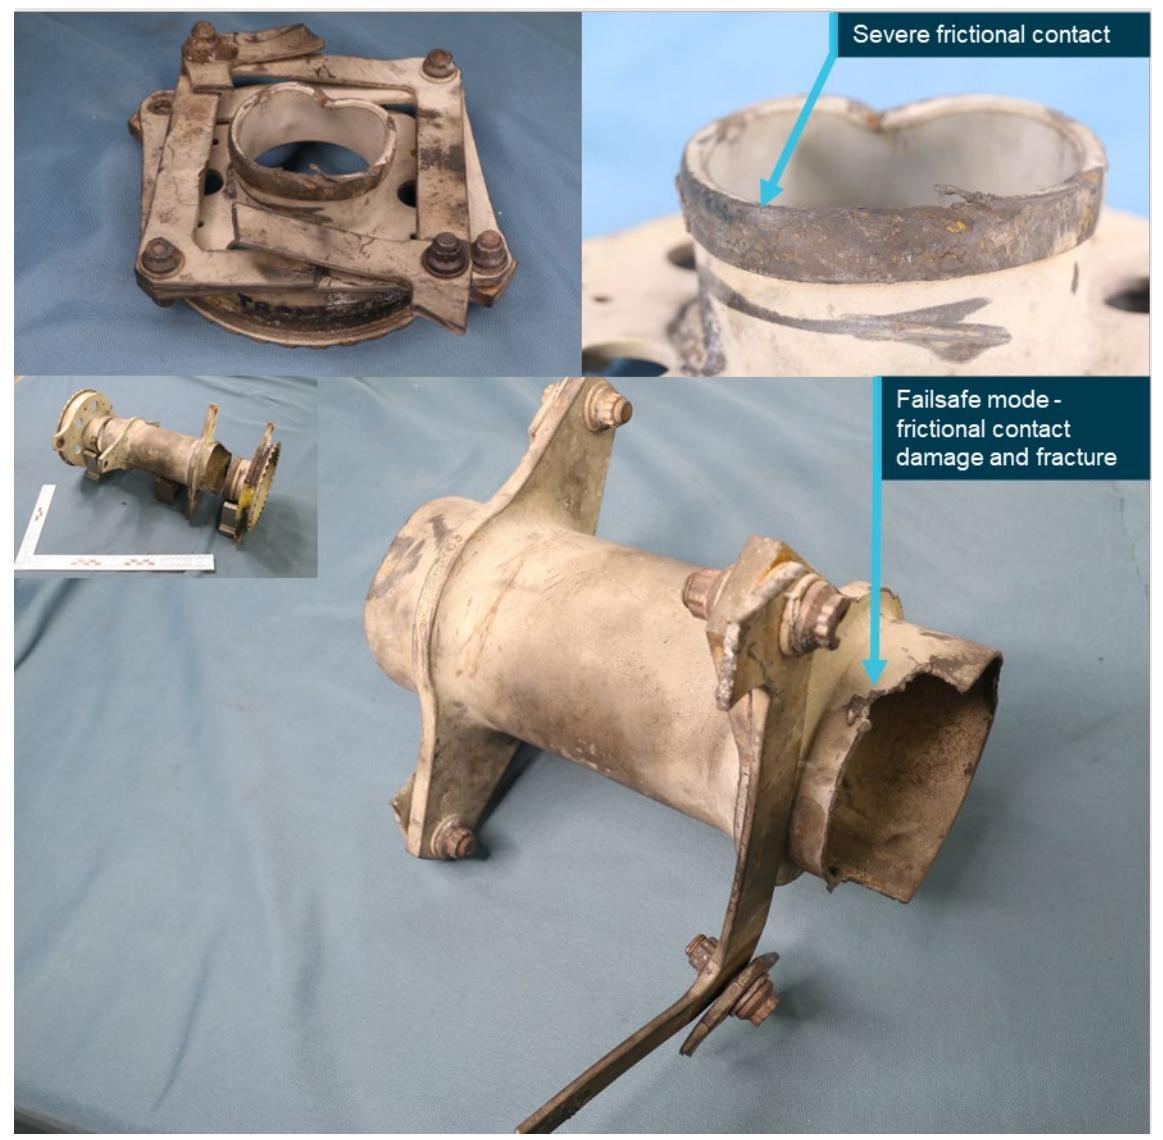
Figure 19: Photographic montage of the KAflex showing damage sustained upon entering fail-safe mode

The identification of severe frictional damage and fracture that had occurred to both the interconnect and the end fitting (transmission) indicated the shaft had entered fail-safe mode Source: ATSB

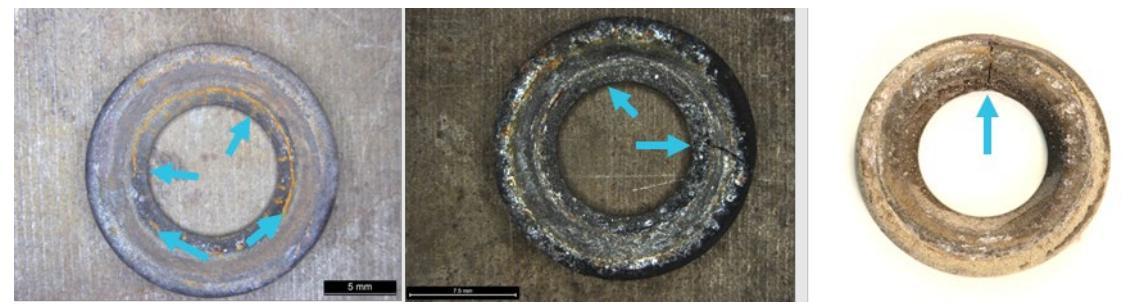
Figure 21: Photographic montage of cracks (arrowed) in countersunk washers from the KAlex attachment hardware

The intact washer (left image) displaying a series of cracks (arrowed) was recovered from the flex frame shown at Figure 20 Source: ATSB

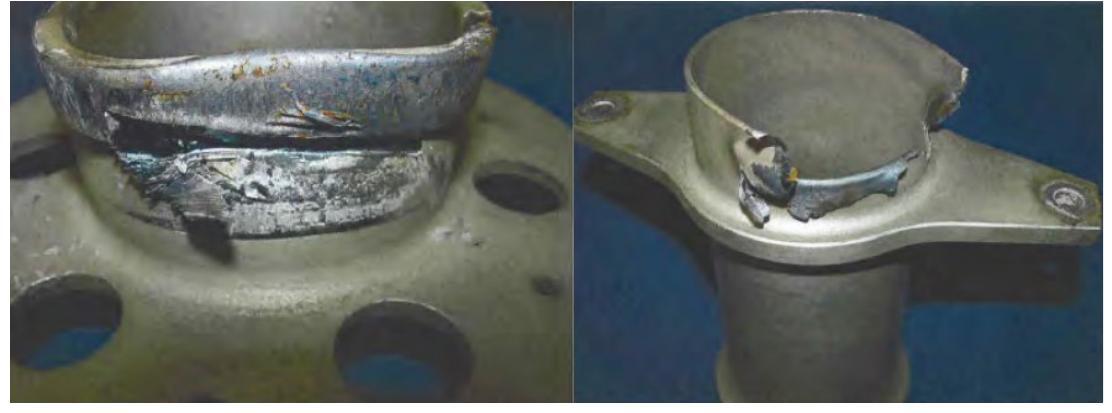
# Figure 22: A KAflex that entered fail-safe mode due to fatigue cracking of a flex frame element

Physical characteristics of fail-safe mode after complete failure of the drive shaft include severe frictional damage and bell-mouth (opening) deformation to the end fitting, along with associated frictional damage, deformation and eventual fracture of the interconnect. Source: Kamatics Corporation

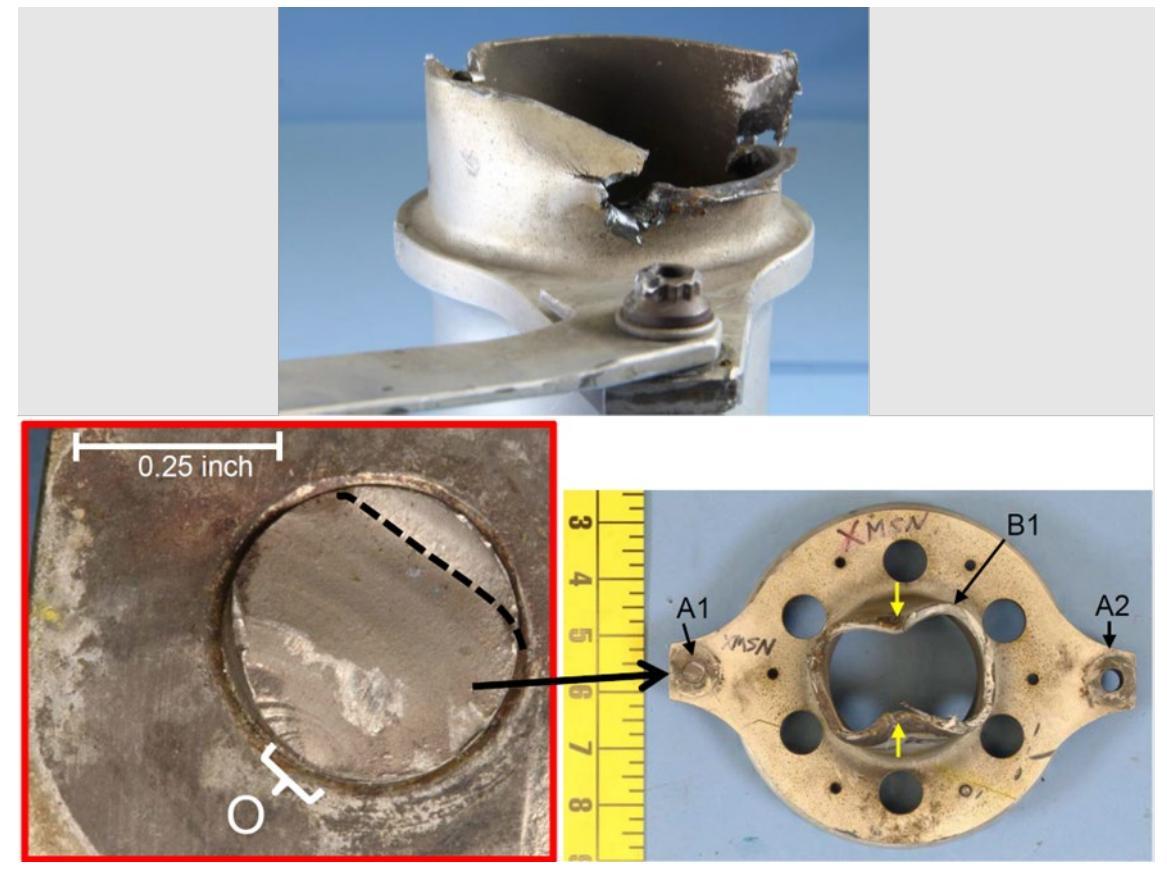
Figure A1: The KAflex entered fail-safe mode following fatigue fracture of an attachment bolt, prior to total failure of the drive shaft

The NTSB materials laboratory found multiple fractures had occurred to the KAflex drive shaft assembly. The KAflex failure was initiated by the fatigue cracking and fracture of an attachment bolt that secured the coupling assembly to the transmission shaft flange (Figure A1). No evidence of any material anomalies were found in the fractured bolt.

The interconnect and end fitting displayed characteristic contact features from entering fail-safe mode Source: NTSB

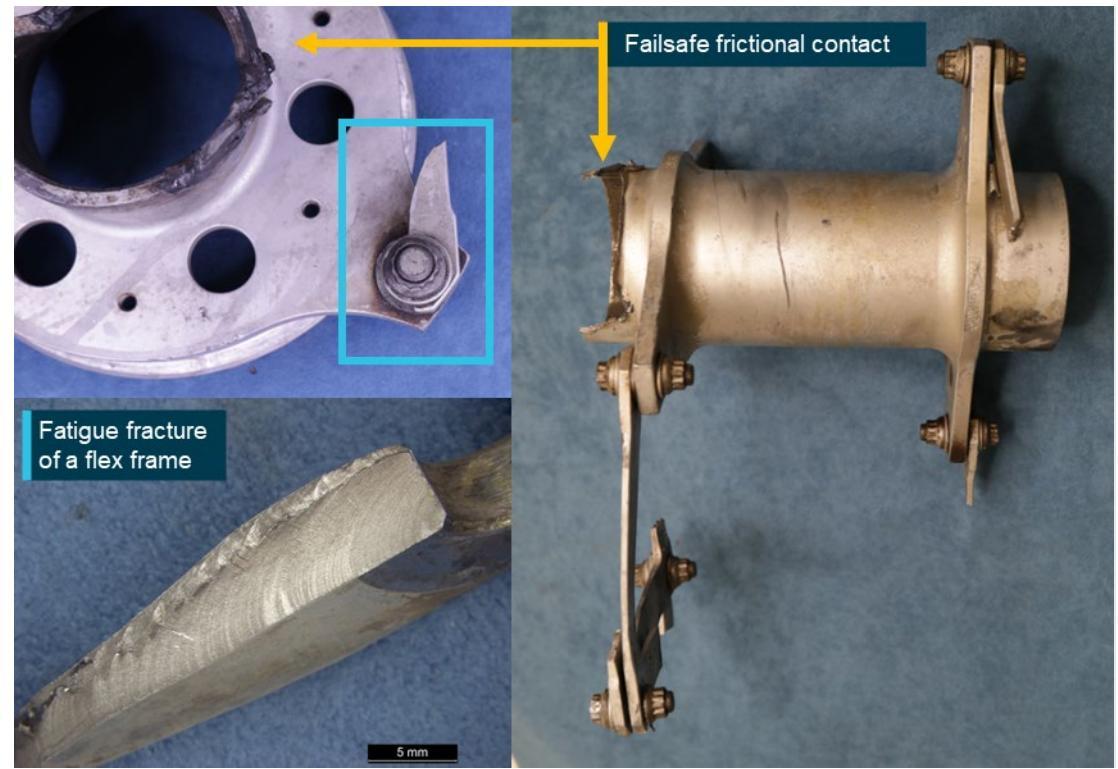
Figure A2: Fatigue cracking of a flex frame element led to the shaft entering fail-safe mode prior to total failure during operation

The ATSB's metallurgical examination found that the KAflex drive shaft had failed due to the development of a fatigue crack in a flex frame that led to its fracture prior to the hard landing (Figure A2).

The interconnect and end fitting displayed characteristic contact features from entering fail-safe mode Source: ATSB
