Australian Government Australian Transport Safety Bureau

In-flight fire and collision with terrain involving Mooney Aircraft Corporation M20J, VH-UDQ

near Luskintyre airfield, NSW on 17 October 2022

ATSB Transport Safety Report Aviation Occurrence Investigation (Short) AO-2022-049 Final – 7 May 2024 Cover photo: VH-UDQ - supplied by aircraft owner

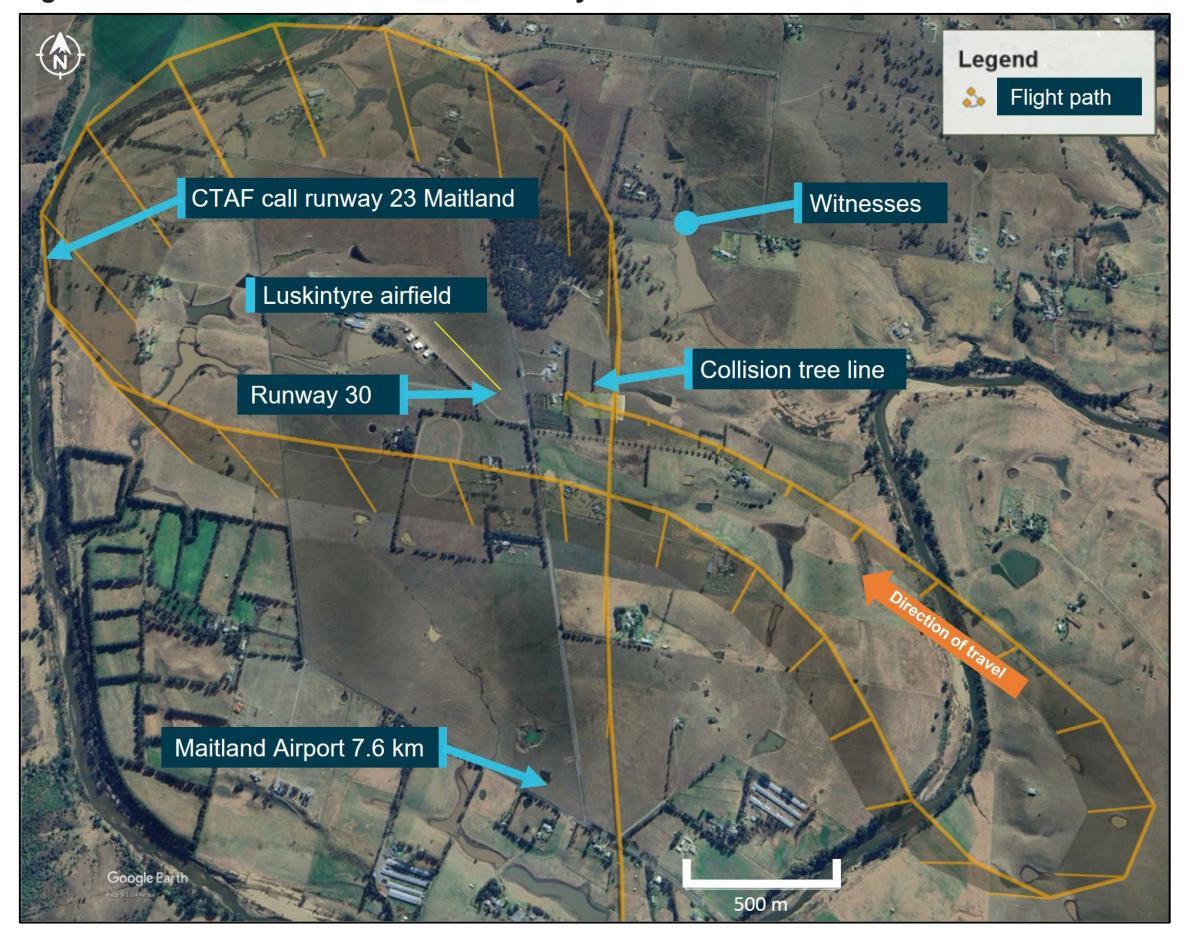
Figure 2: Orbit and descent towards Luskintyre airfield

aircraft with smoke trailing behind. No distress or emergency calls from the pilot were recorded (Figure 2).

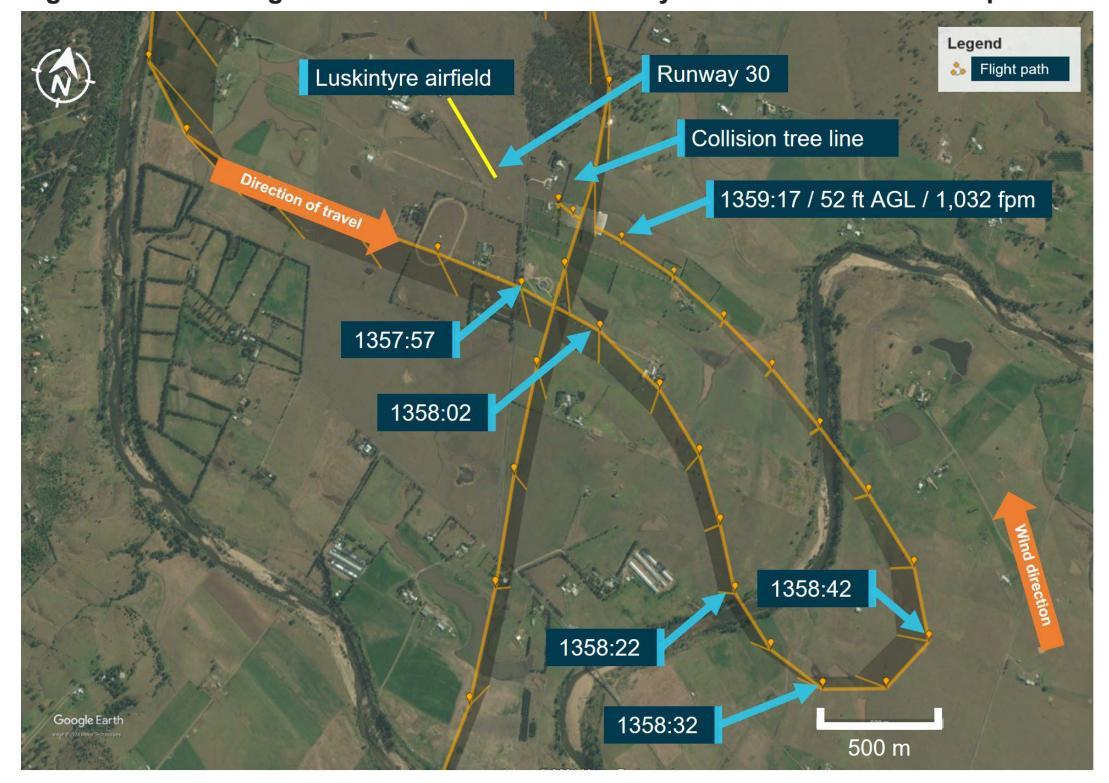
Figure 3: Aircraft flight - final turn towards Luskintyre airfield with time stamps

Flight information sourced from AvPlan⁶ indicated that at about 1358, VH-UDQ completed the orbit of Luskintyre airfield and commenced a descending turn to the right, reducing altitude from 1,863 ft AGL at 1358:02 to 1,597 ft at 1358:22. By 1358:32, VH-UDQ had begun a left turn and by 1358:42 was at 1,273 ft in an established turn and descending towards Luskintyre airfield. The final turn resulted in a tailwind component as the aircraft descended (Figure 3).

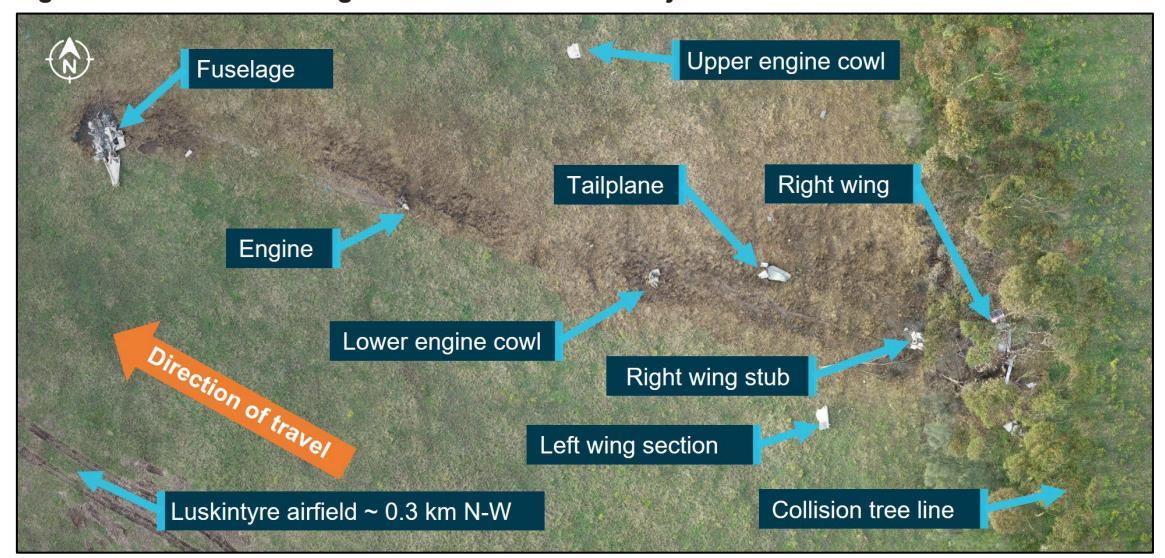
Figure 4: VH-UDQ wreckage trail and location of major items

The initial ground contact points were tyre marks in a grass field ahead of a tree line that separated two grass fields and was located about 330 metres before the runway 30 threshold. The tyre marks began about 67 metres from the tree line and ended about 22 metres before the tree line, indicating that VH-UDQ had become airborne again before colliding with the trees in a near-level attitude. The collision with the closely spaced trees separated the wings from the fuselage and was followed by a progressive break-up of the rest of the aircraft. The resulting wreckage trail was spread over a distance of about 70 metres, on a heading of about 282 degrees (magnetic). Ignited fuel from the ruptured wing tanks created the initial fireball reported by witnesses and generated an intense post-impact fire that consumed the cockpit and cabin area of the fuselage (Figure 4).

The complete aircraft was present at the accident site with all the flight control surfaces and major components accounted for. Examination of the aircraft control systems did not identify any defects that may have affected control of the aircraft. When examining the fuselage remains, the ATSB identified sections of carbon-fibre based products in the aircraft cabin and baggage compartment.

The nose undercarriage was noted to be in the down and locked position however the left and right main undercarriages were found housed in the wheel wells. The main undercarriage actuation and locking mechanism was found to be broken and the damage attributed to the wings separating from the fuselage.

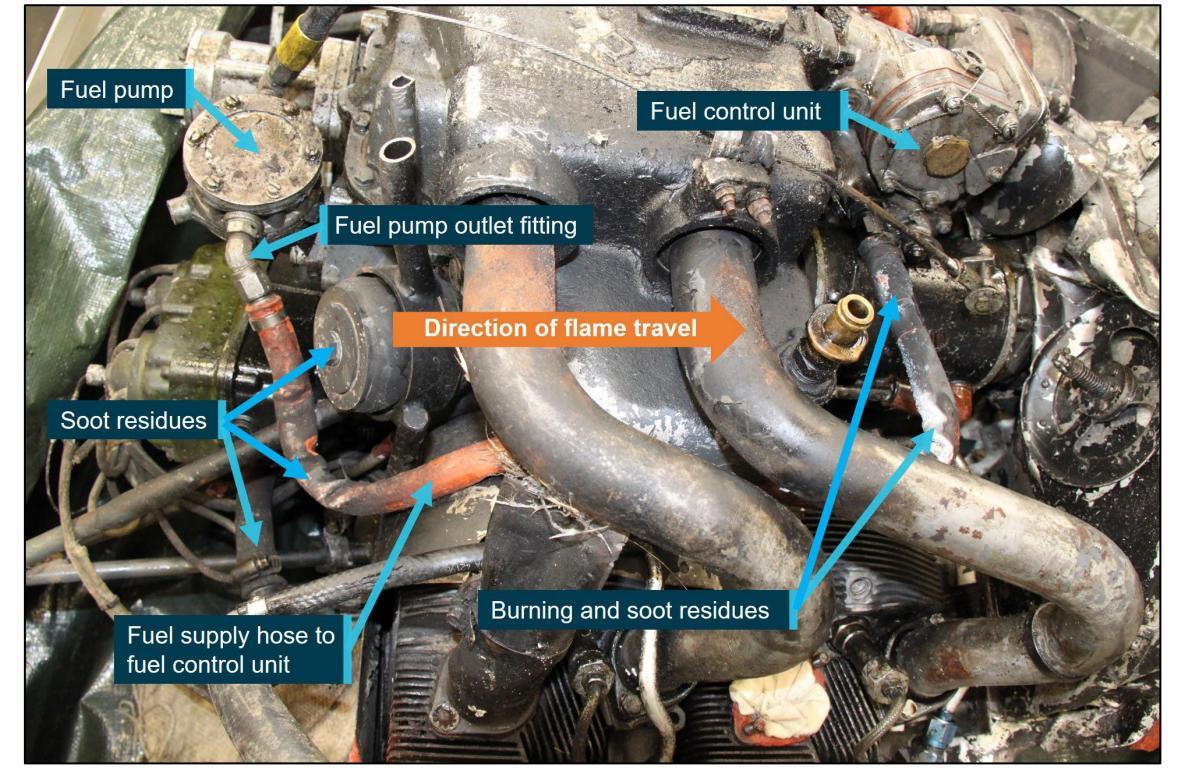
Figure 5: Underside of engine showing components and direction of flame travel

- Evidence of scorching and soot residue on engine hoses and components, presented as a distinct flame path that commenced at the rear of the engine and progressed to the front (Figure 5).
- The origin of the engine fire was localised to the area surrounding the engine-driven fuel pump.
- Pressure testing of the engine fuel supply and distribution hoses did not reveal any fluid leak associated with a hose defect.

• Pressure testing of the engine-driven, mechanical fuel pump detected fluid leakage at the base of the fuel outlet fitting of the pump.

below), it was likely that fuel leaking from the pump outlet fitting produced a vapor that was ignited by heat in the lower engine compartment.

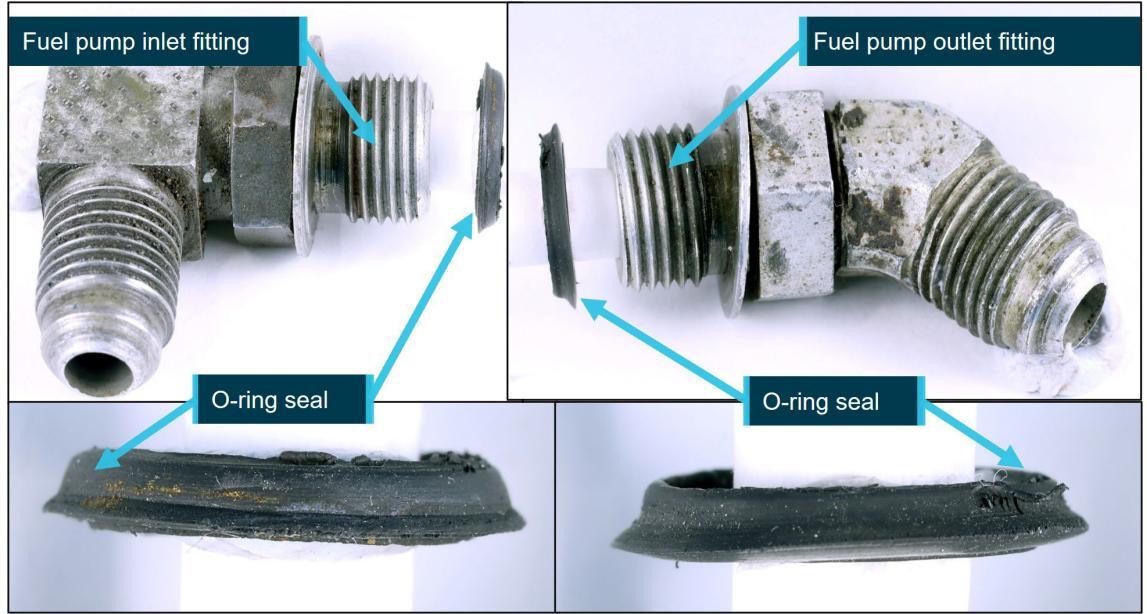
The fuel pump inlet and outlet fittings were removed to allow for examination of the O-ring seals installed between the fittings and the fuel pump body. Inspection of the outlet fitting seal revealed a deteriorated elastomer that had lost its pliability and its round, cross-sectional shape. Further, the seal showed signs of permanent deformation and contained surface defects (Figure 6).

The inlet fitting seal exhibited similar in-service defects as the outlet fitting seal, however the deterioration had not progressed to failing to provide an effective seal. The examination indicated that fuel under pressure was leaking past the outlet fitting O-ring.

An engine compartment fuel leak during the accident flight originated from the engine-driven, mechanical fuel pump outlet fitting due to an O-ring seal that had deteriorated with age and had lost the ability to provide an adequate seal. Maintenance related standard practices specify that O-ring seals are not reused, and they should be replaced when disturbed during maintenance or when a leak is detected.
