Wirestrike and collision with terrain involving Cessna 172N, VH-RSB

Near Merriton, South Australia on 8 October 2023

ATSB Transport Safety Report Aviation Occurrence Investigation (Short) AO-2023-046 Final – 23 May 2024 Released in accordance with section 25 of the Transport Safety Investigation Act 2003

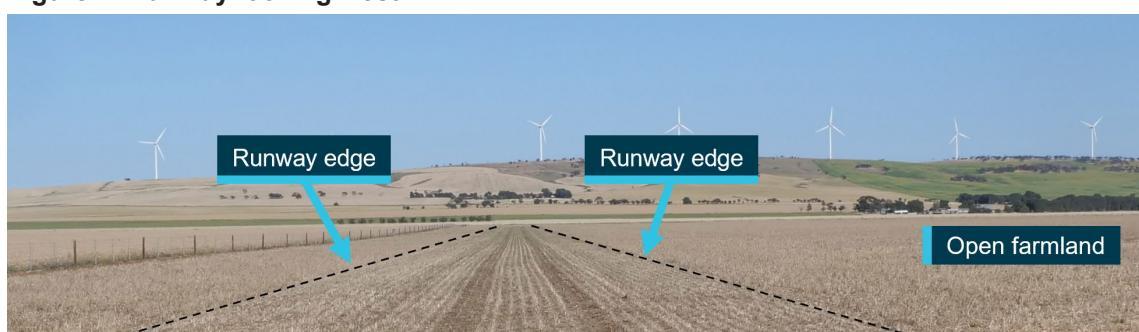
Figure 1: Runway looking west

The runway was a private strip on the aircraft owner's land and they lived less than 1km away. To prepare the runway, the aircraft owner had slashed crops in a relatively flat section of open farmland (Figure 1). It ran in an east–west direction adjacent to a fence line and was about 700 m in length. There were vehicle track marks running the length of the runway, and it was otherwise unmarked.

The extents of the runway were not clearly visible during the post-accident survey, and are illustrated in the following figures as an indication of its approximate location (Figure 1 and Figure 2).

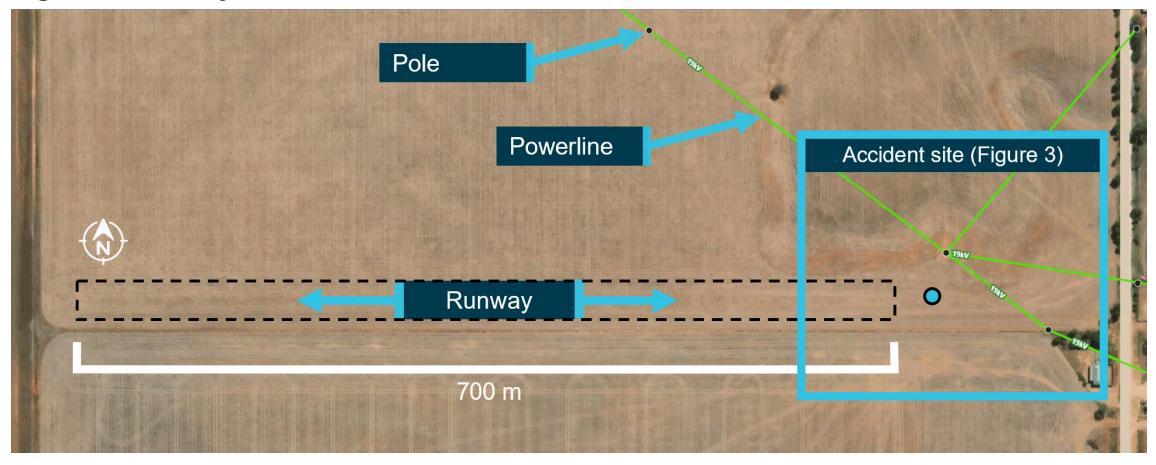
Figure 2: Runway overview

Powerlines are highlighted in green. Image source: Lookupandlive.com.au, annotated by the ATSB.

At the time of the accident there were cattle grazing in the paddock, though it is not known if they were in the vicinity of the runway. The terrain around the runway was also relatively flat, open farmland, and there was reportedly another runway prepared in the same paddock running north–south.

The 19 kV powerlines in the vicinity of the eastern threshold of the runway were of the single-wire earth return (SWER) type. The powerline was estimated to be at a height of 8–8.5 m (26–28 ft) at the point of impact.

Civil Aviation Safety Authority (CASA) Advisory Circular AC 91-02 v1.2 *Guidelines for aeroplanes with MTOW not exceeding 5700 kg - suitable places to take off and land* (Civil Aviation Safety Authority, 2022) recommends that pilots have a thorough awareness of the obstacles in the approach and climb-out flight paths. The ATSB estimated that an aircraft heading west with a typical approach angle of 3° would be in conflict with the powerline at any touchdown point less than about 162 m from it. To be at least 15 m (50 ft) clear of the powerline during landing, the touchdown point would need to be at least 453 m from the powerline, leaving about 420 m of runway for the landing roll.

The runway was about 700 m long, more than twice the take-off and landing distances required for a Cessna 172N. Moving the runway's eastern threshold away from the powerline would have reduced the chance of conflict. Even with the existing threshold location, using the end furthest from the powerline for take-off and landing would have reduced the risk of potential conflict.

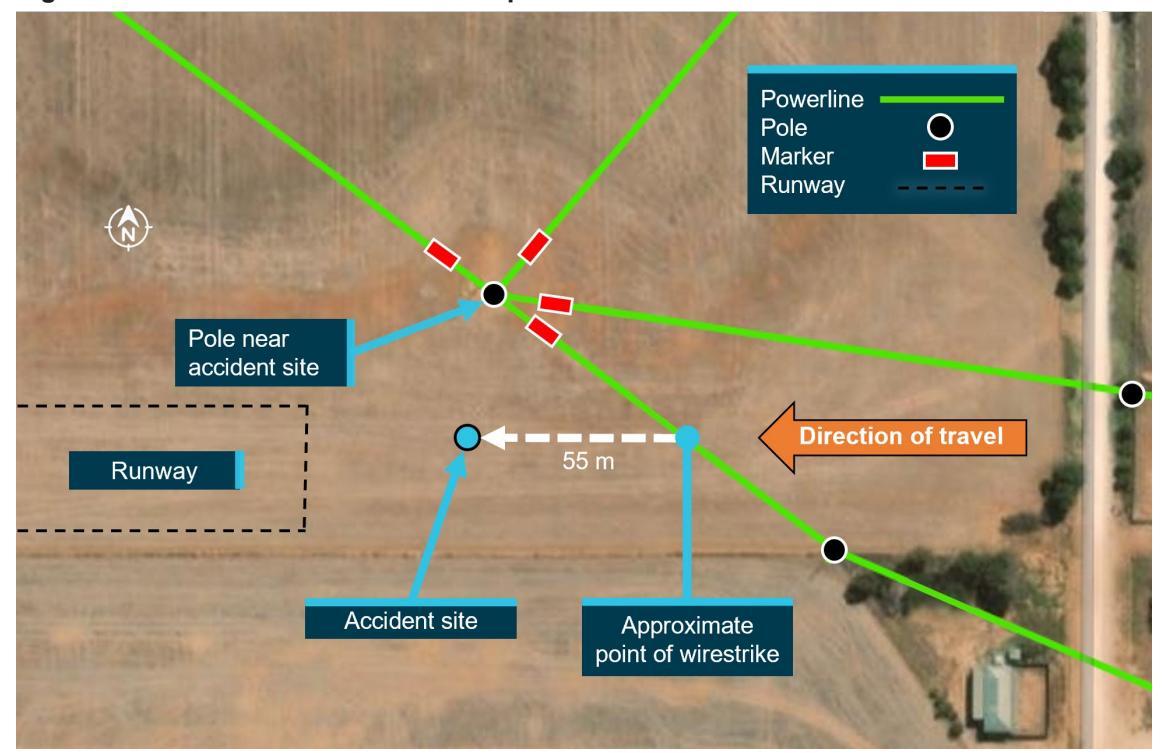
Figure 3: Accident site and location of powerlines

Powerline markers had been fitted to each of the 4 powerlines about 4 m from the pole nearest to the accident site (Figure 3). The markers were marine buoys that had been repurposed as powerline markers. Originally, they would have been bright red, but had faded considerably (Figure 4).

The owner of this infrastructure, SA Power Networks, advised the line markers had been installed in November 2000. They were installed to alert helicopter pilots flying along a powerline for annual pre-bushfire patrols to the presence of another powerline crossing above or below.

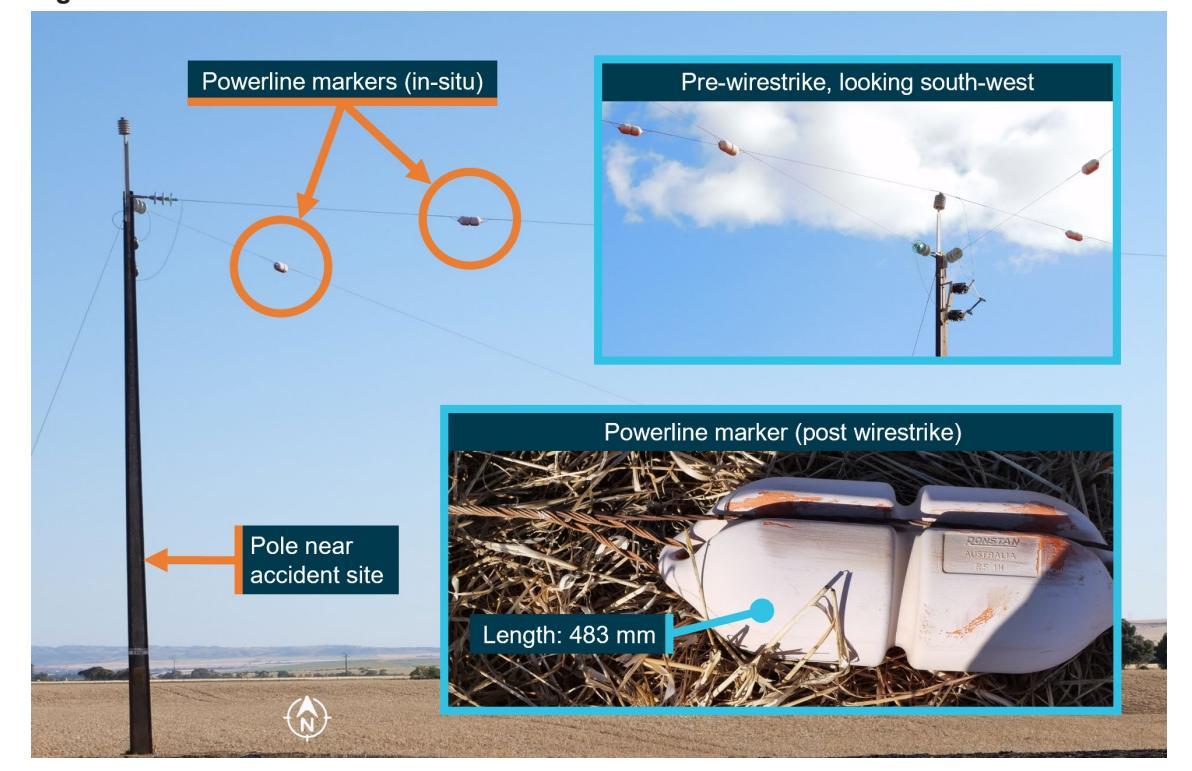
Figure 4: Powerline markers

While there were no powerline markers in line with the runway, the markers adjacent to the nearby pole could alert or remind a pilot to the presence of the powerline. However, their original purpose was to alert pilots flying along a powerline to the presence of another powerline crossing above or below, rather than for a pilot using the runway, and their visibility and location was not optimal for landing on the runway in their locations.

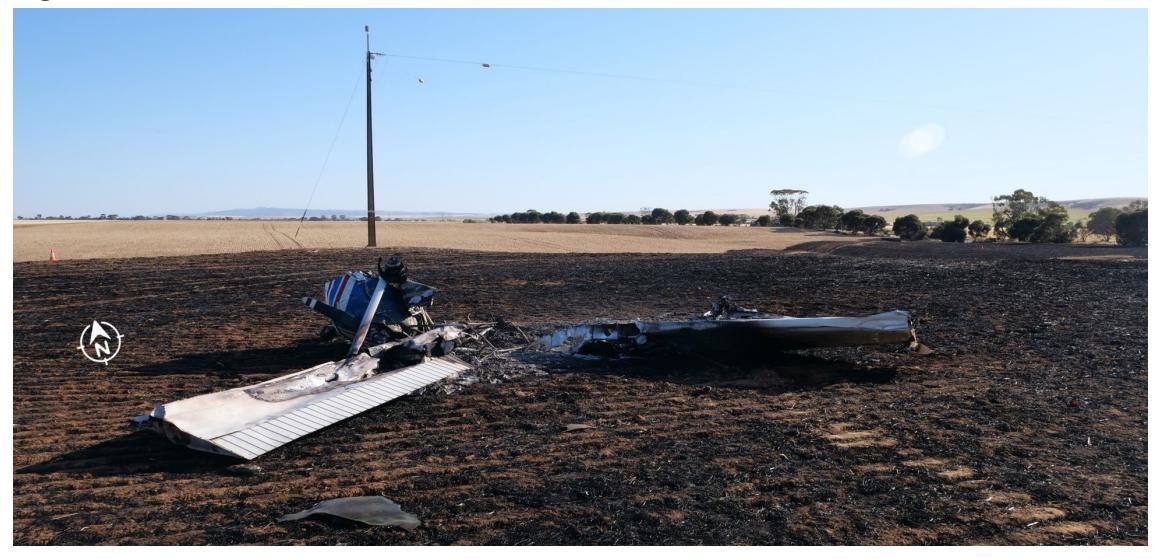
Figure 5: VH-RSB at the accident site

The aircraft's cabin, wings, and fuselage were severely damaged by the intense post-impact fire, limiting the extent to which pre-impact defects could be identified (Figure 5). However, from the evidence available:

- the wreckage position, damage to the left wing strut, and the marks from the powerline on the propeller, engine cowl, and right wing was consistent with the aircraft striking the oblique powerline heading west
- the aircraft impacted terrain steeply and inverted, probably right wing and engine first
- the propeller had indications that the engine was running at low power at the time of impact
- the flap actuator extension was consistent with a flap setting of 10° (see *Cessna 172N flap settings*).

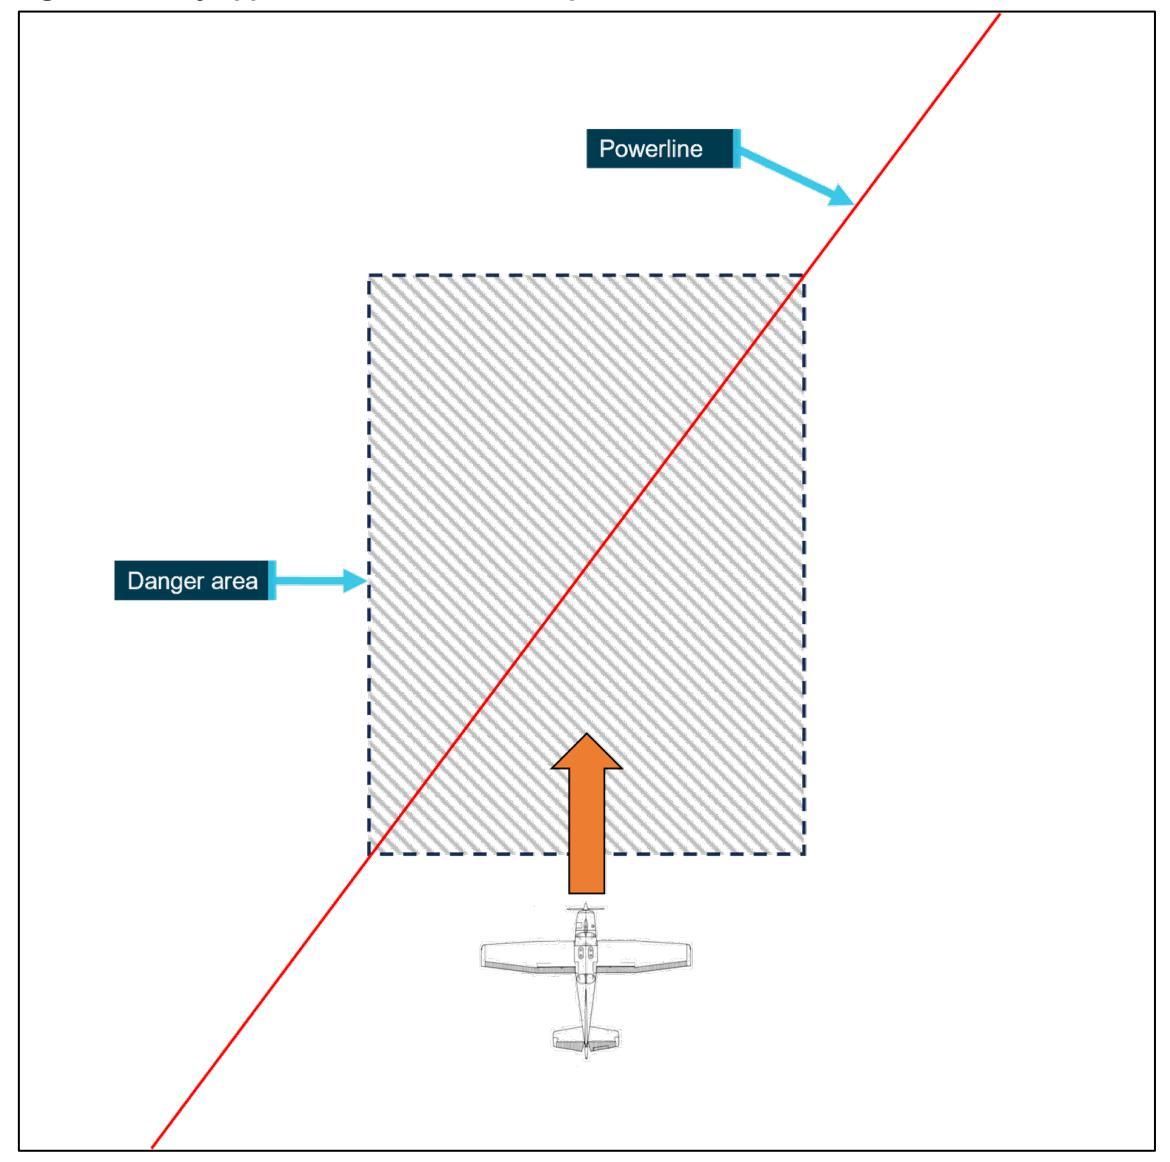
Figure 6: Likely approach of VH-RSB to the powerline

The publication also detailed a number of wirestrikes where aircraft struck a powerline that was known to the pilot. The publication outlines a number of strategies developed by the Aerial Application Association of Australia (AAAA) to help manage the risks associated with aerial operations around overhead powerlines. Regarding aircraft approaching oblique powerlines (as was the case on the accident flight, see Figure 6), the AAAA pilot's manual states:

Crossing a line of wires at an oblique angle [compared to at a right angle] provides a slower rate of closure with the line as a whole and will allow more time to see it. However, the actual speed of crossing a point directly ahead will of course be the same as if it were crossed at right angles.

The danger here is that the pilot's preoccupation with this point may lead to a lack of appreciation of the fact that the aircraft's wing tip will reach the point directly ahead of it slightly earlier. In other words, the pilot may base his [sic] judgement on the wrong section of the wire.

Further, the powerline's oblique orientation relative to the runway can also increase the chance of a pilot misjudging the point where the aircraft was in conflict, increasing the risk of a wirestrike.

A crossing at right angles is to be preferred wherever possible as this reduces the danger area to the thickness of the wire.

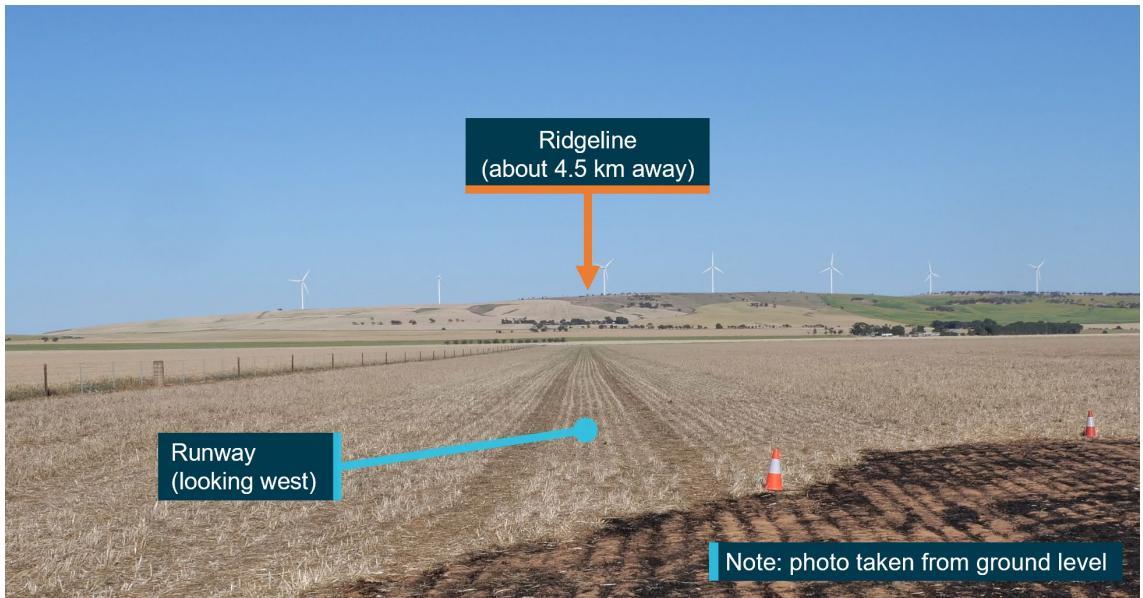
About 4.5 km to the west of the accident site and runway, the terrain rises up from relatively flat, open farmland to a ridgeline (Figure 7).

As outlined in the US Federal Aviation Administration (FAA) publication AM-400-00/1 – *Spatial Disorientation Visual Illusions* (Federal Aviation Administration, 2011), runways that are positioned on up- or down-sloping terrain can produce a visual illusion during the approach to landing. For down-sloping runways, it can result in the pilot believing their approach is low, pitching up, and inadvertently making a steeper approach. Conversely, for up-sloping runways, it can result in the pilot believing their approach as shallower approach.

This can be more pronounced if the up-slope occurs beyond the runway. Pilots may unknowingly move their perception of the horizon toward the top of the rising terrain and create the same visual illusion as an up-sloping runway, resulting in a shallower approach (Previc and others 2004).

The visual illusions associated with sloping terrain can also occur with up-sloping terrain in the distance. In this case, the rising terrain beyond the runway could produce this visual illusion. Had this occurred, the pilot may have mistakenly corrected to a shallower approach, putting the aircraft in conflict with the powerline.
