Collision with terrain involving a Stoddard Hamilton Aircraft Glastar, VH-BAQ

About 18 km north-west of Noosa, Queensland on 12 November 2023

ATSB Transport Safety Report Aviation Occurrence Investigation (Short) AO-2023-056 Final – 14 June 2024 Cover photo: Source: Photo provided by pilot in command

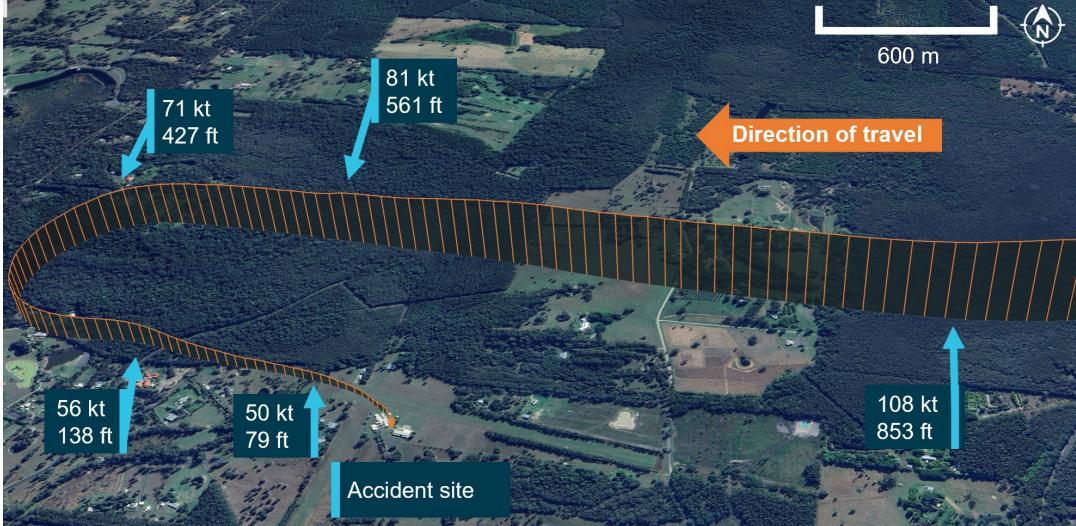
Figure 1: Approach to Greenfields airstrip

They advised that as they crossed a tree line in the runway undershoot (Figure 1) the aircraft encountered sink and in response, they twice increased the engine power. The pilot reported that, despite the increased engine power, the aircraft touched down firmly and simultaneously the aircraft was struck by a gust of crosswind, which picked up the left wing and turned the aircraft to the right towards the house.

This data identified that the aircraft joined downwind at approximately 853 ft above sea level² while descending at 108 kt groundspeed³ (Figure 1). The aircraft subsequently turned base at 427 ft and slowed to 71 kt. The groundspeed when the aircraft turned final was approximately 62 kt and during approach, the speed continued to reduce. The speed as the aircraft crossed the tree line was approximately 55 kt, with the aircraft crossing the threshold at 49 kt.

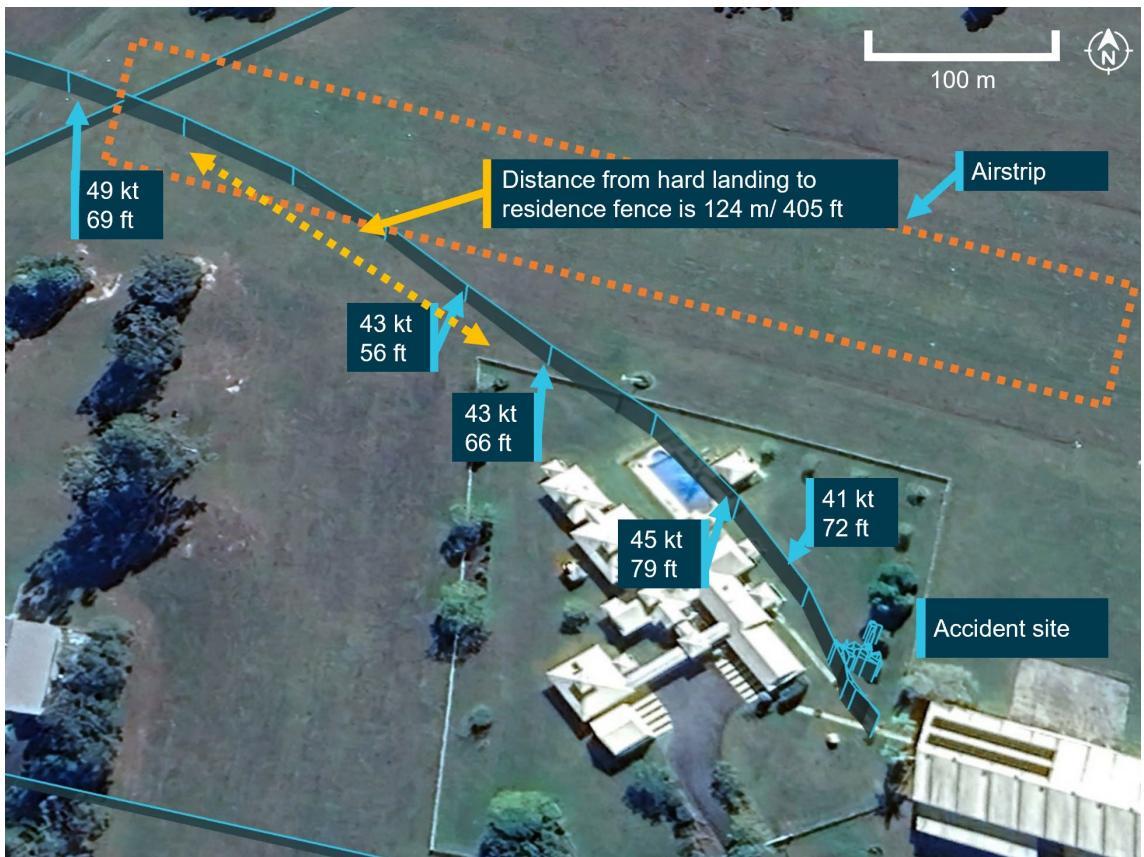
Figure 2: Missed approach and track divergence

During the go-around, the speed reduced from approximately 50 kt to between 40–44 kt until the aircraft struck the tree (Figure 2).

It is likely that the pilot was surprised by divergence as, although they applied full power to conduct a go-around, they did not realign the aircraft with the runway, resulting in the aircraft becoming airborne heading towards obstacles. A pilot's decision making can take up to 4 seconds to perceive and react to an unexpected action and in this time frame the aircraft had travelled towards the obstacles.

As the aircraft likely became airborne at less than the best angle of climb airspeed, V_X (65 kt IAS) the available climb performance was relatively poor and, due to the immediate proximity of obstacles, there was limited ability to accelerate to V_X via a shallow climb profile. Consequently the aircraft's speed and height remained low, resulting in the aircraft striking the top of the tree close to the stall speed, before colliding with terrain.

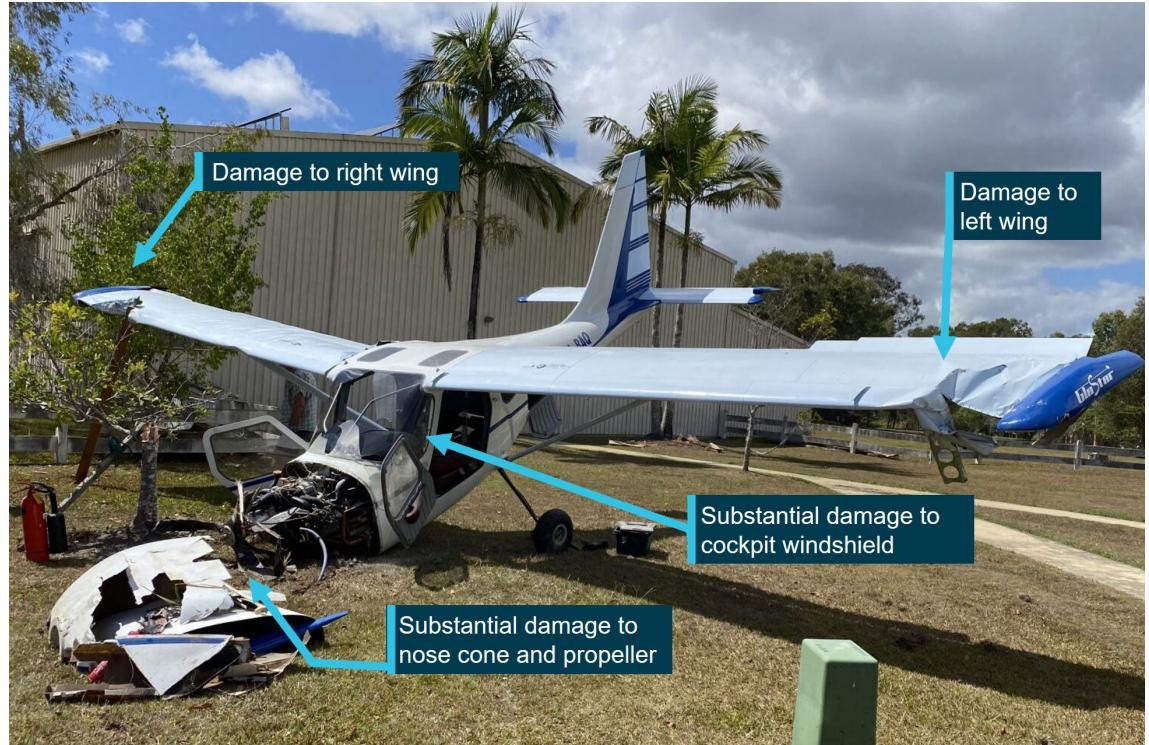
Figure 3: Aircraft damage

The ATSB did not attend the accident site and therefore did not conduct a detailed inspection of the wreckage. However, photographs of the site (Figure 3) were provided to the ATSB and they showed:

- damage to the nose cone, with the propeller largely detached from the engine
- substantial damage to the cockpit windshield
- damage to both wings from contact with terrain.
