Aircraft Accident Investigation Report 821-1004

Cessna 411A VH-AYE Archerfield, Queensland 5 January 1982

BUREAU OF AIR SAFETY INVESTIGATION

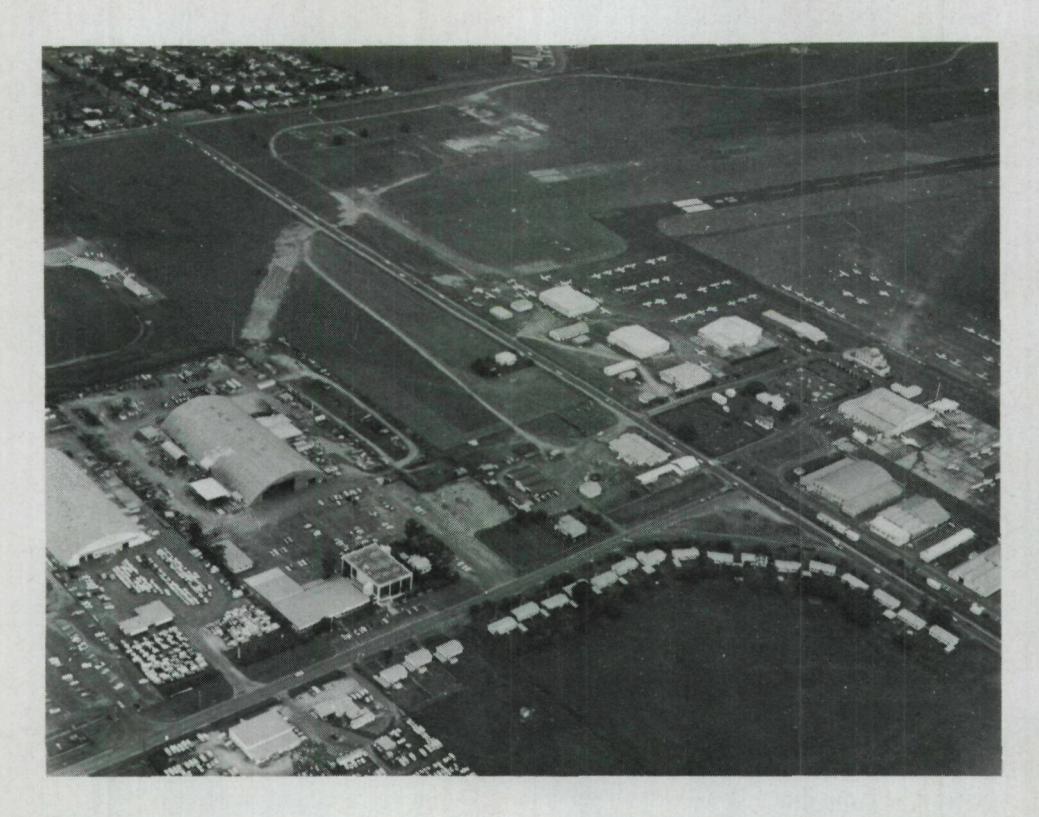
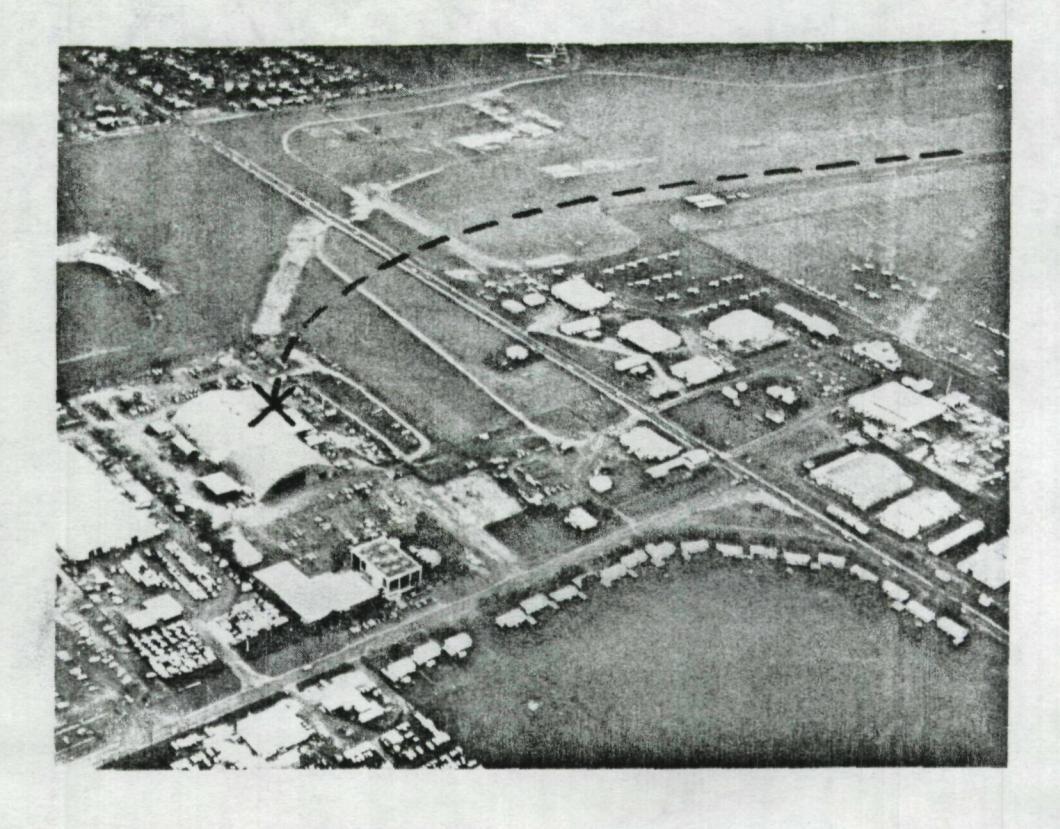
Figure 2. Aerial view of the accident locality, facing south west, showing the departure end of Runway 10L, the approximate flight path of Cessna 411A VH-AYE and the accident site.

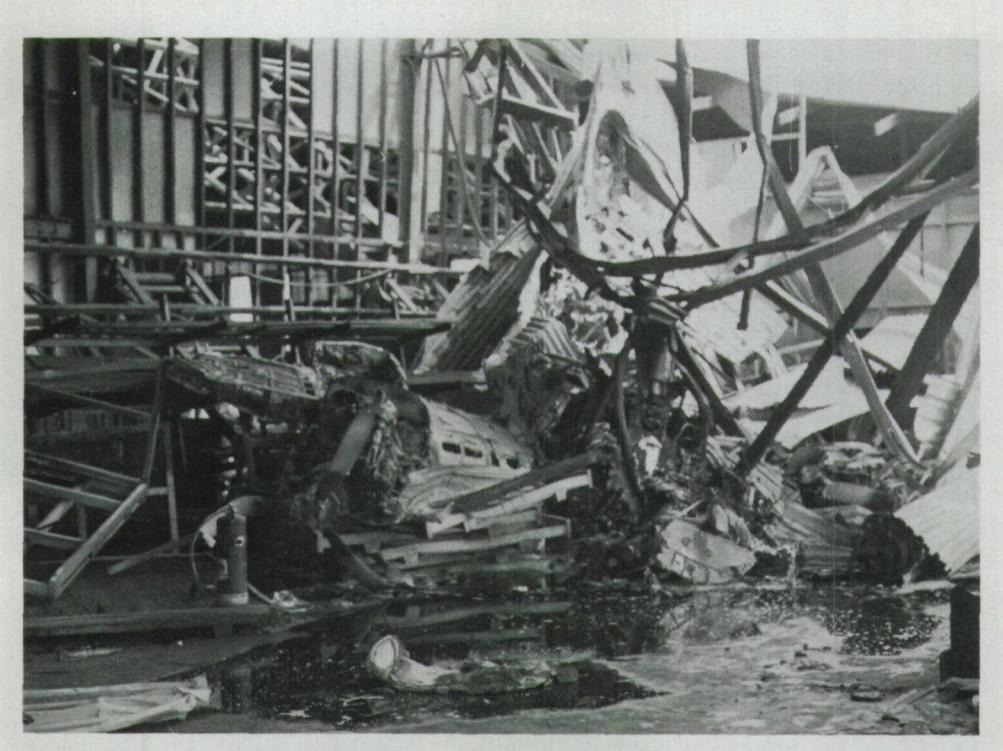
The front of the wreckage was resting on the concrete floor of the annex with the tail section about four metres above the floor supported by the buckled roofing and structure. The only major items separated from the bulk of the wreckage were the wingtip fuel tanks, the nose wheel and lower nose gear leg but these were located within a few metres. A large proportion of the wreckage was consumed by the post-impact fire. All the wreckage was affected by the fire.

Figure 4. General view inside the annex showing the aircraft wreckage interspersed with the building structure. The aircraft is facing towards the viewer with the cockpit area near the centre of the photograph.

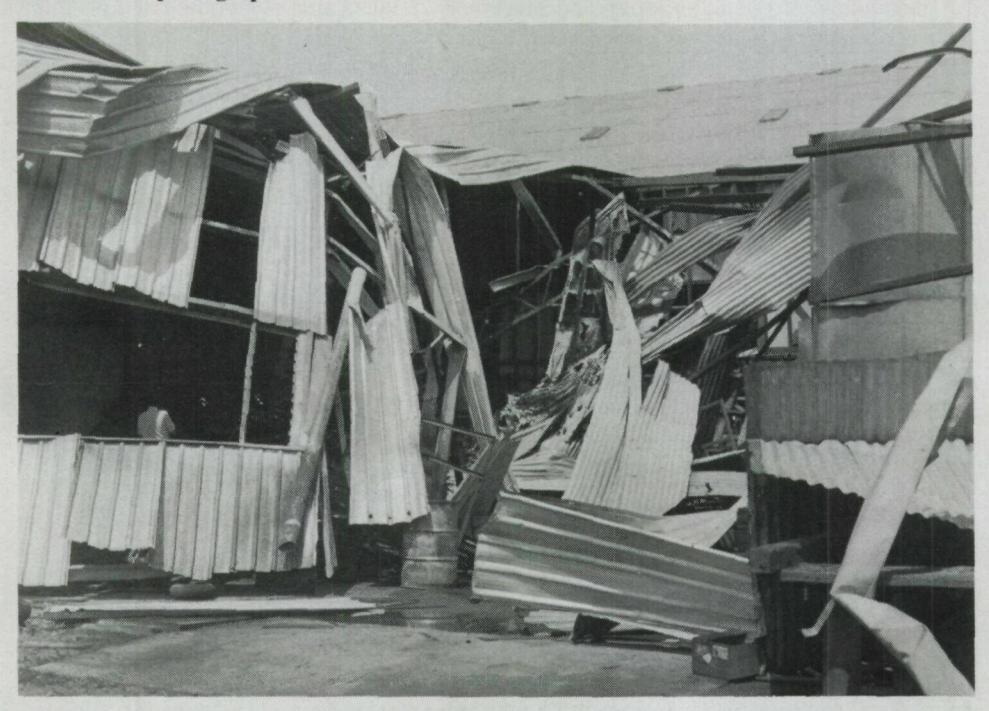
Figure 5. View towards the east of the outside of the annex. The remains of the vertical stabiliser can be seen in the centre of the photograph.

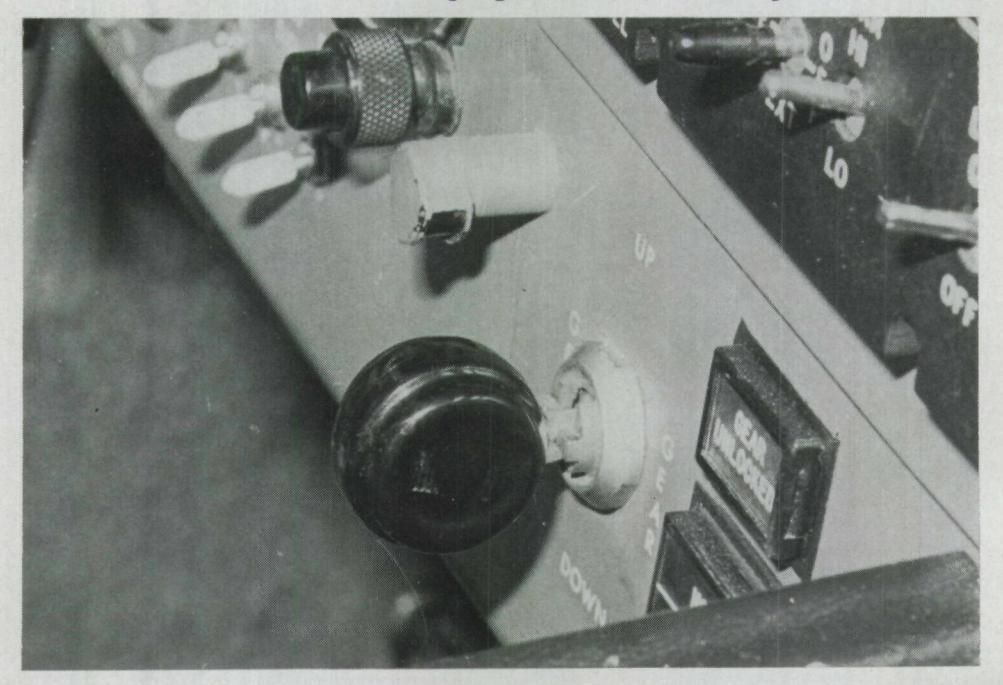
Figure 8. Typical landing gear selector switch as fitted to Cessna 400 series aircraft. Note that the switch is shown in the Off (centre) position.

- (a) Mechanical malfunction during the retraction cycle. As far as could be determined there was no evidence of any failure or defect that would have prevented the landing gear from retracting. The landing gear selector switch and most of the wiring were consumed by fire.
