Interrupted engine start and evacuation involving Saab 340B, VH-ZRK

Melbourne Airport, Victoria, on 5 April 2022

ATSB Transport Safety Report Aviation Occurrence Investigation (Defined) AO-2022-019 Final – 4 December 2024 Cover photo: Melbourne Airport

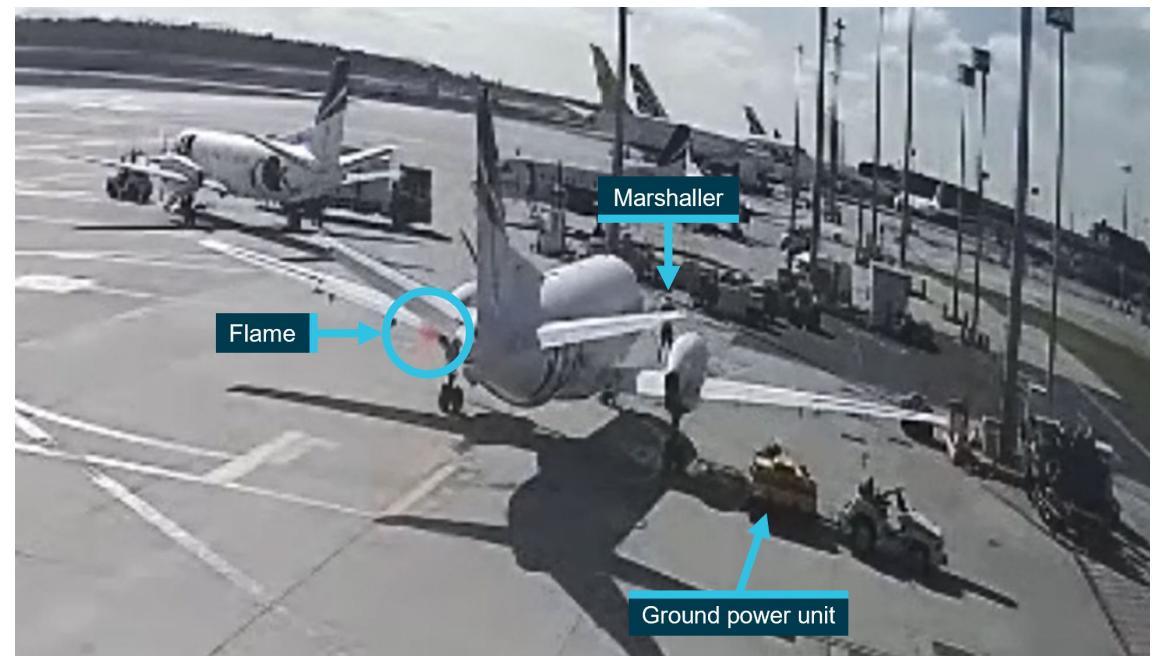
Figure 1: Still image of CCTV showing flame during first motoring attempt

At 1445:28, as the left engine propeller began to rotate again as part of the engine motoring procedure, a tailpipe fire had developed as indicated by flame and smoke coming from the rear of the engine. The marshaller, who was still positioned at the front of the aircraft, saw a 'burst of flame' from the back of the engine (Figure 1) and began to signal to the flight crew to stop what they believed to be an additional engine start (as they were unaware of the motoring procedure). As the marshaller and flight crew were not able to communicate verbally (there was no radio and no communications headset for the Saab 340), the marshaller reported they tried to signal to the captain to shut the engine down using a 'cut-throat' hand signal. They also tried to indicate that there was a fire coming from the back of the engine, however, the marshaller could not recall the hand signal for fire and instead attempted to communicate it by mouthing the word 'fire' and gesturing to the left engine. CCTV recorded the marshaller waving their hands at this time. The captain was responding to the marshaller verbally (noting the marshaller could not hear) advising that they had to continue, however the marshaller continued to try to advise that they had seen fire from the left engine. As a result of the marshaller indicating they observed flames from the engine, the captain ceased motoring the engine and the left propeller stopped rotating.

However, during this process burning fuel was blown through the tailpipe, appearing as a plume of flame and smoke behind the engine. As the left propeller began to rotate during this motoring attempt, the marshaller (unaware of the motoring required by the procedure) mistakenly thought that the flight crew were attempting to restart the engine. Having observed the flame and smoke, the marshaller signalled to the flight crew, which prompted the captain to stop motoring the engine. Residual fuel would have continued to burn inside the engine.

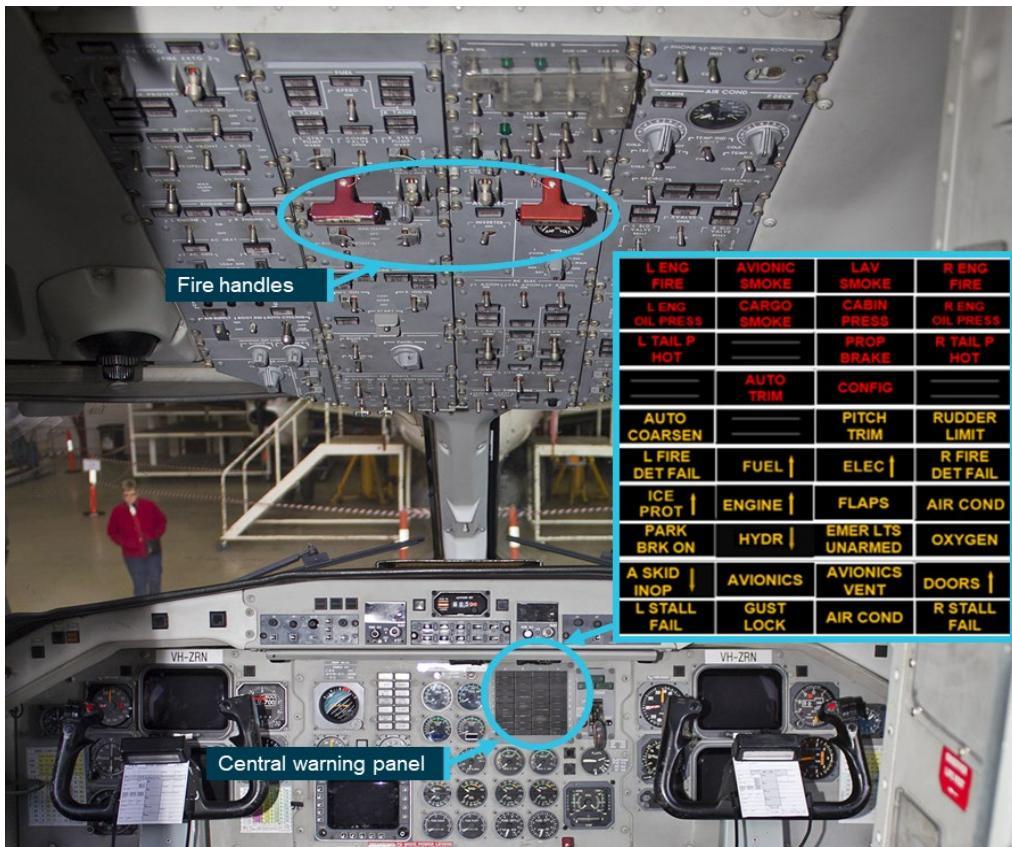
Figure 2: Saab 340B flight deck

Engine fire detection was provided by a continuous loop detection circuit mounted under each engine, outside of the casing when the temperature reaches approximately 300°C. Proximity of fire to this loop would change its characteristics and trigger multiple types of warnings in the flight deck. These warnings consisted of a fire bell, master warning lights, a caption for each engine on the central warning panel, and lights in the fire handle for the relevant engine (Figure 2).

Each engine also had tailpipe overtemperature sensors that triggered the master warning lights and a caption for each engine on the central warning panel (CWP) in the flight deck if the temperature in the tailpipe reached approximately 235 °C. The lights would extinguish after the temperature had reduced.

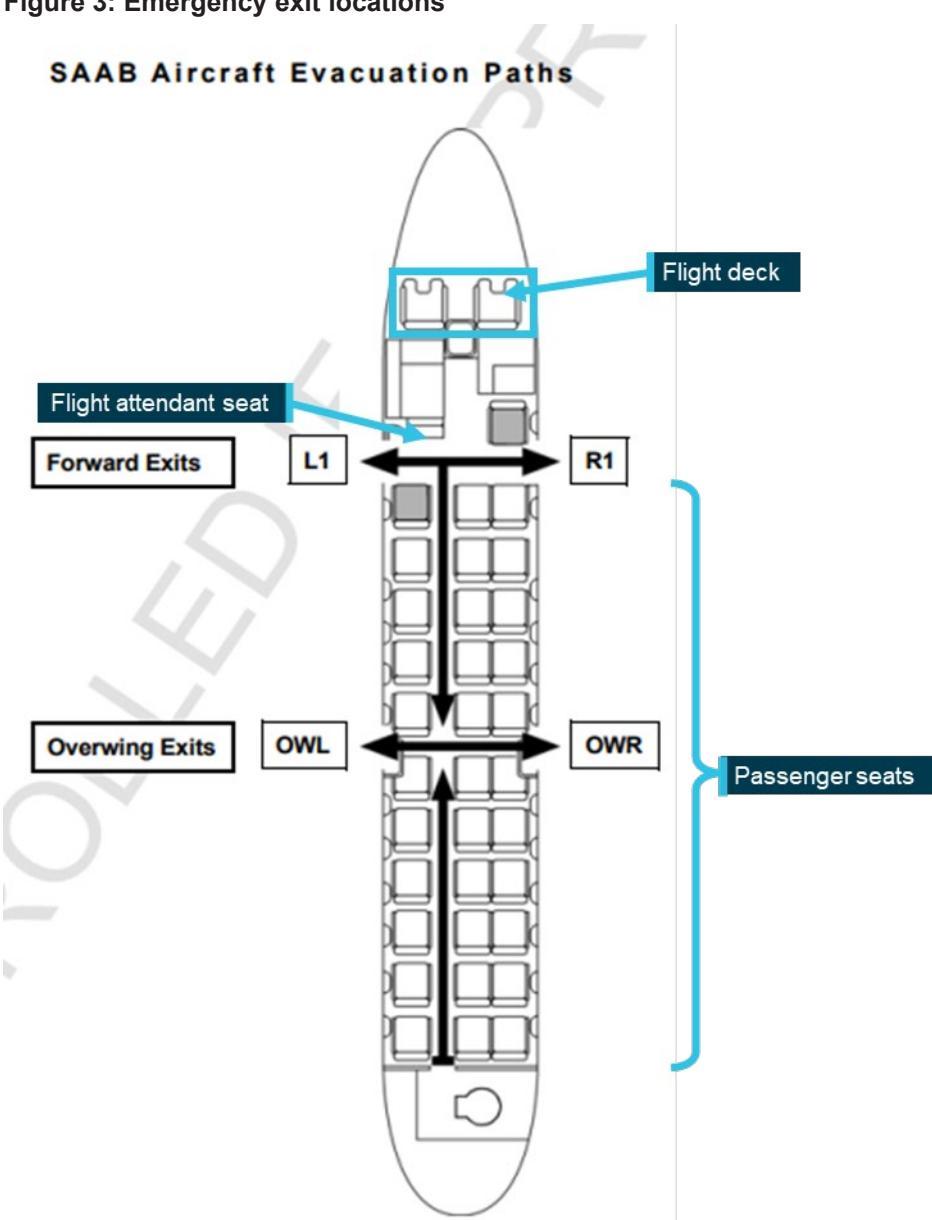
There are 4 emergency exits on the Saab 340 type aircraft. There are 2 exits at the front of the cabin in row 1, and 2 overwing exits in row 6. The sill height of the 2 forward exits is 1.68 m, with no emergency escape slides fitted (Figure 3).

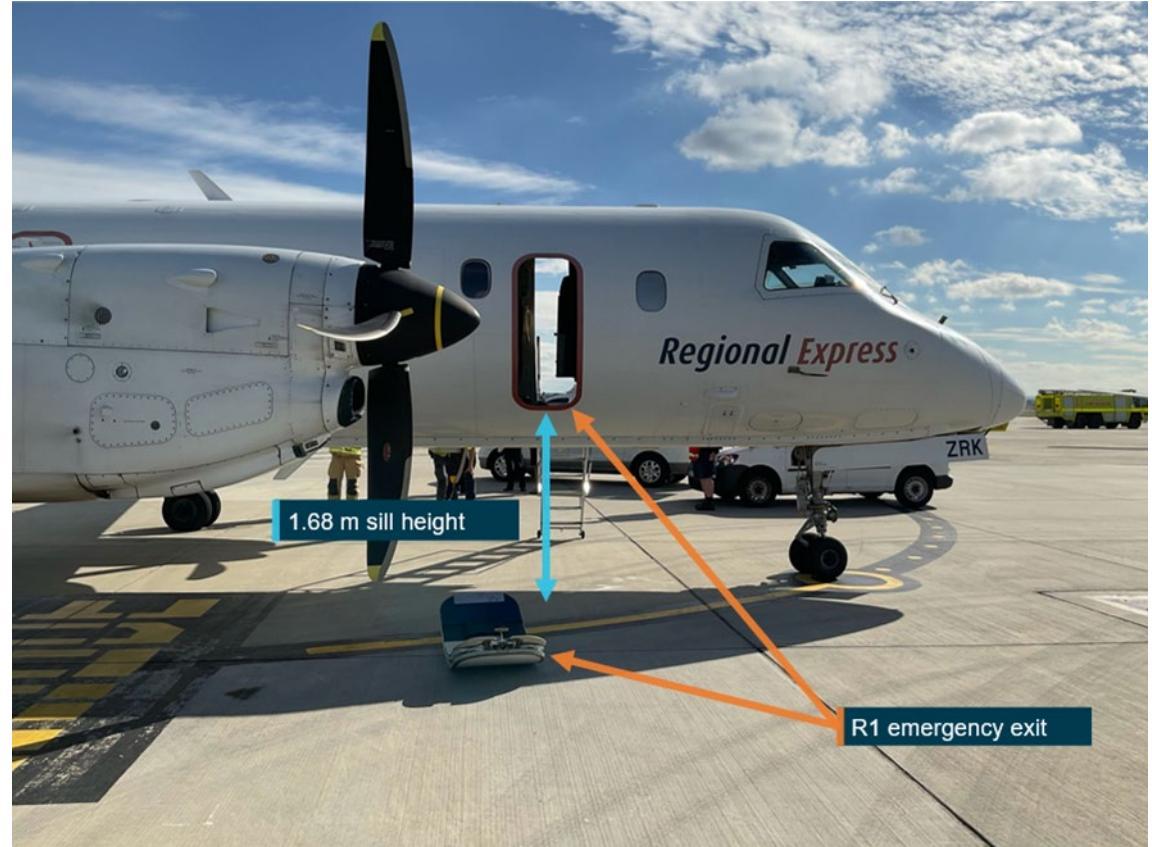
Figure 4: R1 emergency exit on the Saab 340B

The first passenger at the R1 exit hesitated due to the height of the door sill (1.68 m without steps or escape slide) but was encouraged by the flight attendant to exit. This passenger received a minor injury. The FO exited the aircraft after the first passenger, and a refueller and ground staff assisted the remainder of passengers to evacuate. The flight attendant continued to instruct passengers to evacuate and to 'sit and jump'. Some passengers attempted to bring their bags during the evacuation and the flight attendant and the captain (after exiting the flight deck) instructed them to leave everything behind. After receiving these instructions, a small number of passengers still exited the aircraft with their bags.

For this occurrence, the evacuation, from when the evacuation announcement was made until all passengers and crew had evacuated, was completed in about 4 minutes utilising one of the 4 exits.
