# Turbulence event and cabin crew injury involving Boeing 737, VH-VYK

36 km south-east of Brisbane Airport, Queensland, on 4 May 2024

ATSB Transport Safety Report Aviation Occurrence Investigation (Defined) AO-2024-032 Final – 27 May 2025 Cover photo: Nicholas Kimura

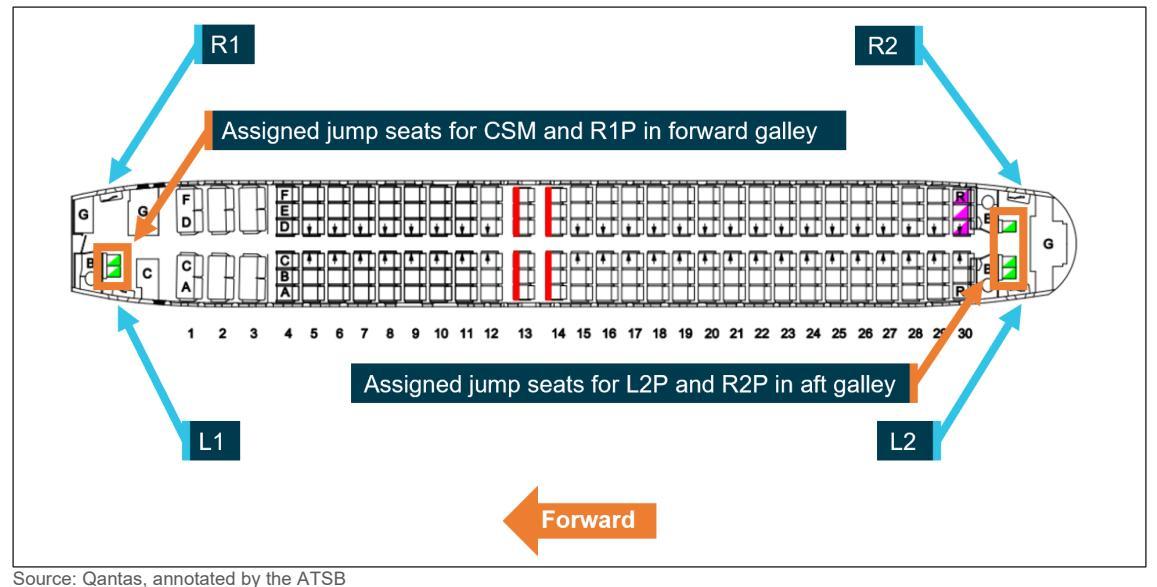
Figure 1: 737 Cabin layout, doors and assigned jump seats for cabin crew

The cabin crew on board was comprised of a complement of 4 members, with their assigned jump seats located in the forward and aft galleys. Each cabin crew member was responsible for one of the 4 main cabin doors (Table 1) during critical phases of flight, with their assigned jump seat (Figure 1) located immediately next to their assigned door. The cabin crew were under the supervision of the customer service manager (CSM) who was responsible to the captain for administration of in-cabin service and liaison with the crew for all service and safety related matters.

The R2P had been in the process of taking their seat when the turbulence occurred. They rose into the air during the turbulence, struck their head on the ceiling, and landed heavily on their feet. R2P immediately fell to the galley floor and told L2P that they were injured, possibly with a broken bone. They were later diagnosed in the hospital with a fracture involving 2 breaks in the ankle and another break in the leg, which required surgery.

The L2P sustained a head injury, due to striking the ceiling or other aircraft fixtures during the event but did not initially believe they were injured. They had several rostered days off after the event. They returned to work on 11 and 12 May and were made aware by co-workers that they were displaying symptoms of possible injury. On 16 May, 12 days after the turbulence event, they were diagnosed with concussion after a consultation with their general practitioner.

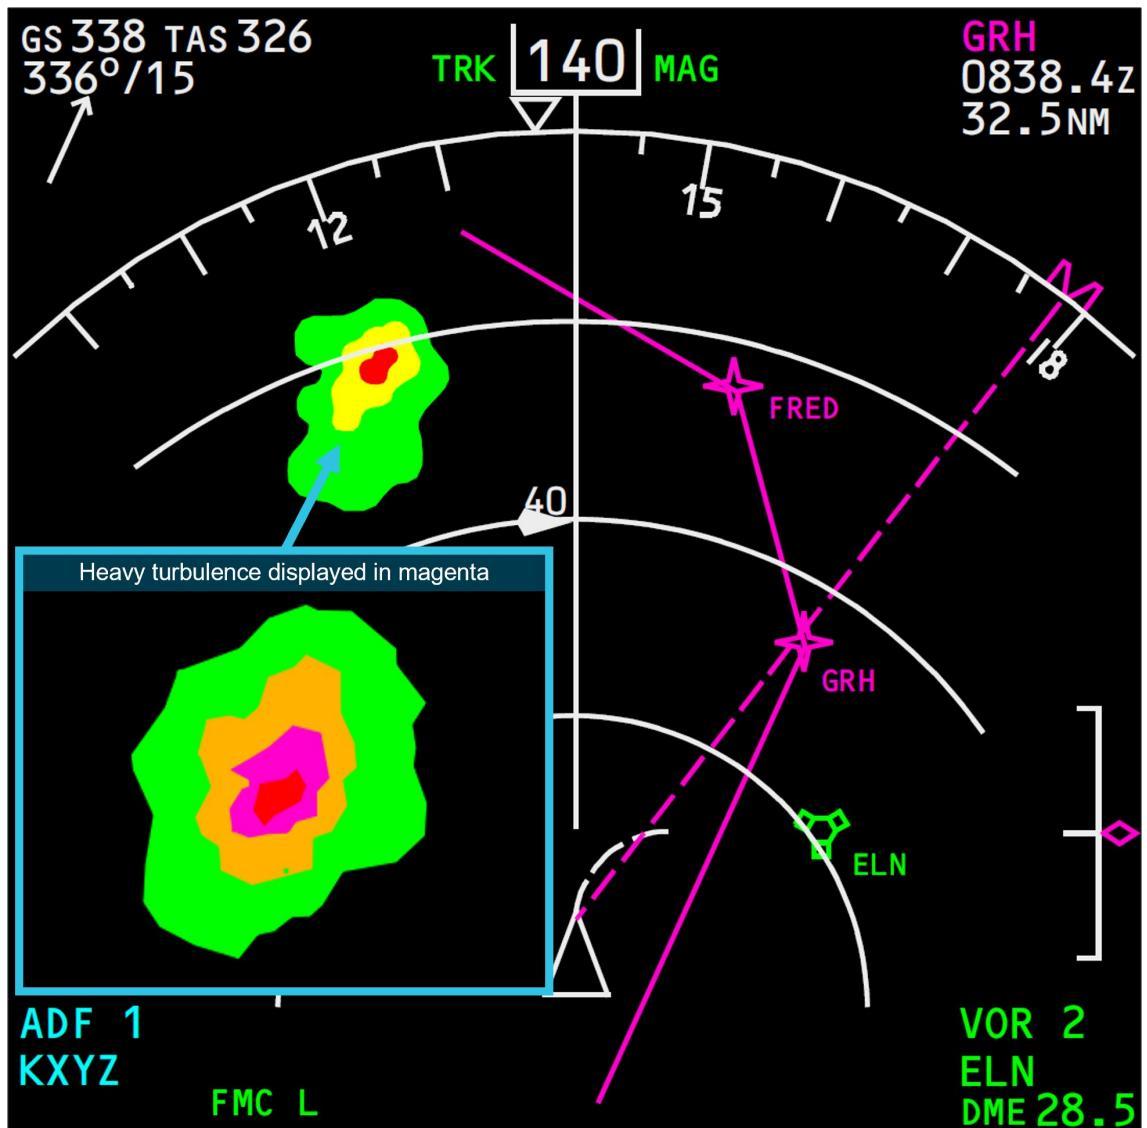
Figure 2: Example depiction of 737 weather radar returns on pilot's navigational display

The turbulence mode displays normal precipitation and precipitation associated with turbulence. When the radar detects a horizontal flow of precipitation with velocities of 5 or more metres per second toward or away from the radar antenna, that target display becomes magenta. These magenta areas are likely associated with heavy turbulence.

The captain did not recall identifying areas of turbulence on the weather radar on descent or report that they were experiencing any difficulties operating the weather radar. Neither the captain nor the operator reported that the weather radar fitted to the aircraft was unserviceable during this occurrence.

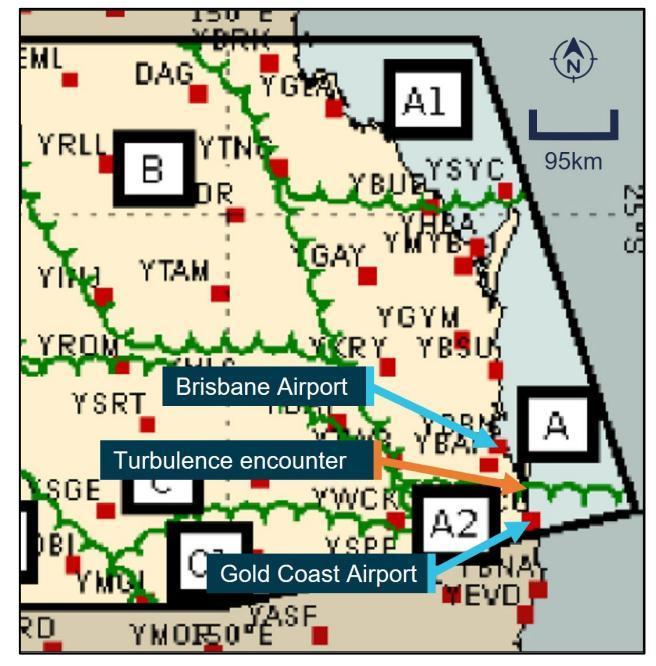
Figure 3: Graphical area forecast Queensland south

The flight transited through a region contained in the graphical area forecast for Queensland south, covering subdivisions A and A2 (Figure 3). Table 3 shows the

forecast conditions for the duration of the descent into Brisbane Airport which was issued at 0815 local time.

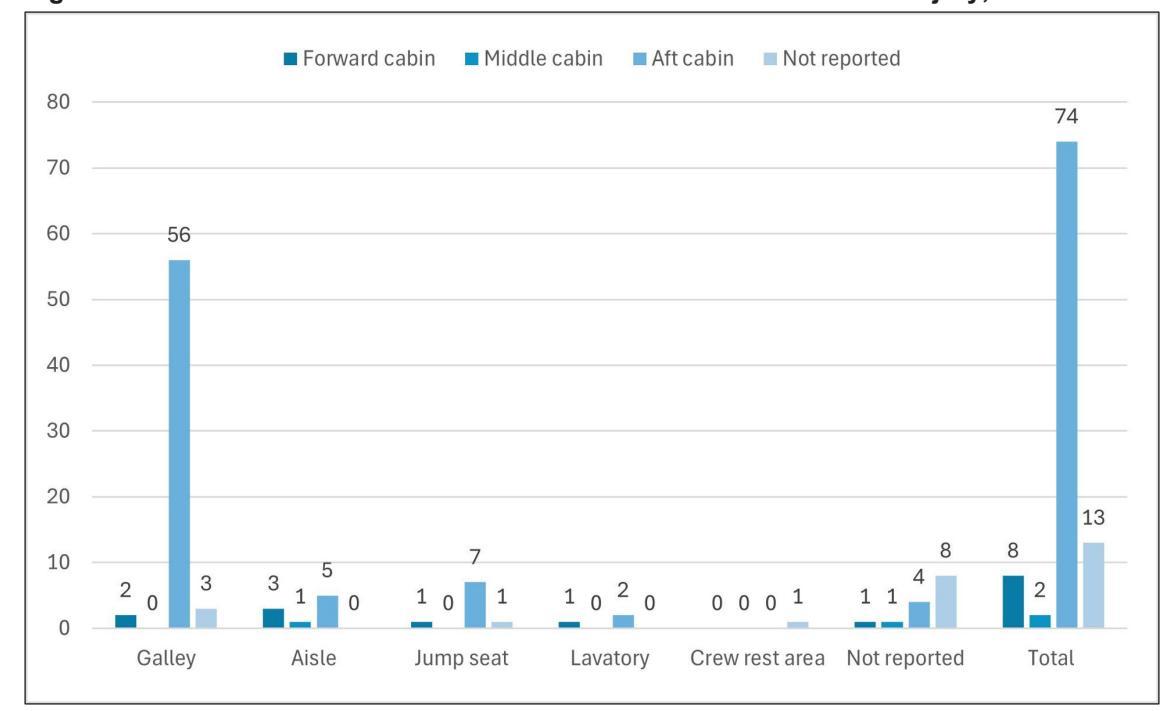
Figure 6: Location of cabin crew at time of turbulence-related serious injury, 2009–2018

The distribution of cabin crew injuries found most occurring in or near an aft galley (Figure 6), which likely reflects that the service-related duties of cabin crew often require

During this occurrence, the R2P and L2P sustained the most severe injuries while unrestrained in the aft galley as they prepared the cabin for landing, which is consistent with research on turbulence-related injuries.
