Collision with terrain involving Kawasaki KH-4, VH-BEU

24 km north of Katherine Tindal Airport, Northern Territory on 11 September 2024

Aviation Occurrence Investigation (Short) AO-2024-050 Final – 9 May 2025 Cover photo: Photograph supplied by lan McDonell

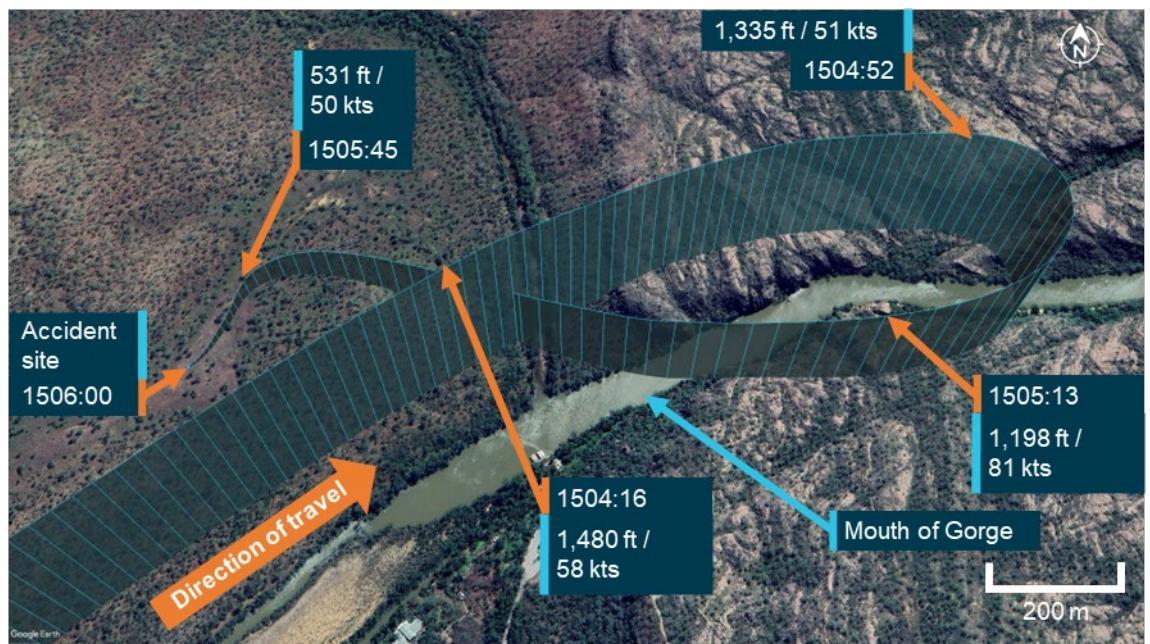
Figure 3: Helicopter flight path with identified elevation and ground speed

The helicopter proceeded downwind towards the clearing, attaining a maximum groundspeed in excess of 83 kt. Given the prevailing wind, that equated to an airspeed of about 70 kt, which was higher than the recommended autorotation speed for the helicopter type (see the section titled *Autorotation*). However, during the final approach to the selected landing site, the groundspeed, and given the crosswind approach, also airspeed was reduced to about 50 kt.

Analysis of flight data identified that the helicopter was over inhospitable terrain at the time of the power loss. After turning towards a suitable landing site, the pilot commenced an autorotation to that location. The helicopter proceeded downwind, initially attaining a maximum airspeed of about 70 kt. The airspeed was then reduced to close to the target minimum rate of descent airspeed of 48 kt, providing good potential flare effect to both slow the helicopter prior to touchdown and increase the rotor RPM if necessary.

Despite that, the pilot reported there was minimal flare effect when they approached the landing site, likely due to low rotor RPM. As a result, the pilot was unable to prevent the helicopter colliding with terrain during the termination. Importantly however, none of the occupants were injured.

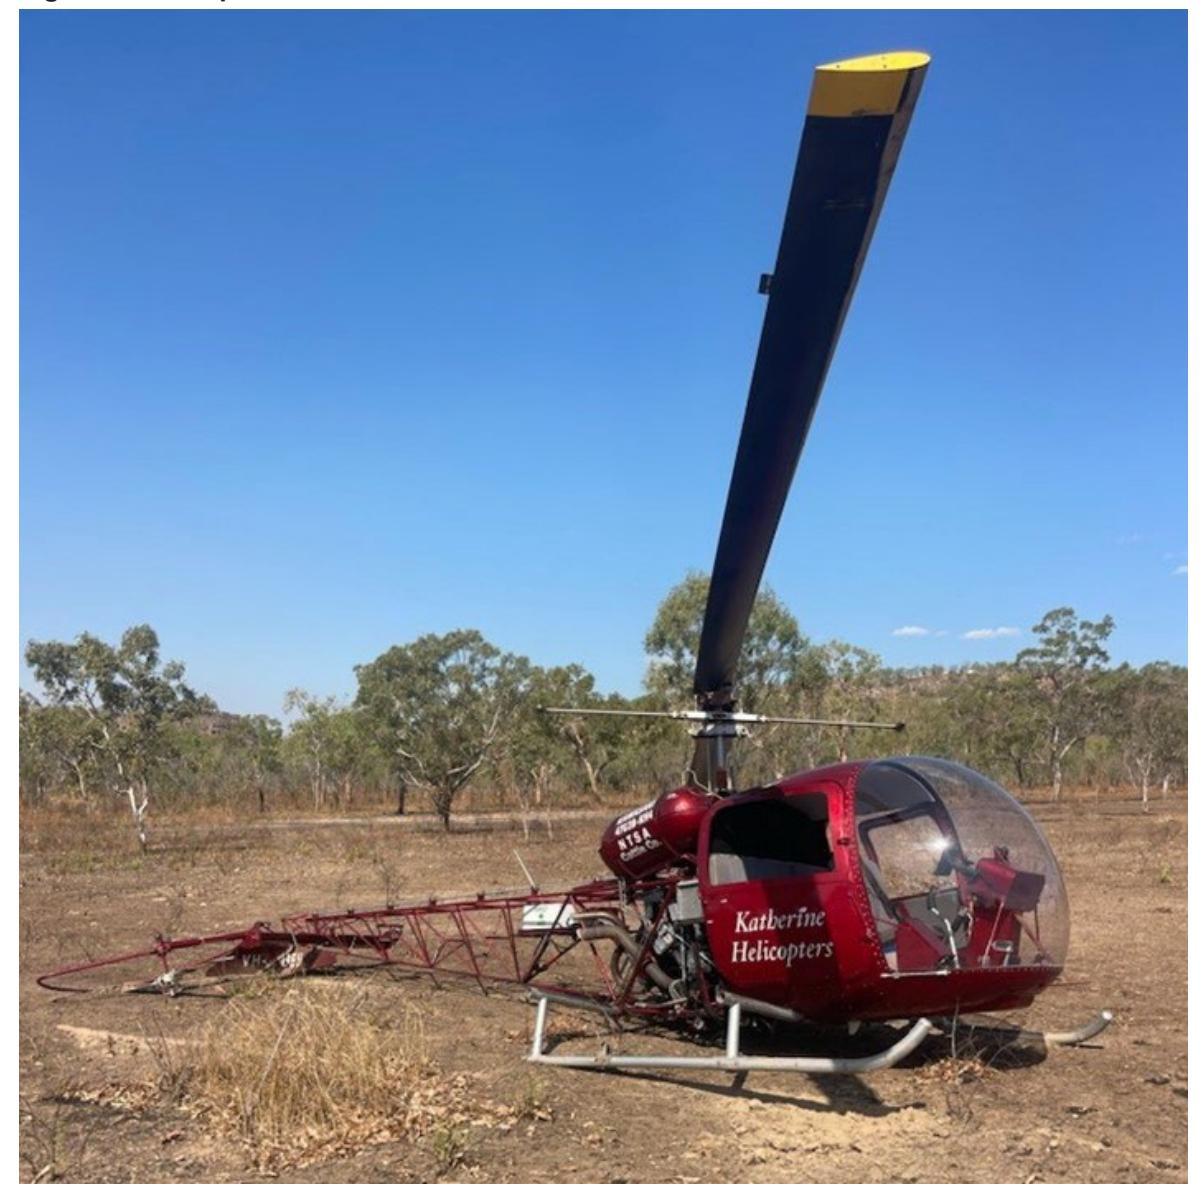
Figure 4: Helicopter accident site

The pilot reported that, on nearing the landing site, they attempted to flare the helicopter but there was minimal flare effect, which they assessed was most likely due to low main rotor RPM. Consequently, the pilot attempted a run-on landing, during which the helicopter collided with terrain, damaging its tail rotor/shaft and skids (Figure 4).

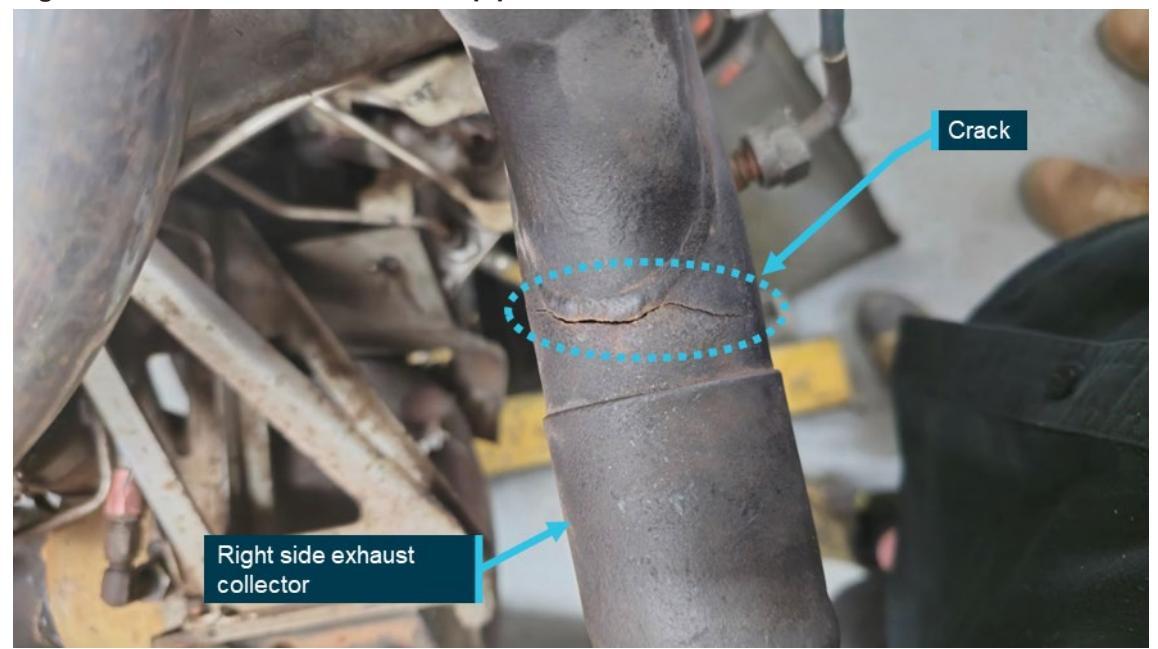
Figure 6: Cracked exhaust collector pipe

Following the incident, the operator started the Lycoming TVO-435 engine and observed that the wastegate did not operate. Thereafter, they removed the engine and delivered it to a third party maintenance facility for examination. As depicted in Figure 6, the post-incident inspection of the engine revealed the presence of an approximately 6.5 cm crack on the right exhaust collector, with no other defects identified.

The exhaust system of the aircraft engine attains extremely high operating temperatures. The consequent widening of the crack due to heat expansion would result in the escape of exhaust gases from the defective section, resulting in inadequate drive pressure for the turbocharger compressor and reduced power output. Information provided by the engine manufacturer supported that conclusion. As such, exhaust gas bleed from the crack before the turbocharger resulted in the wastegate remaining closed.

The ATSB did not undertake a metallurgical analysis of the exhaust pipe, however, exhaust systems are generally prone to metal fatigue over time due to continuous vibration under corrosive conditions and a cyclical pattern of constant heating and cooling with extreme thermal fluctuations.¹²

While it could not be established when the exhaust crack occurred, the maintenance facility that conducted the post-accident engine examination assessed that, based on the location and appearance of the defect, it was likely not impact-related. They further stated that, as the helicopter did not have an engine cowl, the leaking exhaust gases would not have left a residue. This would have made the crack more difficult to detect during a pre-flight inspection when the engine was cold.

However, based on information from the engine manufacturer and the personnel that conducted the post-accident engine examination, a pre-existing crack in the exhaust collector likely reduced the engine power output during the flight.

- The right exhaust collector was found to have developed a significant crack, which likely resulted in engine power loss during flight.
- The pilot was unable to cushion the landing during termination of the autorotation, likely due to low rotor RPM, resulting in the helicopter colliding with terrain.
