Collision with terrain involving Cessna 150M, VH-WWU

40 km north-west of Northampton, Western Australia, on 21 March 2025

ATSB Transport Safety Report

Aviation Occurrence Investigation AO-2025-014 Preliminary – 28 May 2025 Released in accordance with section 25 of the Transport Safety Investigation Act 2003

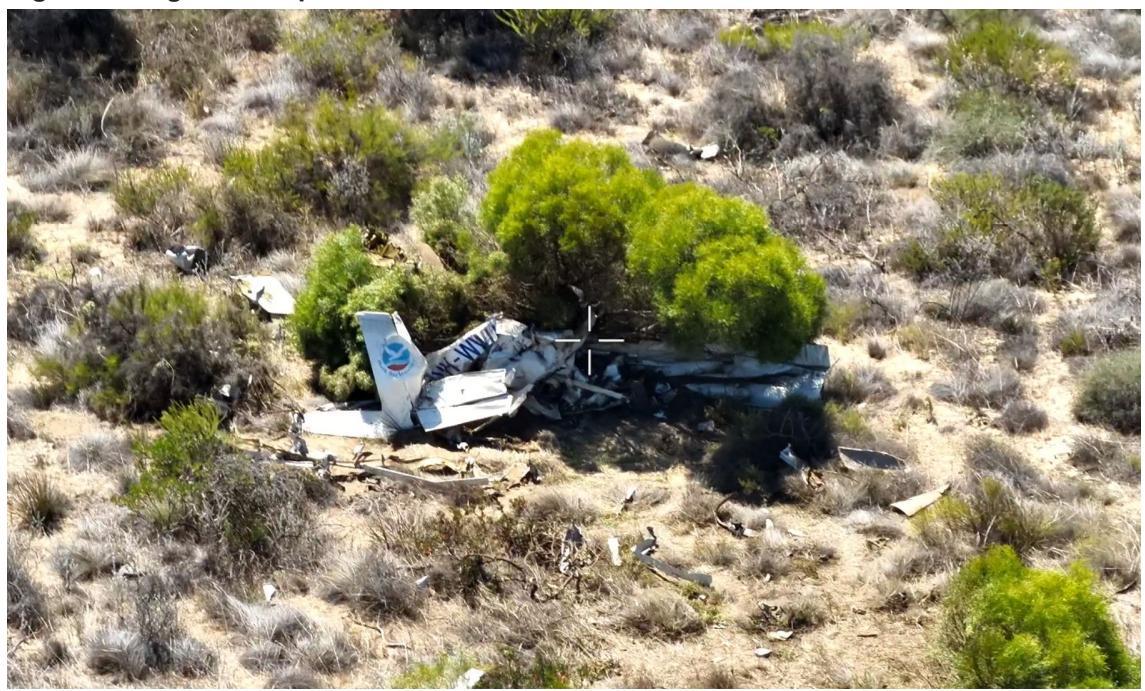
Figure 2: Original final position of VH-WWU at the accident site⁴

At 1116:43, a call was placed to police by a member of the public stating they had come across aircraft wreckage by the side of a road as they were driving past (Figure 2). The accident was 84 km north-west of Geraldton Airport, and about 0.5 km right of the direct track. The member of the public stated that although they had been nearby, they had not seen or heard the aircraft or the impact.

The aircraft was destroyed, and the pilot was fatally injured.

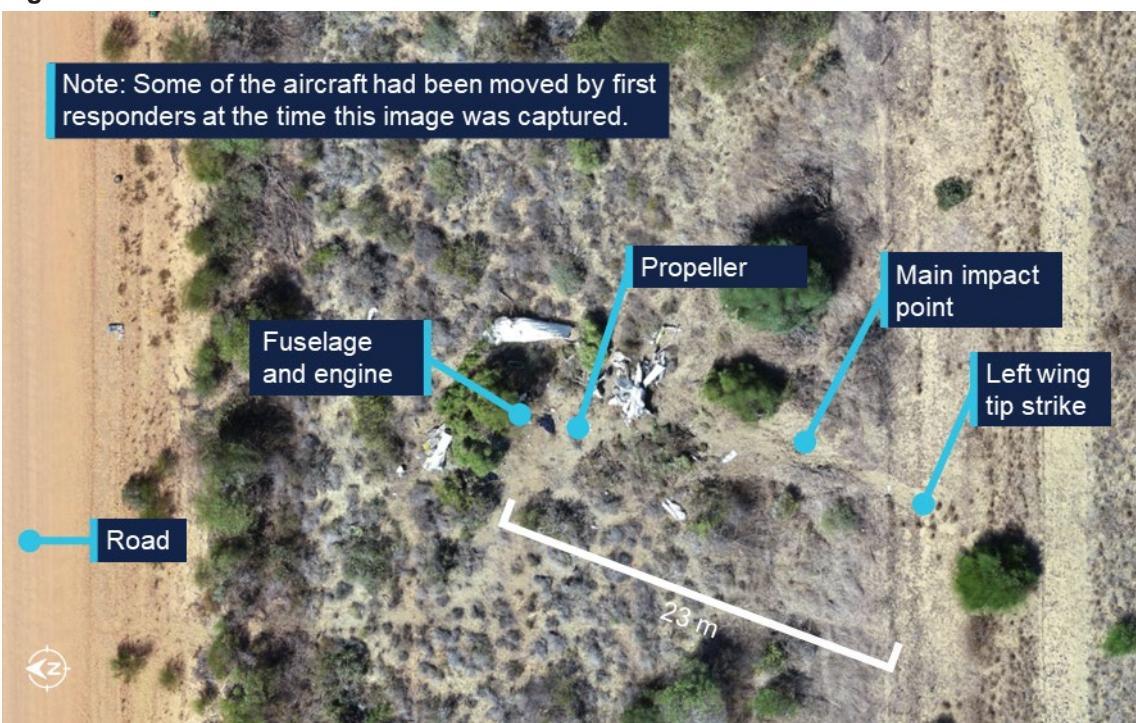
Figure 3: Overview of VH-WWU accident site

The ATSB commenced the accident site examination on the following day, 22 March. The wreckage trail extended in a north-easterly direction, about 23 m from the initial impact point to where the main wreckage, including the wings, empennage, engine and propeller had come to rest (Figure 3). There was no fire, and fuel could be smelt in the area.

Ground impact marks and damage to the airframe indicated that the aircraft impacted the terrain in a left wing-low, steep nose-down attitude at high speed (Figure 3). All major aircraft components were accounted for at the accident site. The disruption to the airframe from the impact limited the extent to which the aircraft could be examined. Of the components that could be examined, no pre-impact defects were identified. Bending and damage to the propeller was consistent with the engine running at the time of impact.
