Airframe overspeed involving Diamond DA40, VH-EQF

63 km east of Kingaroy Airport, Queensland on 12 February 2025

ATSB Transport Safety Report Aviation Occurrence Investigation (Short) AO-2025-007 Final – 6 June 2025 Cover photo: Mitch Coad, modified by ATSB

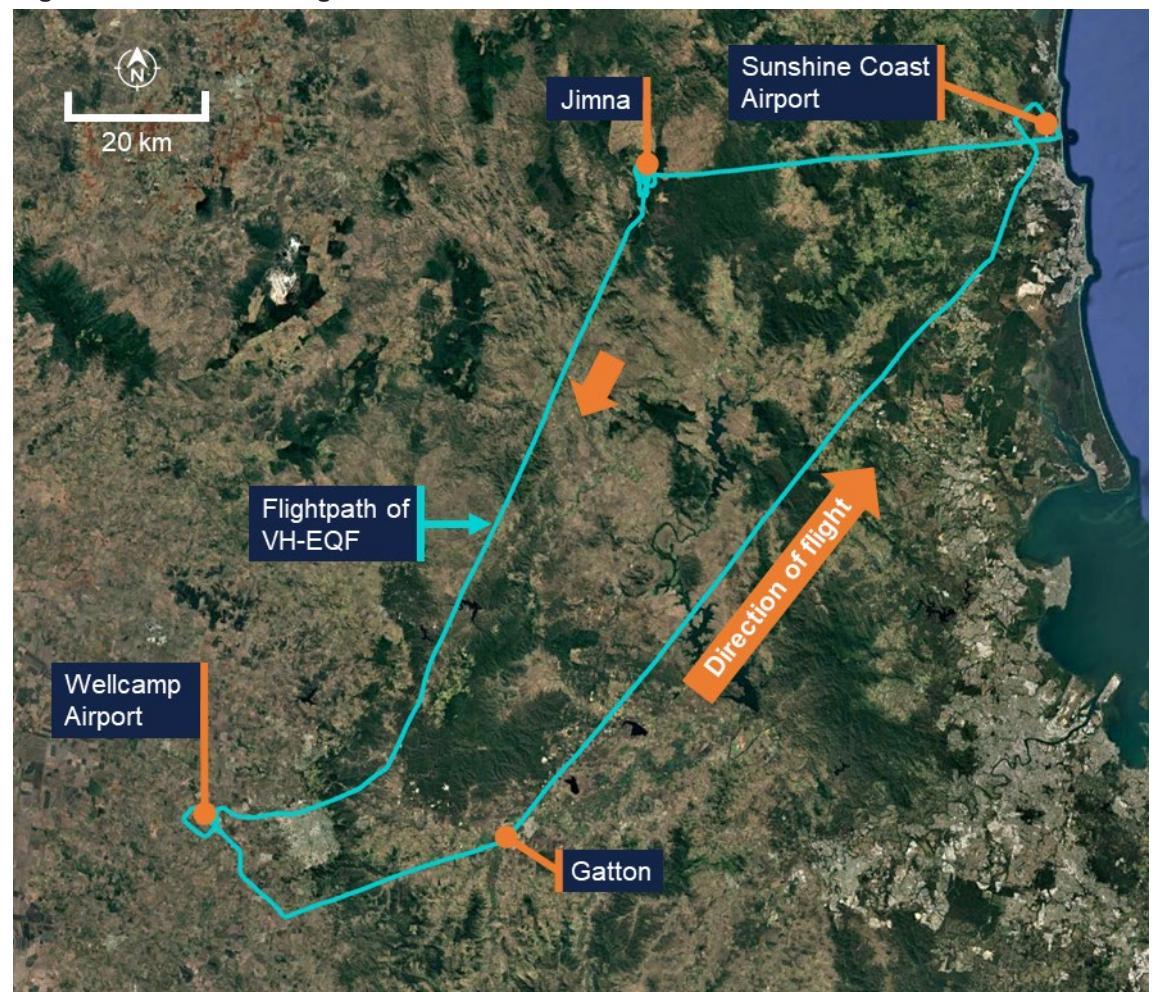
Figure 1: Overview of flight

At 1520 local time on 12 February 2025, an instructor and student departed from Brisbane West Wellcamp Airport, Queensland for a training flight in a Diamond DA40 aircraft, registered VH-EQF and operated by Flight Training Adelaide. The flight intended to track via Gatton and Sunshine Coast Airport before conducting stall and upset recovery training near Jimna and then returning to Brisbane West Wellcamp Airport (Figure 1).

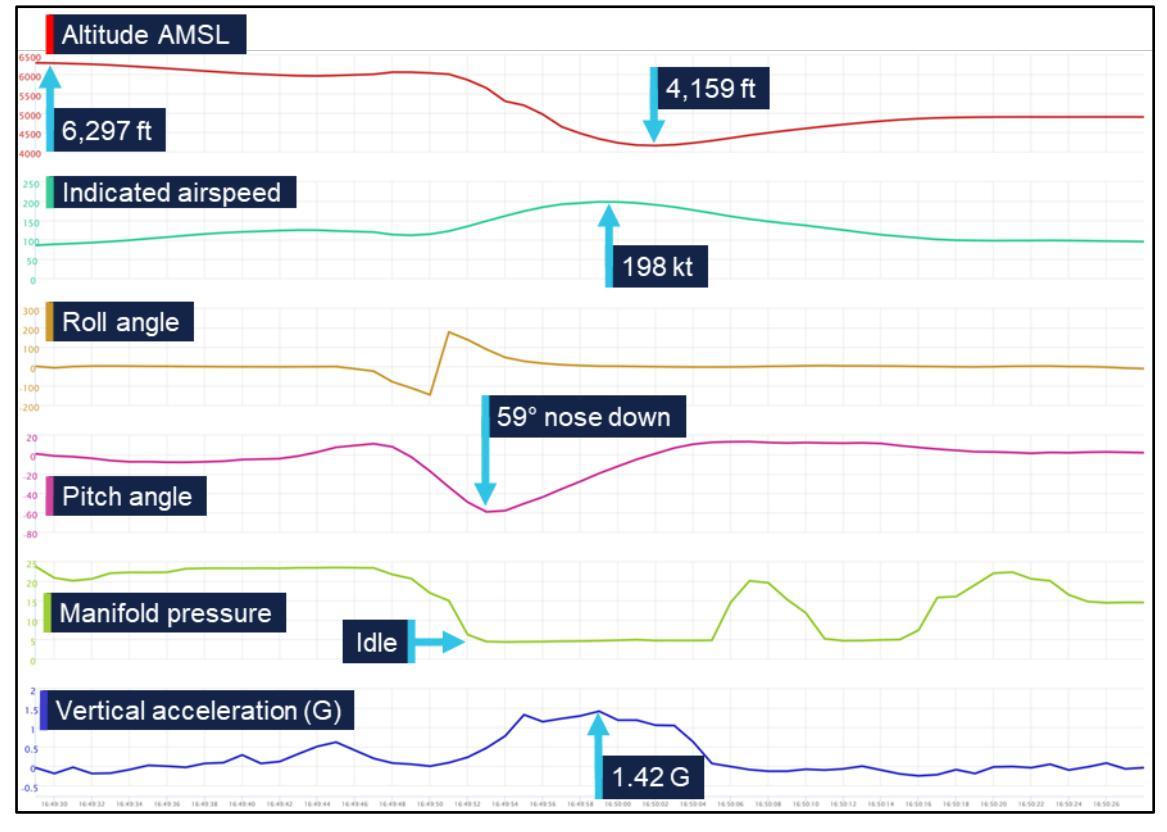
Figure 4: Recorded data from VH-EQF

The manoeuvre commenced at 1649:29 with a slight descent and acceleration from an altitude of 6,297 ft AMSL. The left roll then commenced at 1649:47 at an airspeed of 120 kt, a pitch angle of 11° nose up and the bank angle reached 79° left one second later. At the same time engine power began reducing.

A second later, at 1649:49, the pitch attitude reduced below the level attitude and the bank angle reached 111° left before the aircraft rolled beyond inverted (180° roll) 2 seconds later. At that time, the pitch angle was 33° nose down and the engine power was reduced to idle as the aircraft accelerated through 122 kt.

At 1649:53, 6 seconds after the roll commenced, the aircraft had rolled through 271° and was now in a right 89° bank, and the pitch angle had reached 59° nose down, with the speed rapidly increasing past 149 kt. Three seconds later, the speed increased beyond the never exceed speed (V_{NE}) of 178 kt and continued increasing. At 1649:56, with the nose still pitched down 19° and the wings now level, the speed reached a maximum of 198 kt. At the same time, the recorded G level increased to a maximum of 1.42 G. Speed then began to reduce and 3 seconds later, the aircraft reached a minimum recorded altitude of 4,159 ft AMSL, about 2,600 ft above the ground. Another 5 seconds later, at 1650:04, the speed reduced back below V_{NE} .

The instructor responded to the nose down attitude by reducing power to idle but then prioritised minimising G load during the recovery from the dive. Although the instructor achieved this aim, with a maximum recorded G value of 1.42 G, well below the 3.8 G maximum, by not increasing pitch more positively, the aircraft's speed increased rapidly and significantly exceeded the never exceed speed. Exceeding this limitation risked structural damage or failure.
