Signal passed at danger involving passenger train TE43

Between Fortitude Valley and Bowen Hills, Queensland on 24 May 2023

ATSB Transport Safety Report Rail Occurrence Investigation (Defined) RO-2023-004 Final – 18 June 2025 Cover photo: Queensland Rail

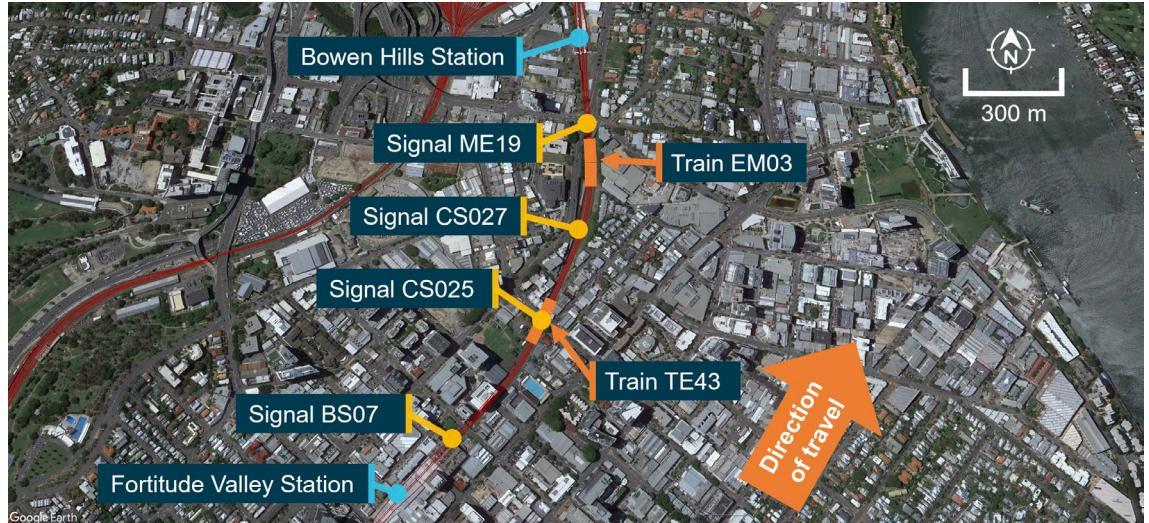
Figure 2: Approximate stopping locations of train TE43 and train EM03 after train TE43 passed signal CS025 at stop

Train TE43 stopped about 64 m past signal CS025, and about 296 m behind train EM03 (Figure 2). The rear of train EM03 was about 92 m ahead of signal CS027, which was also displaying a restricted indication. The driver of TE43 recalled seeing the rear of train EM03 as it started to move.

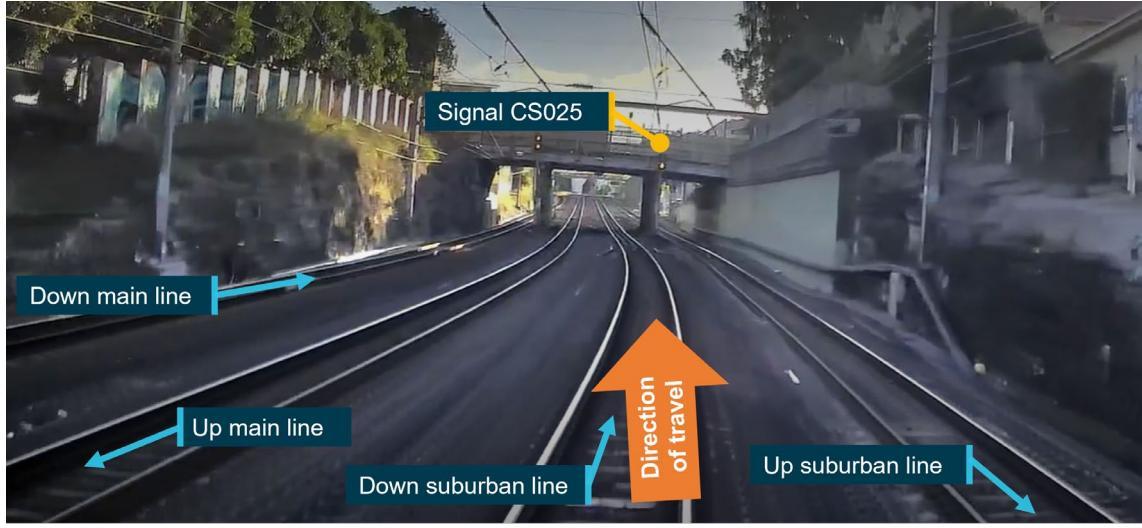
Figure 4: Approach to signal CS025 along down suburban line towards Bowen Hills Station

Signal CS025 was a 4-aspect⁶ automatic signal located at the 2.545 km mark on the down suburban line, mid-section between Fortitude Valley Station and Bowen Hills Station (Figure 4). On approach to signal CS025, the mainline speed for this track section was 60 km/h.

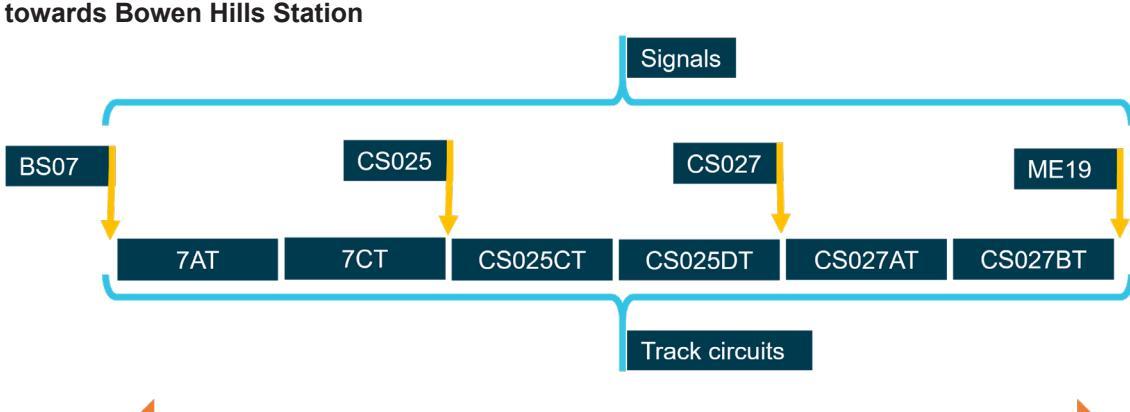
Figure 5: Track circuits between signal BS07 and ME19 on the down suburban line towards Bowen Hills Station

There were 2 track circuits between signal CS025 and the next signal CS027 (CS025CT and CS025DT) (Figure 5). Signal CS025 would display a stop indication when either track circuit CS025CT or CS025DT was detected as occupied. Additionally, if track circuit CS027AT was occupied, after CS025CT and CS025DT had cleared, CS025 would also display a stop indication.

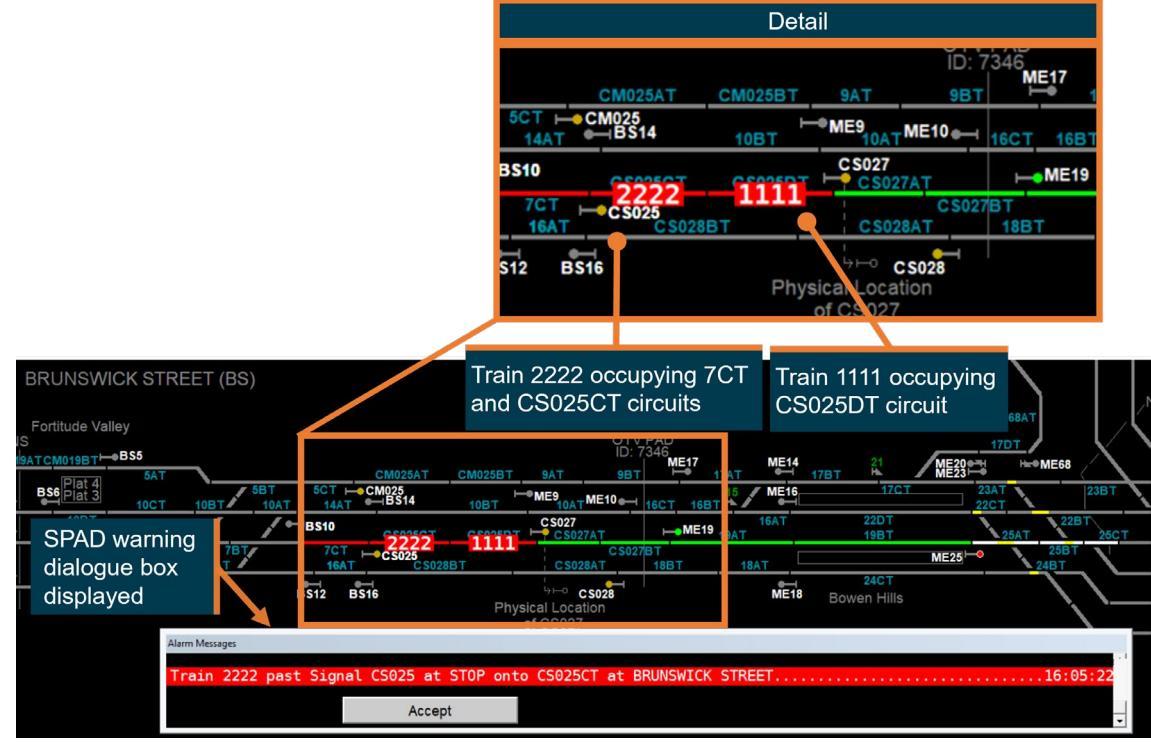
Figure 6: UTC simulation of train passing CS025 at stop

QR confirmed via simulation that the UTC system would generate a SPAD alarm, and display a SPAD message indication on the NCO's workstation for signal CS025, if track circuit CS025DT was occupied by another train ahead when signal CS025 was passed at stop (Figure 6). In this simulation track circuit CS027AT, ahead of signal CS027, was unoccupied.
