Flight instrument issue in IMC involving a Piper PA-27, VH-DTL

near Flinders Island aerodrome, Tasmania, 18 April 2014

ATSB Transport Safety Report Aviation Occurrence Investigation AO-2014-072 Final – 14 July 2014 Released in accordance with section 25 of the Transport Safety Investigation Act 2003

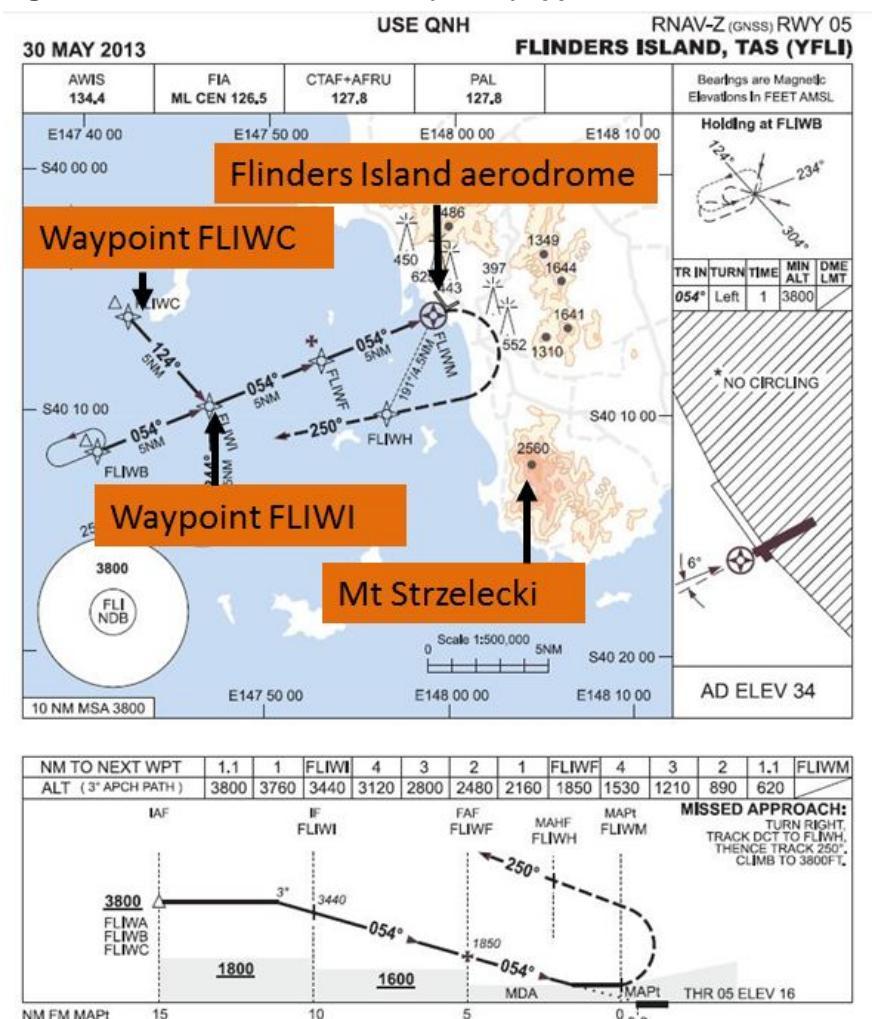
The pilot set up the global positioning system (GPS) to track for the runway 05 area navigation global navigation satellite system (RNAV (GNSS)) approach to Flinders Island, via waypoint 'FLIWC', abeam Prime Seal Island (Figure 1). As the aircraft passed overhead the waypoint, the aircraft was clear of cloud and the pilot cancelled his SARTIME¹ with ATC. He was advised by ATC that there was no relevant IFR traffic. Shortly after, the pilot heard an aircraft departing Flinders Island and he broadcast an inbound call on the common traffic advisory frequency (CTAF).

After passing overhead the waypoint, the pilot reported that the GPS did not sequence to the next waypoint, 'FLIWI', for the approach. He had AvPlan² on an iPad and continued to fly the approach using AvPlan. After passing the subsequent approach points and when at about 1,000 ft AGL on approach to runway 05, the aircraft encountered heavy rain. Although clear of cloud and visual with the ground, the pilot was unable to maintain forward visibility and therefore unable to sight the runway. Aware of rising terrain to the south of the aerodrome (Mt Strzelecki), the pilot commenced a left turn in an attempt to circle back to approach the runway, using the iPad to indicate the runway location.
