Australian Government

Australian Transport Safety Bureau

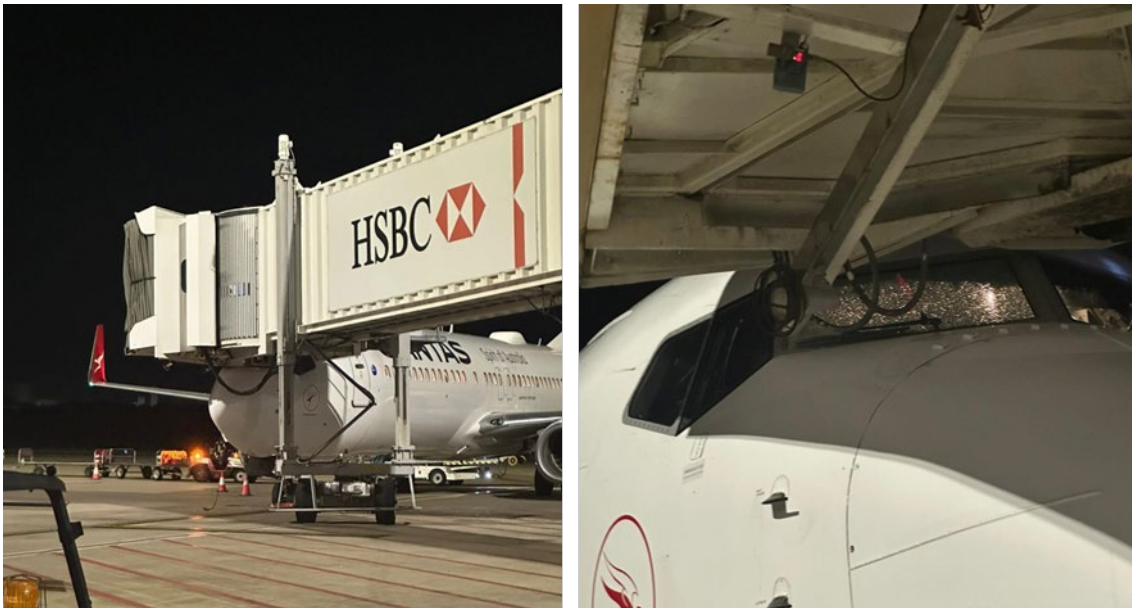
Figure 4: Collision and damage to QF186

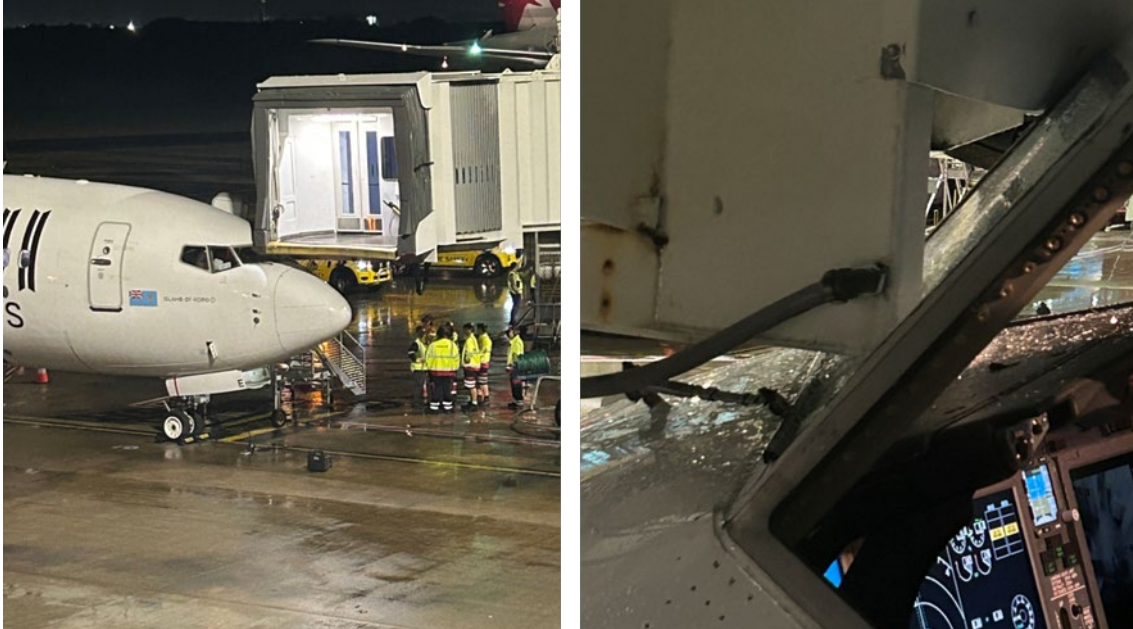
Source: Brisbane Airport Corporation
