Australian Government

Australian Transport Safety Bureau

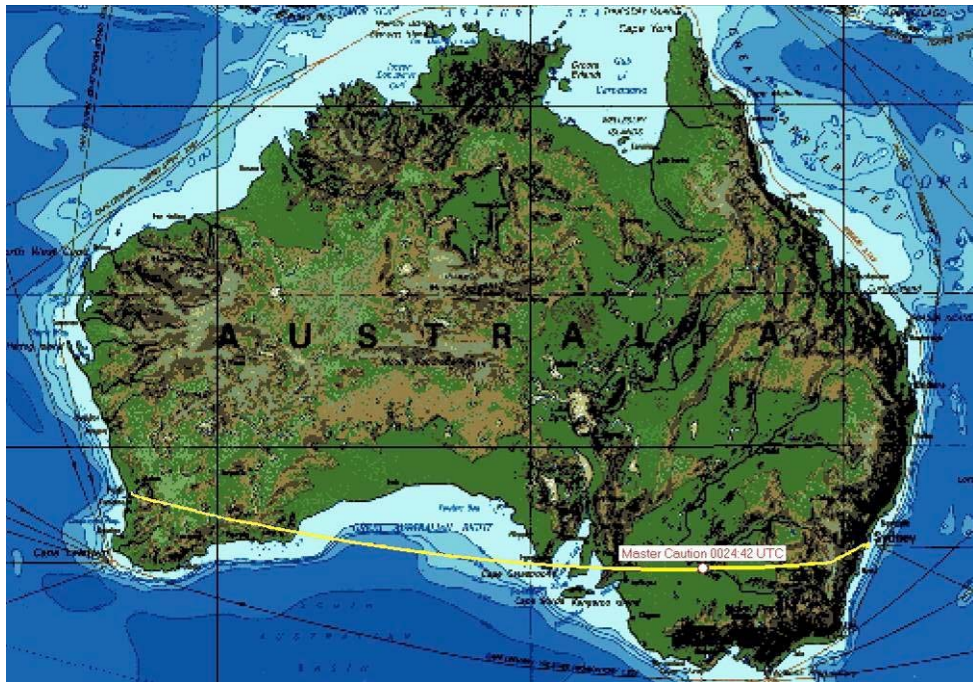
The pilot in command observed that the centre tank fuel pump switches on the forward overhead panel were selected to the OFF position (Figure 2) and he immediately selected them to the ON position. The main fuel tanks were low on fuel and the investigation estimated that there was about 100 kg in each of the main

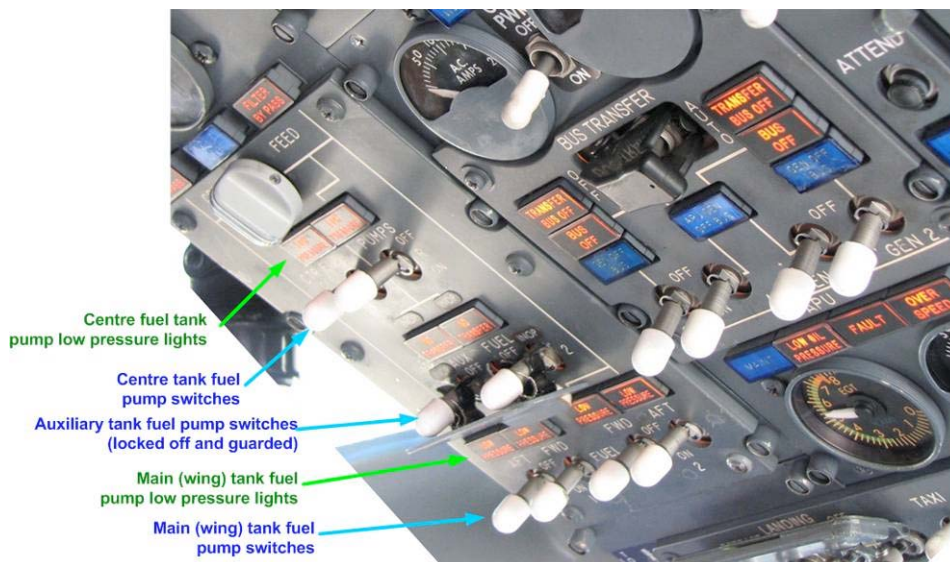
The crew completed the *Before Start* checklist, obtained a push back clearance from air traffic control and were cleared by the despatching engineer to start the engines. The crew completed the push back, engine start and before taxi procedures and the *Before Taxi* checklist. The aircraft then taxied and departed from runway 21.
