**Australian Government**

**Australian Transport Safety Bureau**

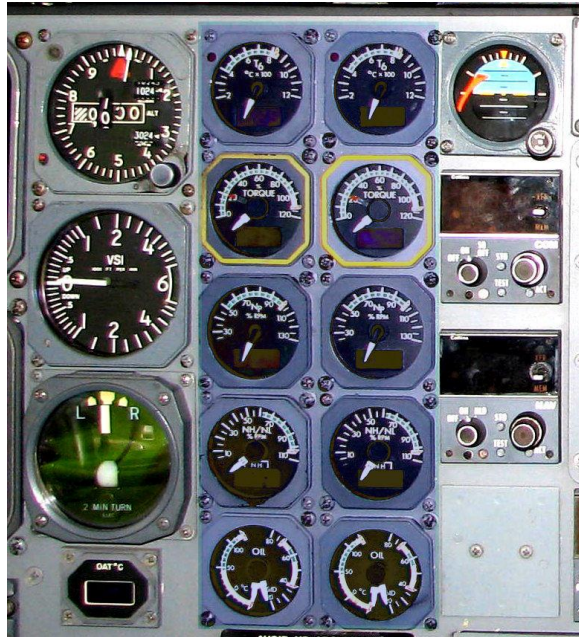
#### **1.5.4 Indications in the event of fuel starvation**

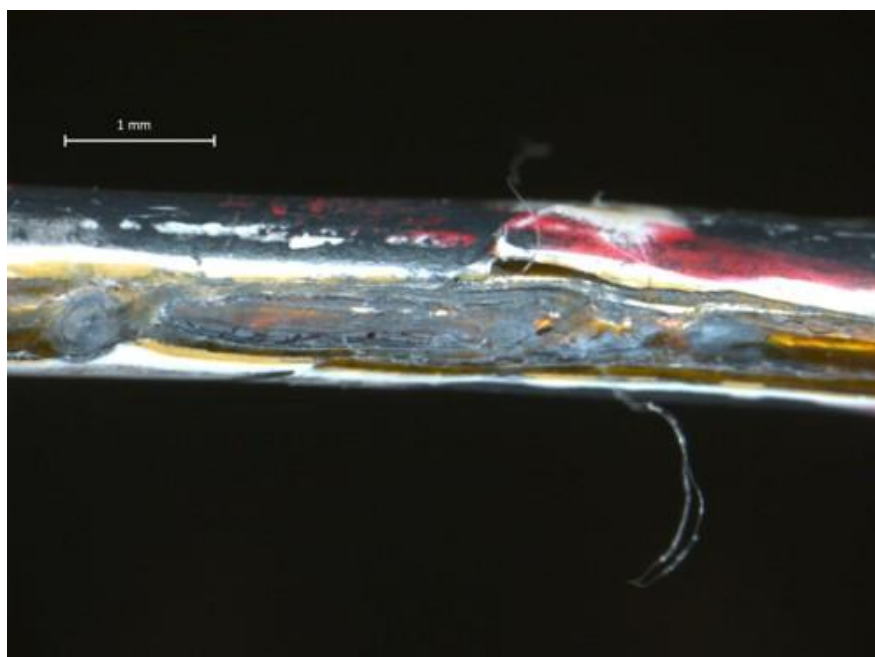
## **1.6 Meteorological information**

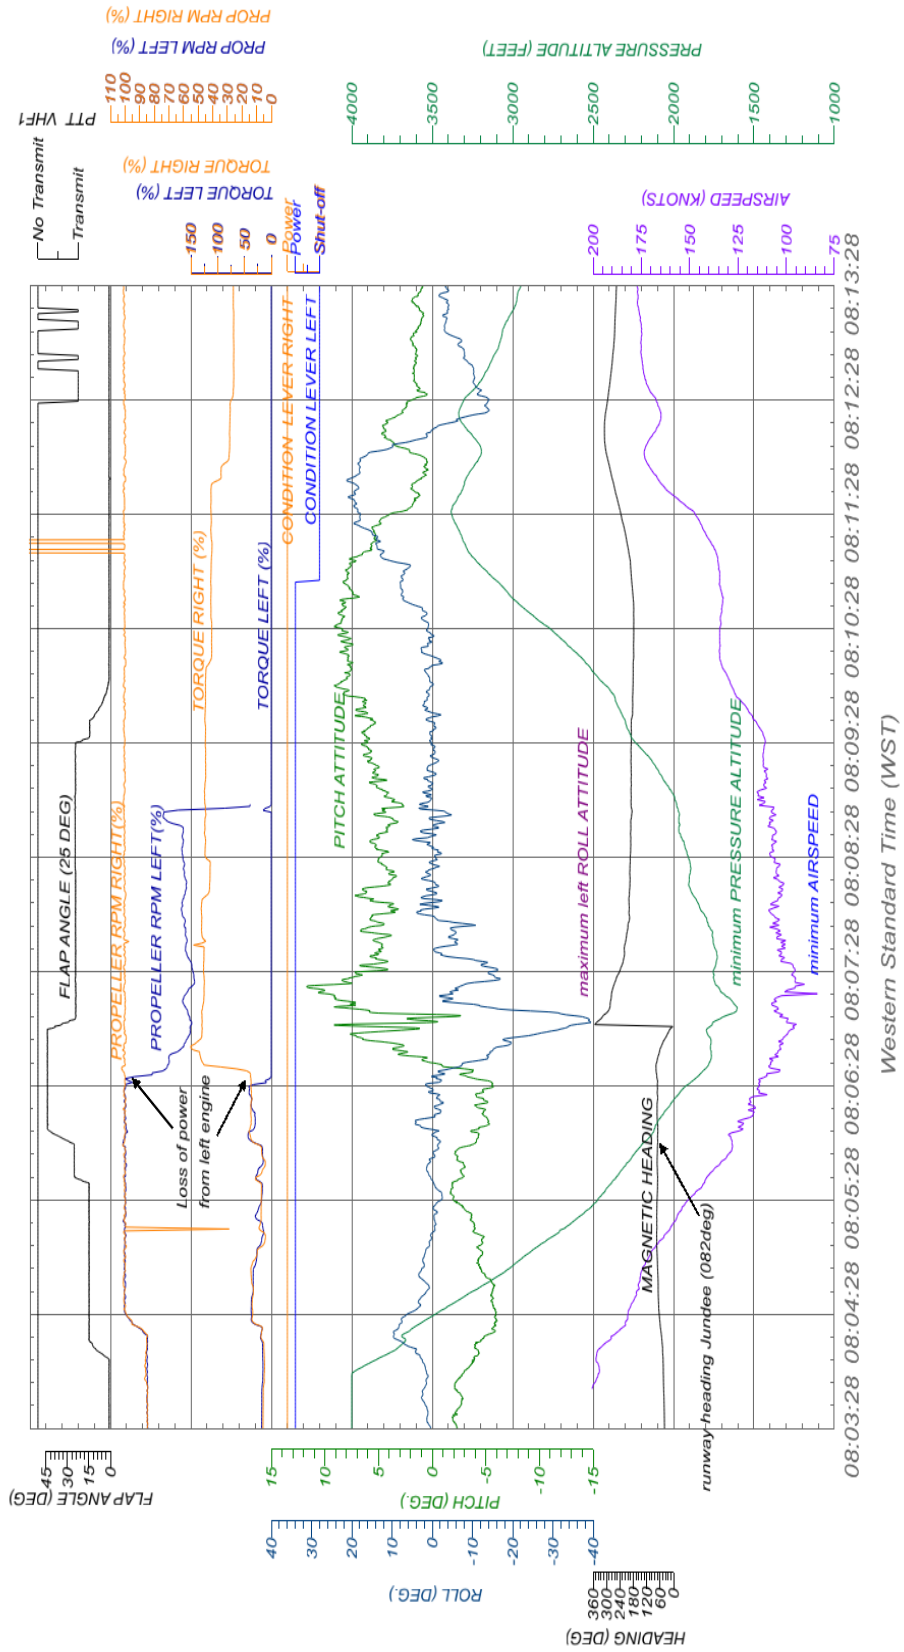
## 1.11 Tests and research

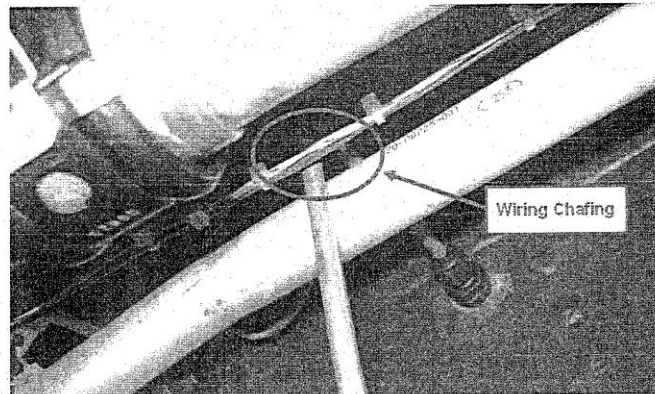
Figure 1 - Example of Wiring Chafing to be Avoided
