**Departmental investigation  
into the grounding of the  
Singapore flag  
off-shore support vessel  
Britoil 22  
off the coast of  
Western Australia  
on 18 November 1998**

Navigation Act 1912 Navigation (Marine Casualty) Regulations  
into the grounding of the Singapore flag off-shore support vessel

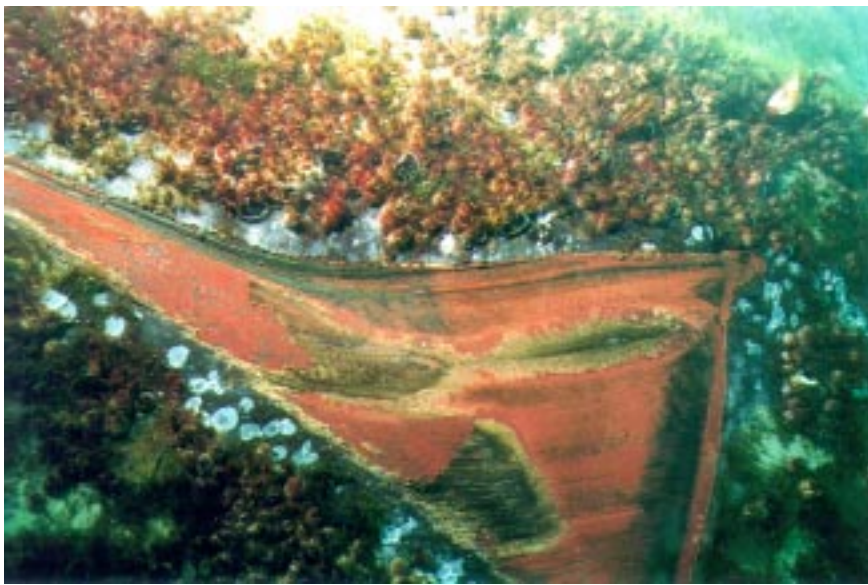
FIGURE 8  
**Scoring of shell plate and paint forward of hole**

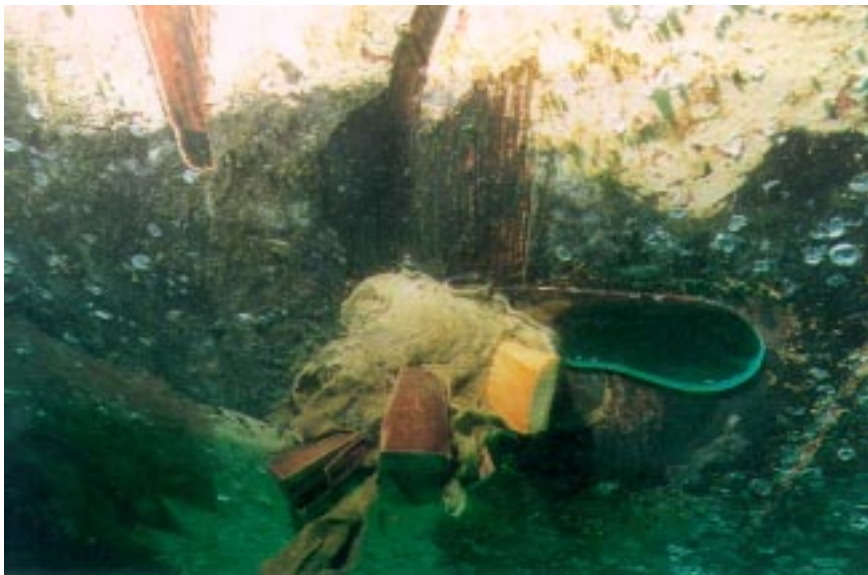
FIGURE 9  
**Repair with wooden plugs and Denso tape**
