Departmental investigation into the collision between the fishing vessel EXTERMINATOR and the Liberian tanker UNISINA

off the southern coast of NSW on 25 April 1997

#### Report No. 116

AUSTRALIA Department of Workplace Relations and Small Business

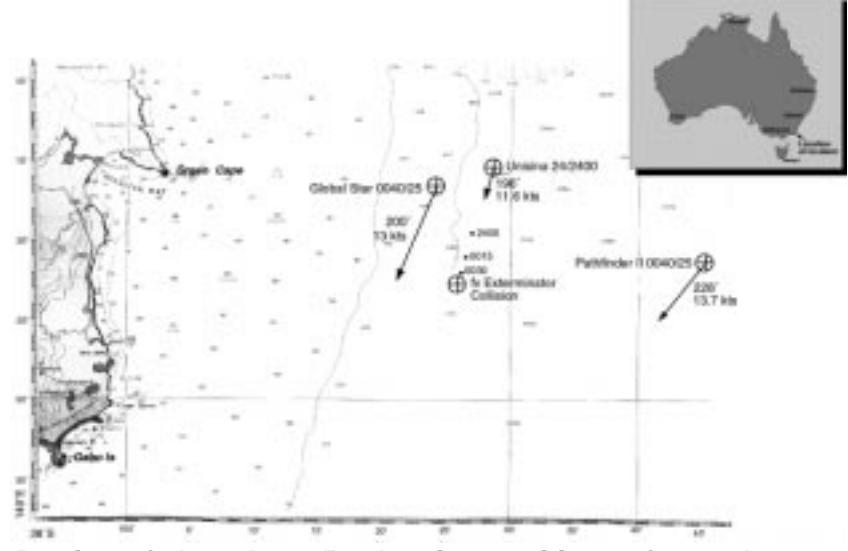
Examination of *Unisina's* deck log book and navigation charts shows that, without any deviation from the logged course, at 0040 on 25 April 1997, *Unisina* was within four cables eastward of the collision position provided by *Exterminator*.

Portion of chart Aus 359 showing positions of vessels

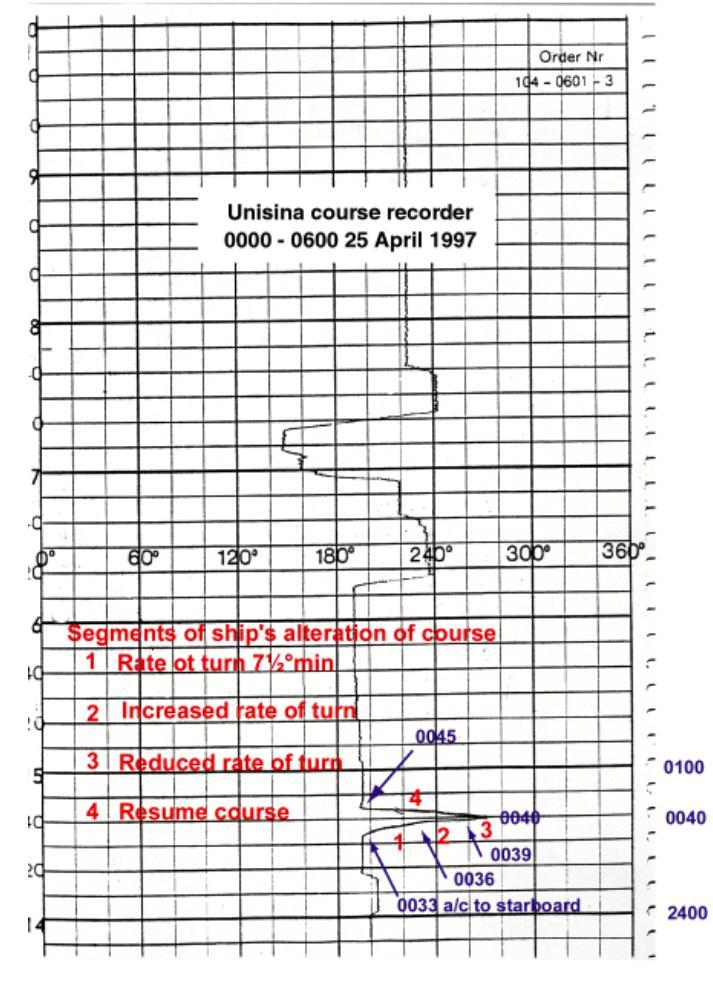
The course recorder chart indicates that at 0033, *Unisina* started to change course to starboard from a heading of 195° and, at 0038½, had reached a heading of 236°, a rate of change of only 7½° per minute. During this time, *Unisina* would have advanced 1.45 miles. There was then a rapid swing to starboard, to 260° at 0039, indicating the helm had been put hard to starboard at 0038½, followed by a reduced rate of change to 270° at 0040, after which the vessel swung back to port and was back on the 195° course at 0045.

Portion of Unisina course recorder chart showing the alteration of course to starboard shortly before 0040 From the evidence of the course recorder chart it is apparent that, at 0038, the Second Mate suddenly found that the lights had not been those of a northbound vessel at a distance, but those of a small vessel at much closer range and he had to apply first hard to starboard and then hard to port wheel in an attempt to avoid collision. Whereas it would be normal for the initial alteration to starboard to have been made in autopilot, by the Second Mate, the AB does not appear to have been put on the wheel for these manoeuvres.
