Australian Transport Safety Bureau

Aviation Occurrence Investigation AO-2008-083

Collision with terrain, VH-EKS 67 km WNW Scone Aerodrome, New South Wales 24 December 2008

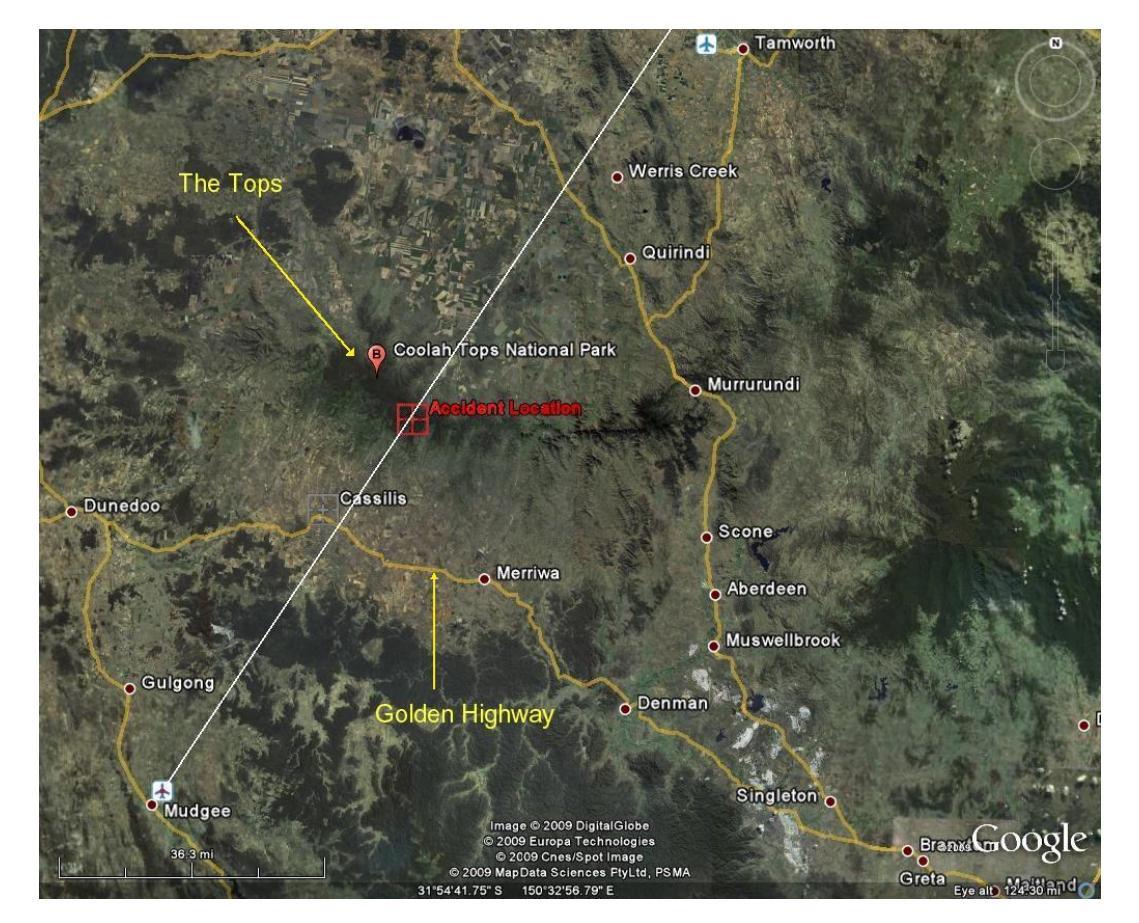
Figure 1: Track from Mudgee to Glen Innes

On departure from Mudgee, the pilot climbed the aircraft to 5,000 ft above mean sea level (AMSL), an altitude that was reported to be below the cloud, on a direct track to Glen Innes (Figure 1). The pilot reported that, crossing the Golden Highway and approaching the Coolah Tops National Park ('the Tops'), the weather ahead deteriorated, with increasing cloud above and below the aircraft and the cloud base lowering.

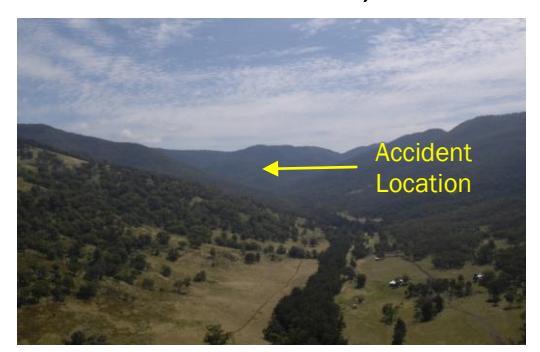
Figure 2: Valley looking Jemmys north-east (photo courtesy of **NSW Police Force**)

The pilot recalled that, when he levelled out, he started to lose sight of the Tops and surmised that he had descended into a valley. In fact, the pilot had descended the aircraft into Jemmys Valley, which is a closed valley framed by north-east to south-west ridgelines on its eastern and western sides, and an east-west ridgeline to the north (Figure 2). The elevation of the northern ridgeline

3 Qualified to fly on instruments in accordance with the is about 1,150 m (3,750 ft), while the highest terrain is located at the north-western corner of the valley at a height of 1,240 m (4,070 ft).
