ATSB TRANSPORT SAFETY REPORT

Aviation Occurrence Investigation A0-2010-025

Hobart, Tasmania

Total power loss, VH-MTC

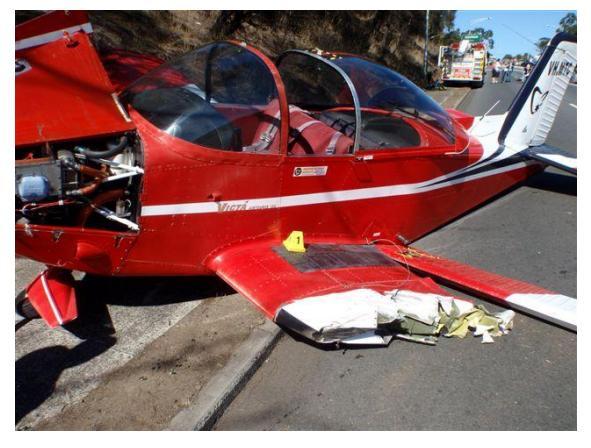
Figure 2: Aircraft wreckage on Brooker Highway

During the approach the aircraft lost altitude quicker than expected, and the pilot was forced to approach beneath the Lower Domain Highway overpass. The pilot reported that immediately prior to touchdown, the aircraft's right wing contacted a concrete barrier resulting in the aircraft moving left and clipping a gutter. The aircraft then contacted a pole and some trees before coming to rest. During those impacts, the aircraft's left mainwheel and most of the left wing were torn from the aircraft (Figure 2).

The aircraft was seriously damaged and the pilot uninjured.

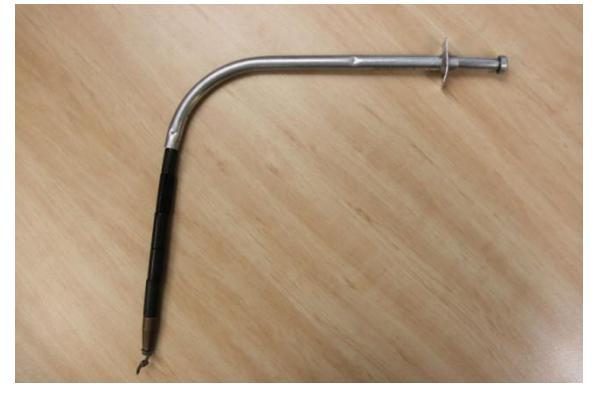
Figure 3: Airtourer fuel dipstick

Some pilots reported that the dipstick could be difficult to use and could give variable fuel quantity readings. The pilot of the aircraft reported that he had experienced difficulty with the dipstick when he first started using it.

Information from sources engaged in commercial Airtourer operations, confirmed that there were differences in the use of the dipstick. Some pilots reported that they pushed the button to remove the dipstick from the tank, while others, including those pilots trained on the aircraft soon after it entered service in the 1960s, reported that they were instructed to remove the dipstick in the rigid condition. The latter technique was reported to prevent the segments from falling further into the tank, causing the dipstick to over read.

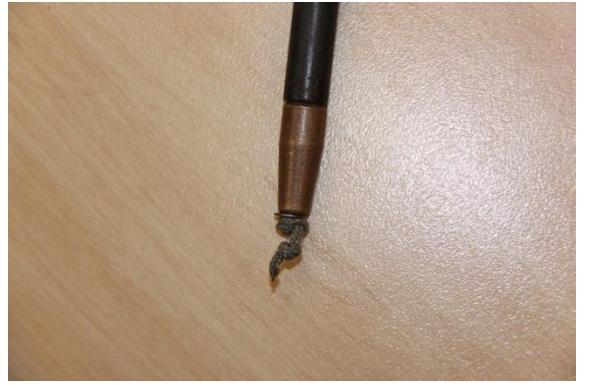
The aircraft's dipstick was examined following the occurrence. It was noted that the dipstick had been modified and that the cord holding the six segments together had been replaced at some time. The cord extended beyond the lower end of the dipstick, with two knots securing the bottom segment with a metal washer (Figure 4).

Figure 4: Aircraft's dipstick, showing knots at the Figure 6: Extended dipstick cord - extension lower end button fully depressed

The action by the pilot to depress the dipstick extension button before removing the dipstick from the tank may have combined with the non-standard modifications to the dipstick to allow the collapsible segments to fall further into the fuel tank. That would have immersed a larger number of segments into the fuel in the tank and resulted in an erroneous fuel level indication.

The aircraft owner's association has produced an article for their newsletter highlighting the correct method of fuel dipstick use to aircraft owners. That article can be accessed through the association's website at <u>www.airtourer.asn.au</u>

The aircraft's type certificate holder has devised an Operations Bulletin for issue to owners of the aircraft type that will detail the correct method for the use of the dipstick. At the time of the release of this report, the bulletin was undergoing review by the type certificate holder.

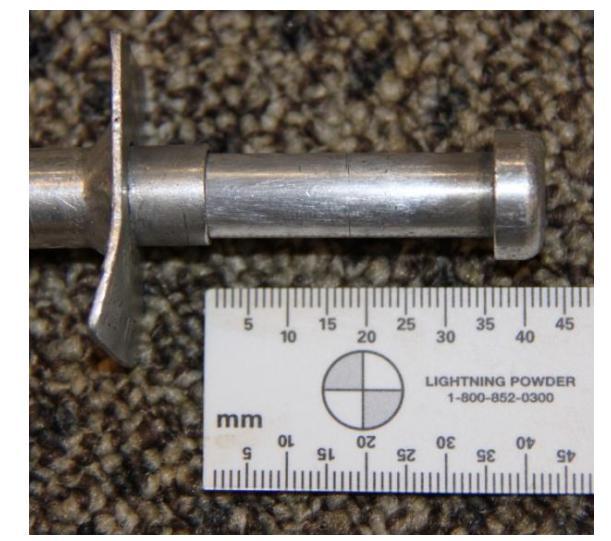
Figure 5: Dipstick button extension

The dipstick activation button extended beyond the upper end of the tube by about 37 mm (Figure 5). Fully depressing the aircraft's dipstick button allowed the collapsible segments to extend by a further 27 mm, or about one 5-gal segment (Figure 6). The segments of the dipstick were marked in litres and imperial gallons.

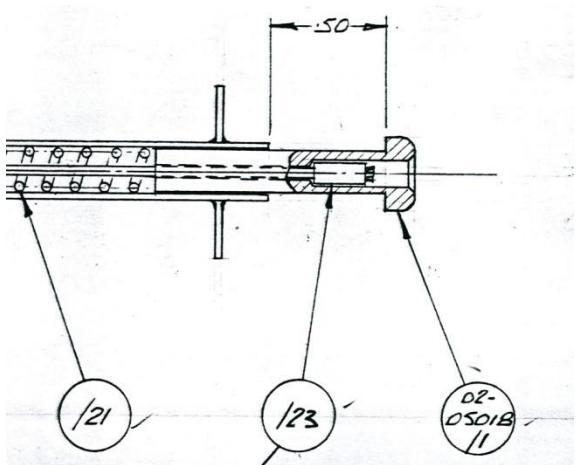
Figure 7: Manufacturer-specified dipstick drawing

The manufacturer's drawing for the dipstick specified a 0.5 in. (12.5 mm) extension when the extension button was activated (Figure 7). The drawing showed that the dipstick's internal cord was to be terminated at each end with a copper swage fitting. Both swaged ends remained fully recessed within each end of the dipstick once fitted.
