ATSB TRANSPORT SAFETY INVESTIGATION REPORT Rail Occurrence Investigation 2004/005 Final

Derailment of Train 4VM9-V Benalla, Victoria

23 September 2004

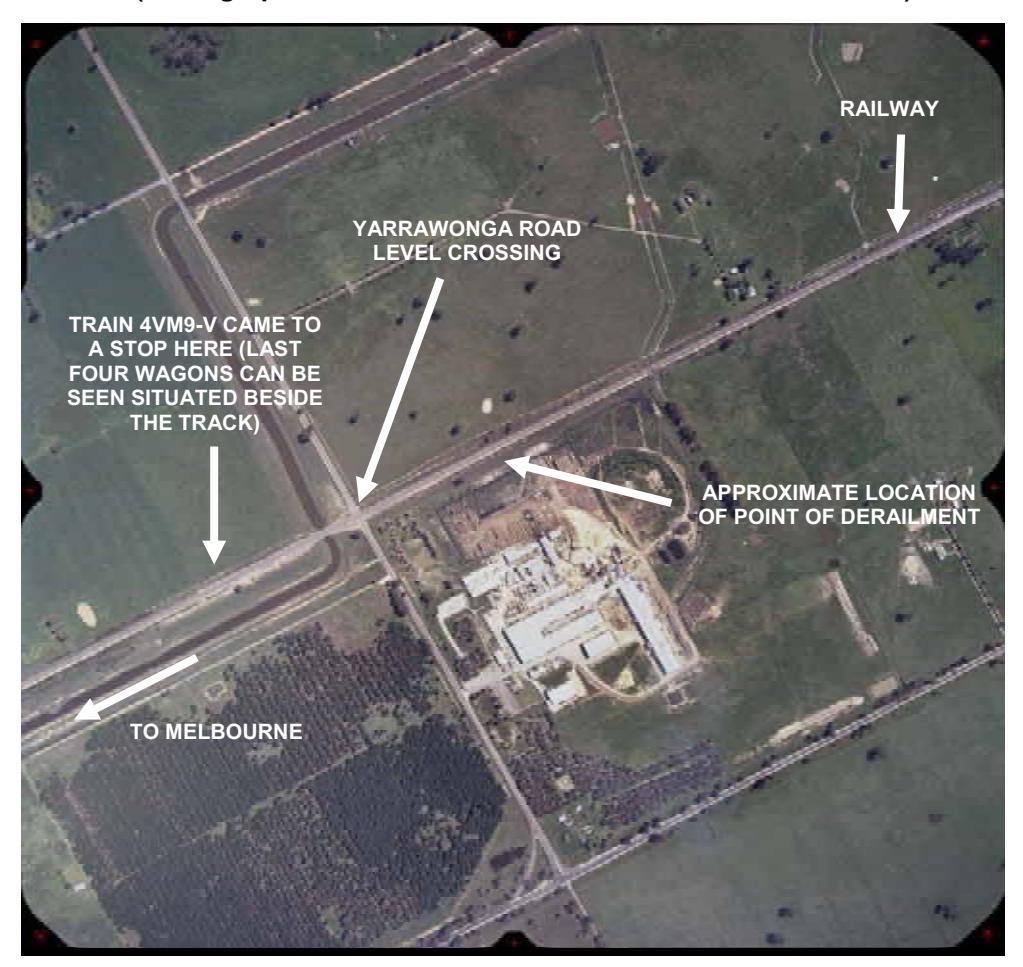
Figure 2: Aerial photograph of the occurrence site north of Benalla, Victoria. (Photograph taken in October 2004 soon after the derailment)

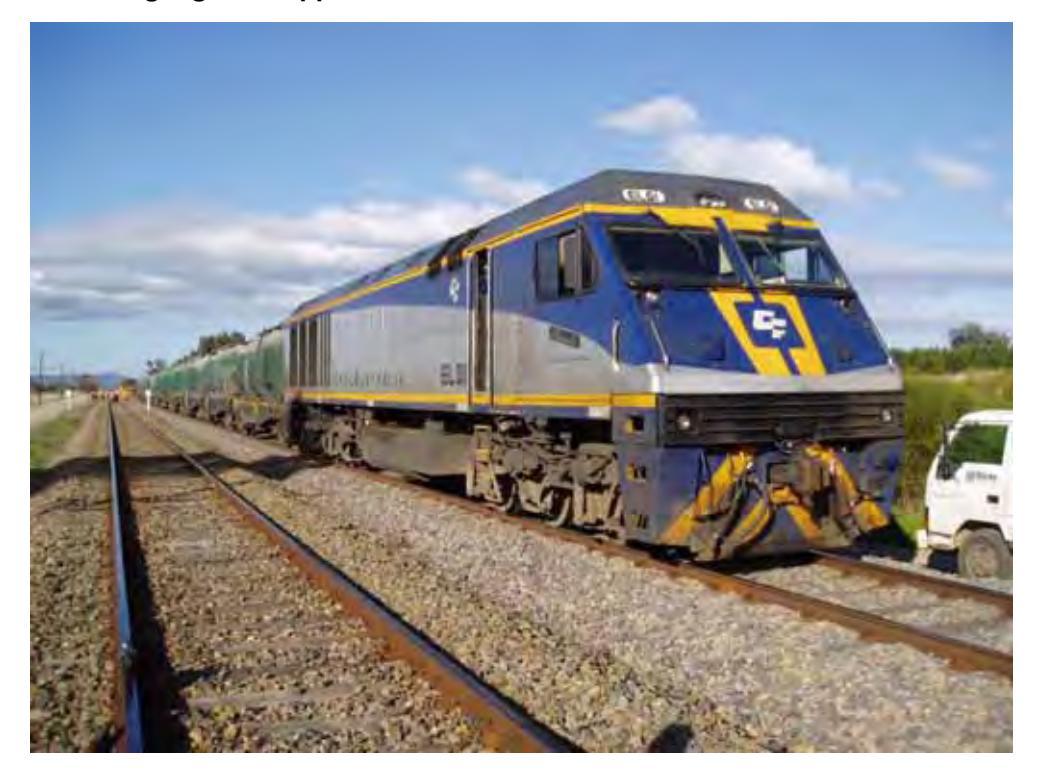
Figure 3: Train 4MV9-V after coming to a stop following the derailment. The train is standing on the standard gauge line with the parallel broad gauge line opposite

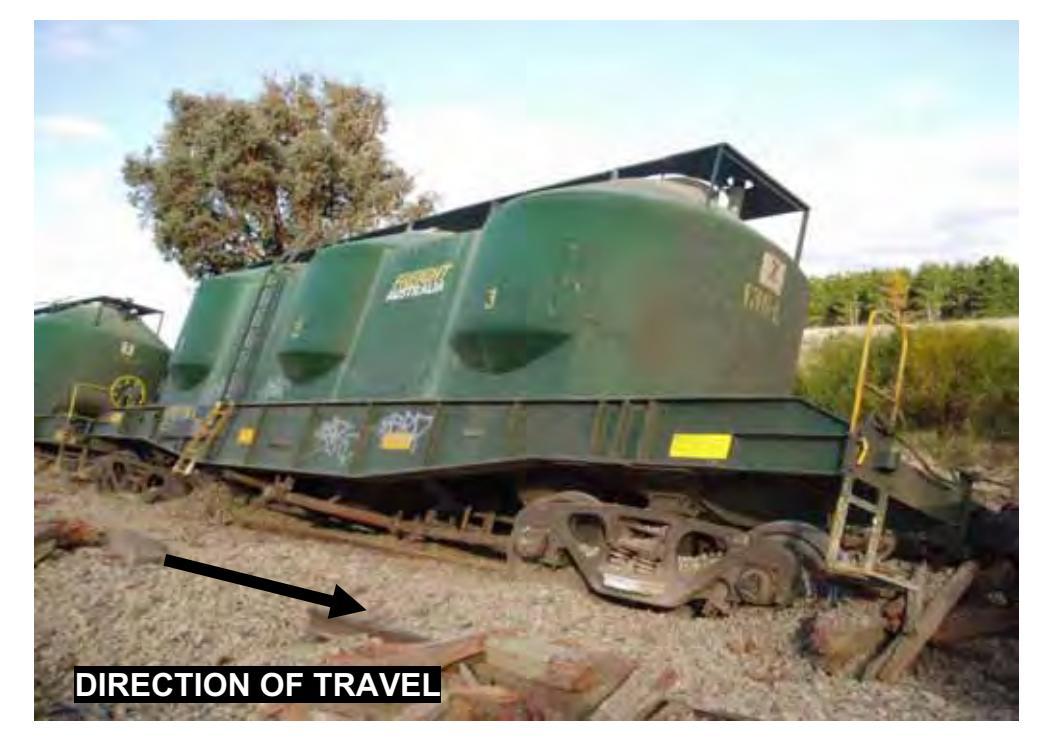
Figure 4: The second last wagon in the train, amidst severe track damage

Approximately 530 metres of track was damaged including sleepers, broken and crippled rails, fastenings and formation damage. Severe track damage occurred over approximately 80 metres underneath and immediately behind the location where the last three derailed wagons came to a stop.

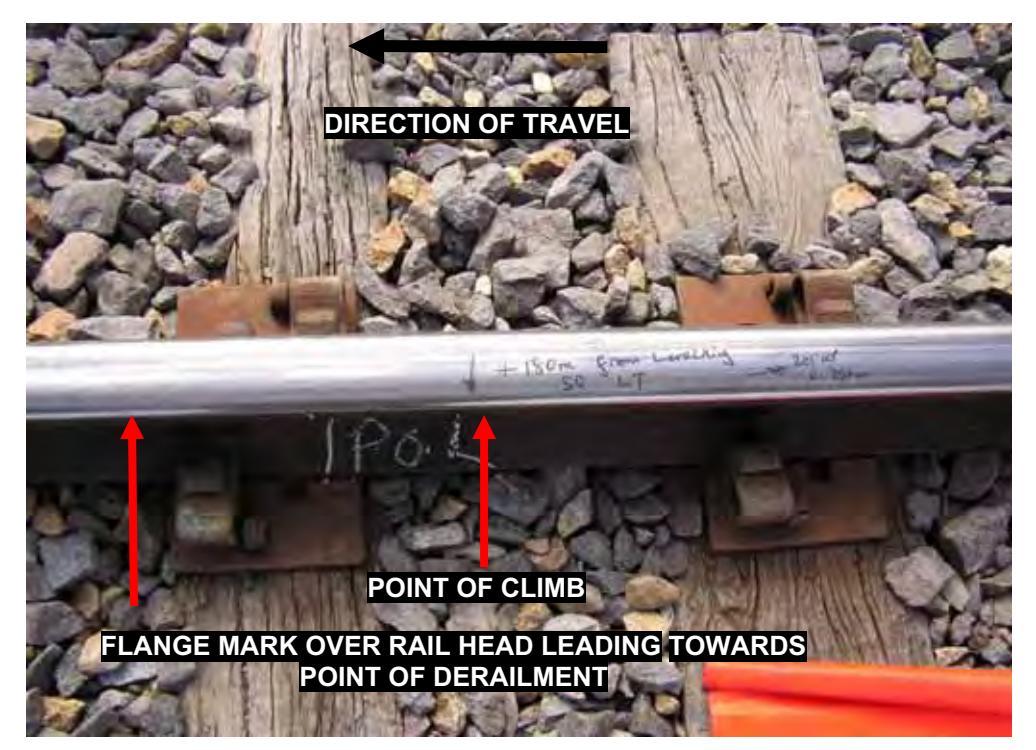
The initial mark of the occurrence appeared at a point 200.767 route kilometres from Melbourne. (Refer to figure 5). This indication of where a wheel flange left its proper location inside the western side or right-hand rail, known as the point of climb (POC)⁶, was approximately four metres north of the POD (200.763 km). From the POD, indications of wheel set flange marks appeared on the sleepers – one on the outside of the western rail and one on the inside of the eastern or left-hand rail.

Figure 5: Photograph showing the point at 200.767 km where the wheel flange started to climb the inside face and travelled over the western rail

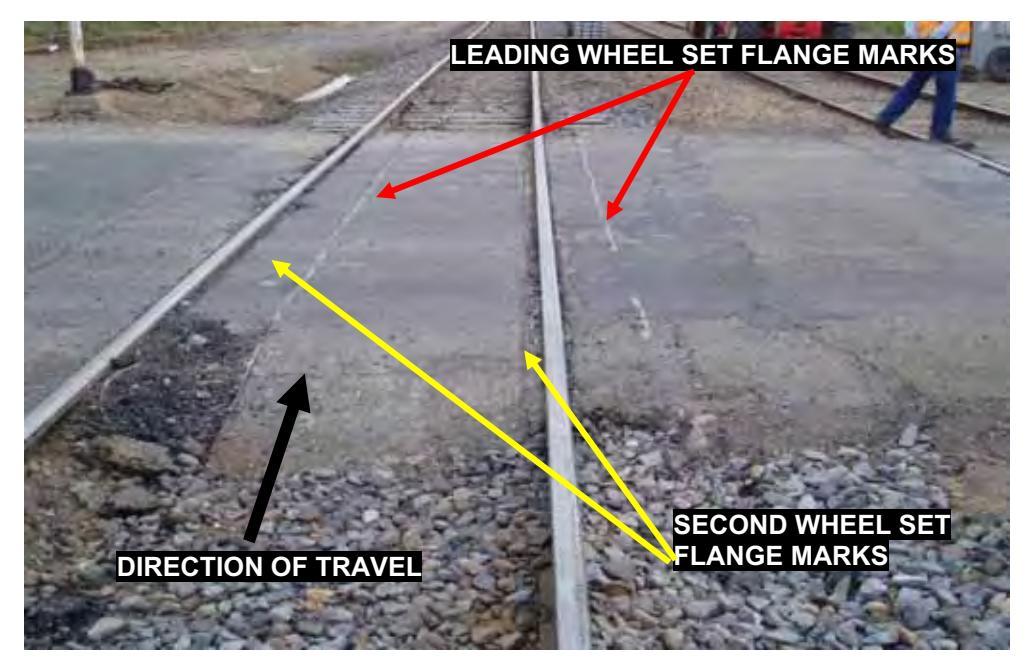
The set of flange marks continued to the Yarrawonga Road level crossing (200.614 km) to the south and continued over the bitumen surface to the sleepers on the other side. An increased level of track damage occurred south of the level crossing. Referring to figure 6, the red coloured arrows indicate the course of a derailed wheel set. The second wheel set of the same bogie, while still running on the rails at that stage, was being steered in the direction of and parallel to the leading wheel set. The much lighter flange marks left by the second wheel set are indicated in yellow.

Figure 6: Wheel flange marks of the first wagon to derail at Yarrawonga Road level crossing. Photograph taken following partial restoration of derailment damage

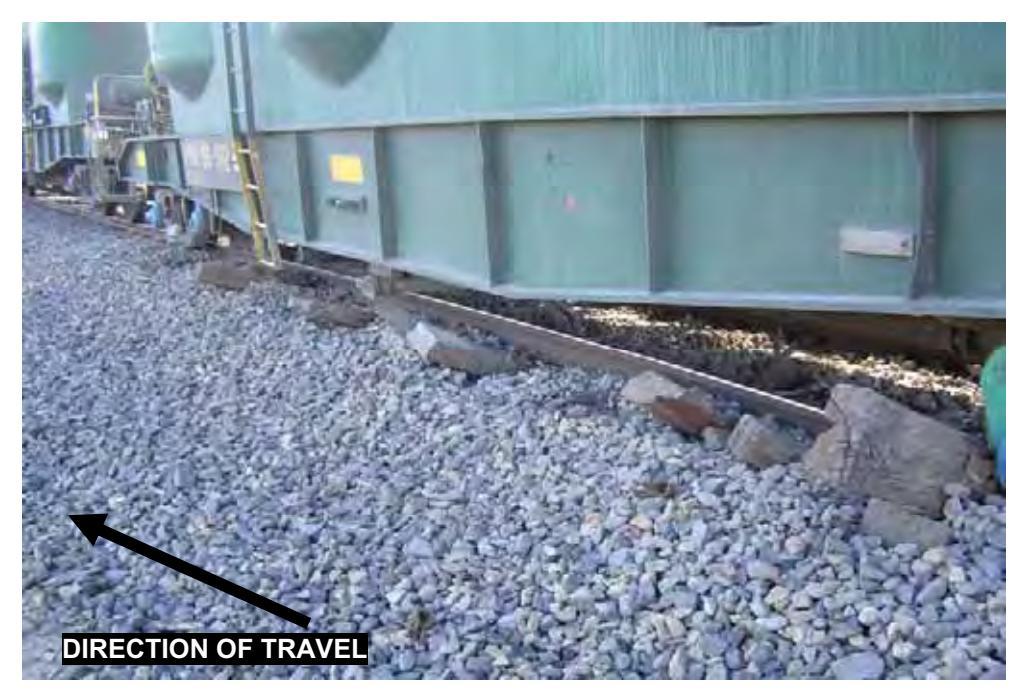
Figure 7: VPBX 155-S, the 12th wagon in the train, sustained relatively minor damage. Photograph shows the derailed left-hand leading wheels and evidence of broken sleepers which led to a loss of gauge retention

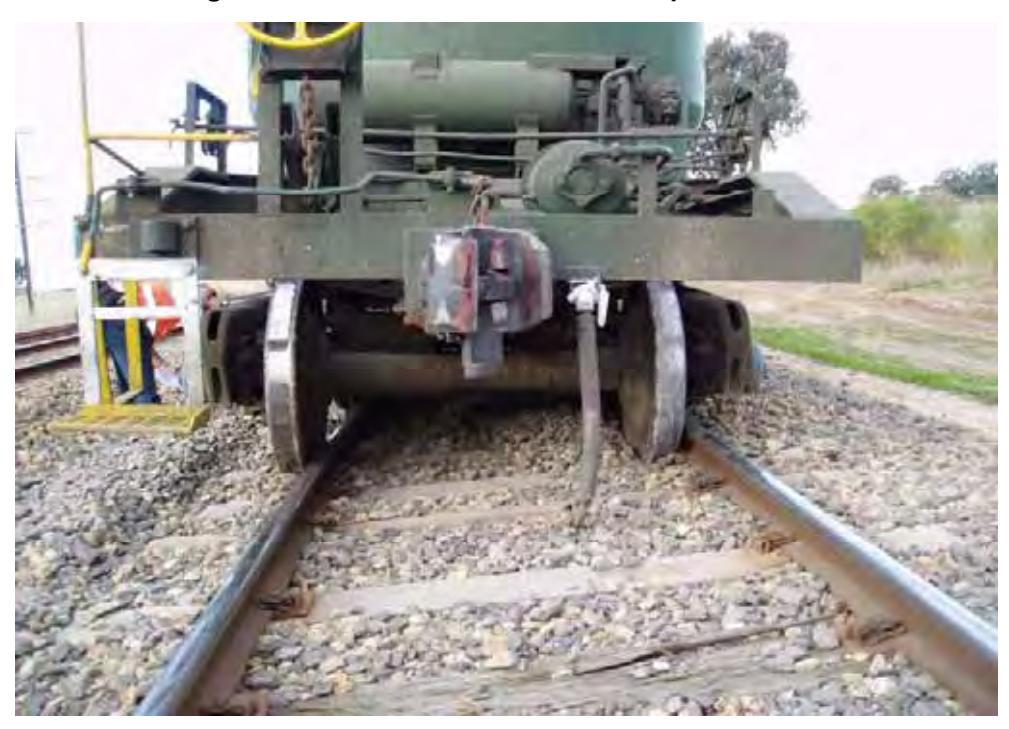
Figure 8: Wagon VPBX 155-S showing the leading wheel sets during recovery following the removal of the forward portion of the train. Note the sinking of the left side wheels into the sleepers and ballast

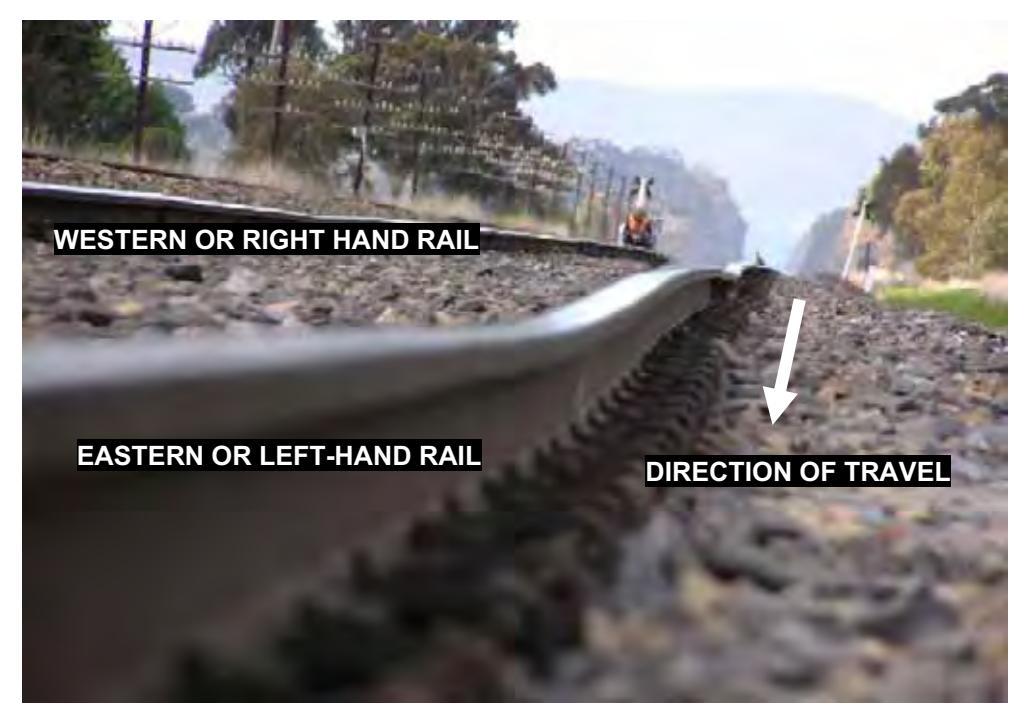
Figure 10: In a direction looking away from Melbourne, using a telephoto lens to augment and clarify the observation, the photograph shows the eastern side rail vertical profile and the two dips, over a distance of approximately 50 metres north of the POL

An analysis of the likely vertical reaction of the first cement wagon to derail showed that the nine metre vertical track wave form evident, would approximately match the 9.5 metre body bounce wave length at a speed of about 75 km/h. This condition induced body roll in the wagons of the train. (Refer to Appendix 7.2).

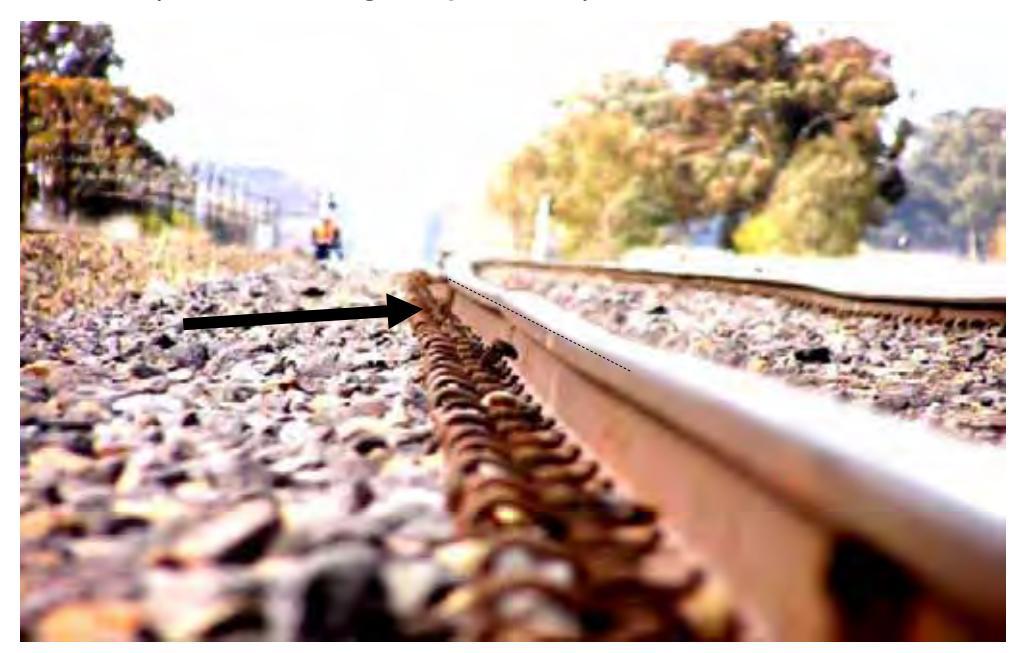
Figure 11: Example of peaked welds in the western rail just north of the POD (enhanced through telephoto lens)

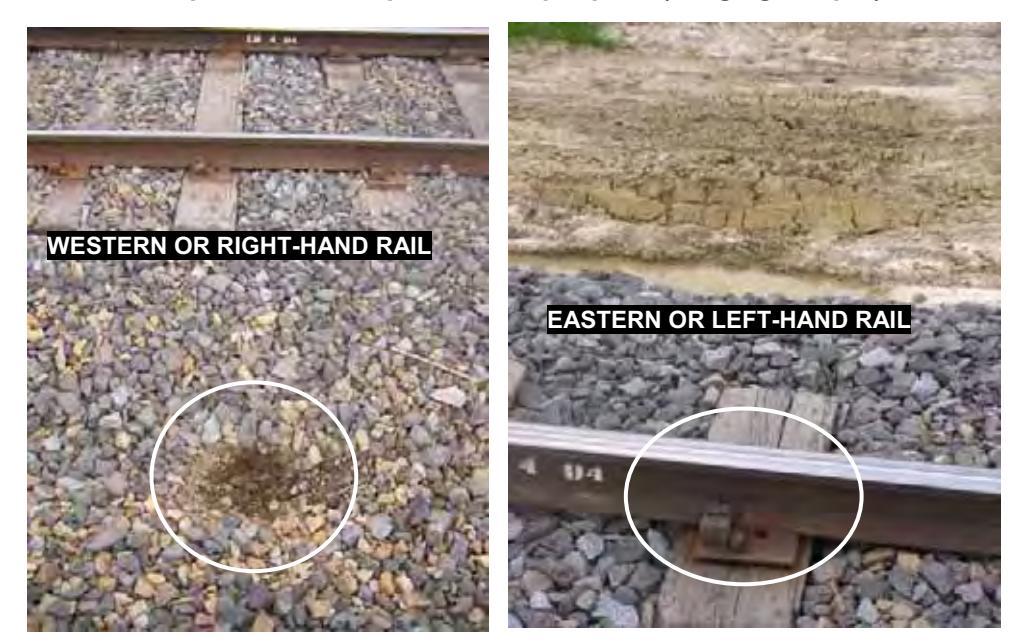
beside the formation and visible track settlement at the cross drains, mainly along the eastern rail. There was also evidence that the cross drains had become blocked and ineffective. Given the presence of relatively sharply peaked welds and poor sub-grade, the extra impact load over soft formation appears to have led to dynamic deflections exceeding 8.5 mm and would have caused progressive track settlement. The sleepers at the lowest point in the dips were found to be 'hanging' in that there was considerable space between the sleeper plates and the sleeper. Some spaces were filled with ballast particles.

Figure 12: Example of cross drain location showing ballast contamination from poor sub-grade/damp/soft formation, pooled water and separation of sleeper and sleeper plate (hanging sleeper)

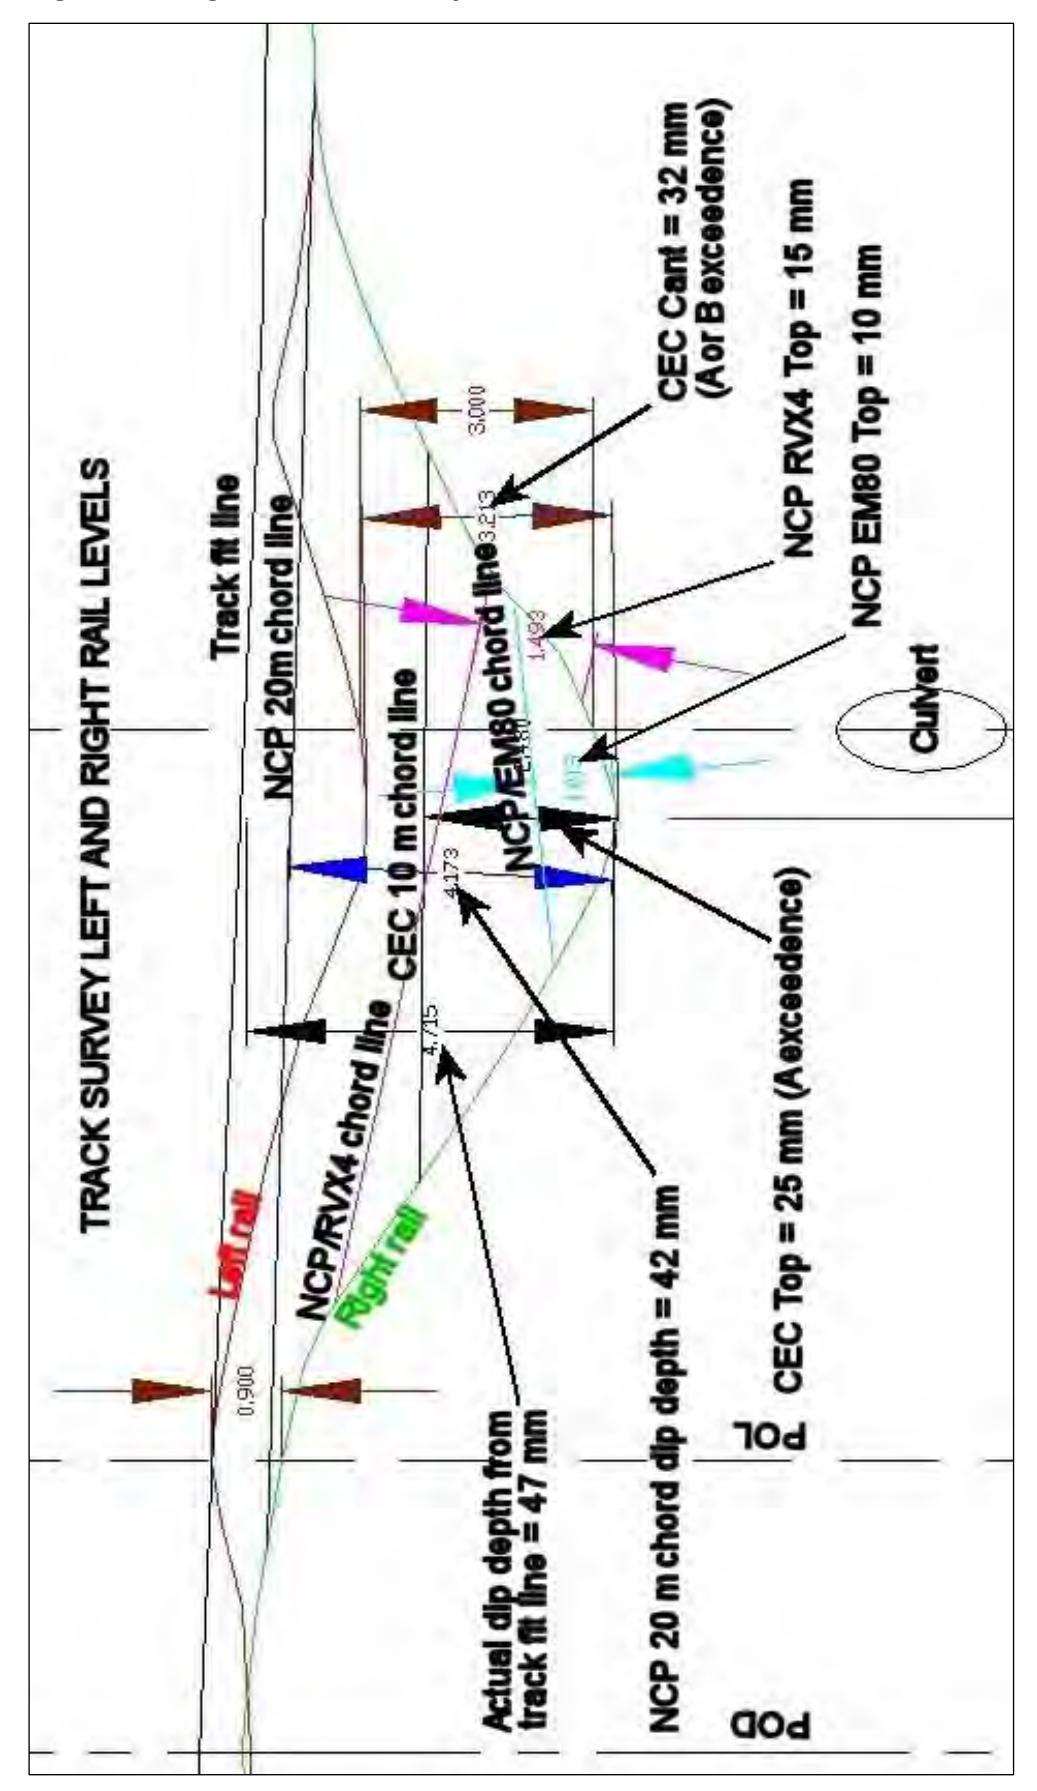
Figure 13: Diagram of track surveyed with CEC and NCoP standards overlaid

The application of the NCoP 'top' and 'short' twist limits would have provided a further insight into the track condition because it allows ready interpretation of track geometrical shape by a track inspector. The AK Geo. standard 'top' and 'short' twist measurements cannot be readily or precisely interpreted by a track inspector. In addition, the AK Car had possibly become the arbiter of track geometrical defects. This left track inspectors and engineers in practice, dependent upon the geometry measurement system without being able to check on the outcome's veracity. That is, the AK Geo. standard used should have included additional manual measurement procedures to determine the presence and scope of any defect reported by the AK Car.

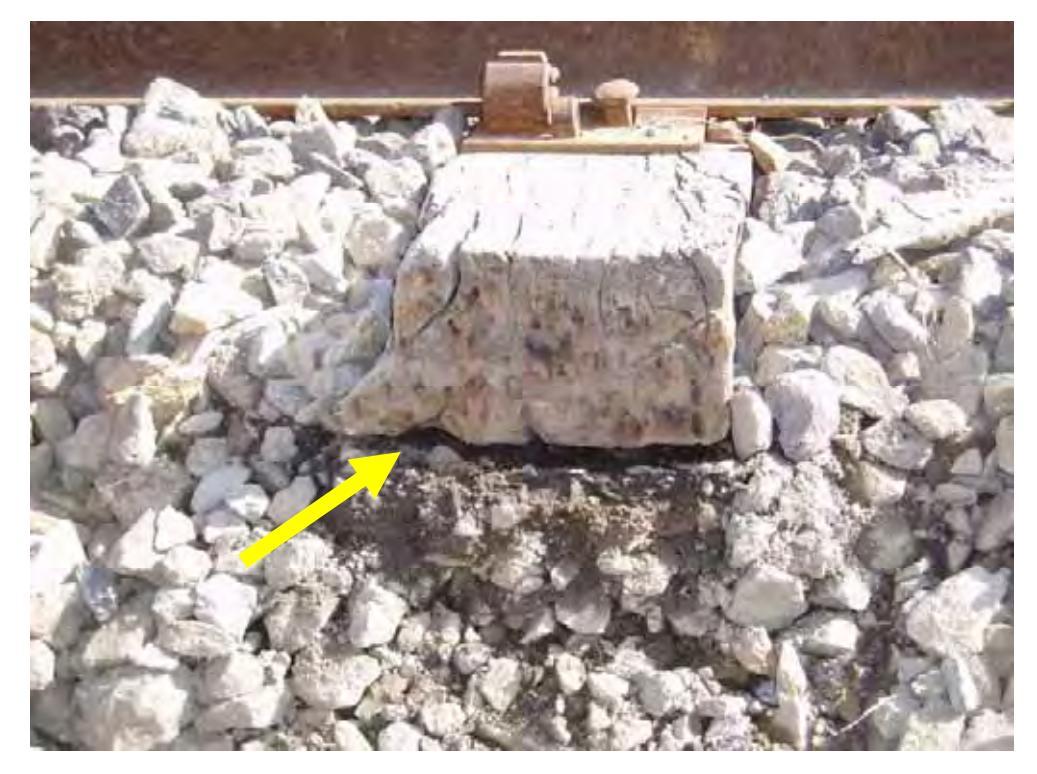
Figure 14: A profile cut into the ballast at the occurrence site indicates the presence of contamination which contributed to the development of voids under sleepers

At the location immediately before the POD, the eastern rail dip was about 47 mm deep and the western rail dip was about 15 mm deep. (Refer to figure 14). The cross-level at the bottom of the dip was approximately 32 mm, which is an exceedence under CEC 8/86 for tracks of Class 1, 2 and 3, and was an 'A' type exceedence under CEC 7/86 for track Class 1 and a 'B' type exceedence for track Class 2. However, this is not an exceedence under the AK Geo. standard. It is very likely that the figures would have increased under load as these survey measurements were made with unloaded track.

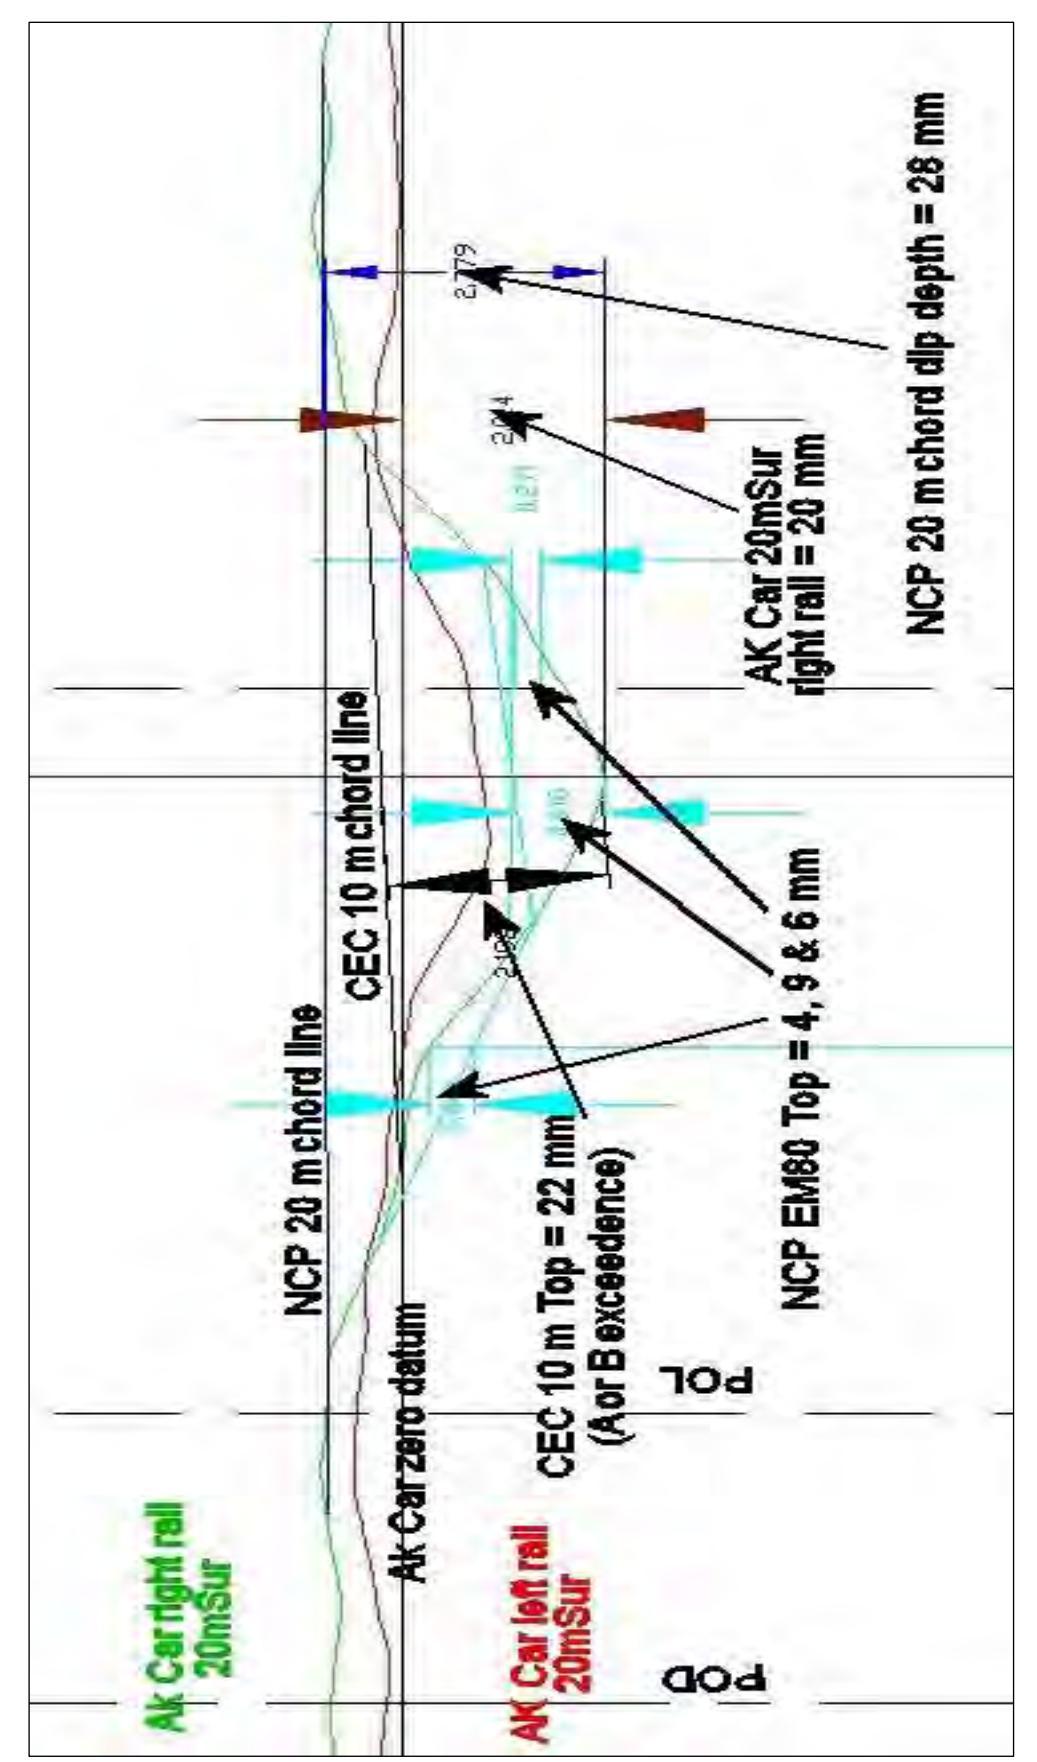
Figure 15 shows the AK Car '20Sur' data from which is derived the 'Top' data for comparison with the AK Geo. standard. It also shows the AK Car basic rail vertical profile data, called '20mSur' (for eastern and western rails, red and green respectively), which follows the same general form as the survey data and shows a lesser depth of dip. This might have been a consequence of the passage of time, an artefact of the measurement system and its associated physics and maths, or the setup and operation of the AK Car. In any event, the 'Short - Top' data used for comparison with AK Geo. standard limits were the 4 mm, 6 mm and 9 mm figures shown progressively around the dip.

Figure 15: AK Car 20mSur data

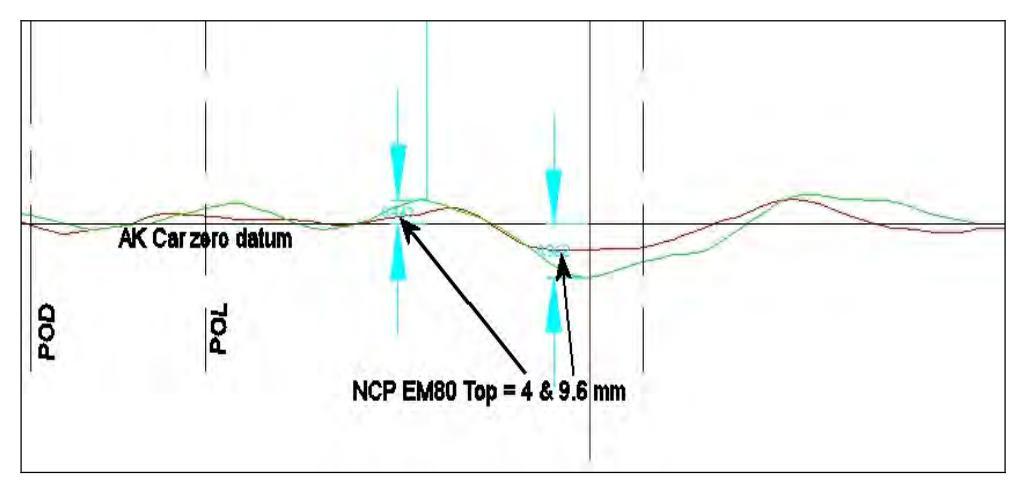
The 'Top' data set was checked against the AK Geo. standard requirements. This is shown graphically in figure 16. It is clear that the significant dip shown in the AK Car '20mSur' data, and even more obviously in the survey data, had gone undetected. The 'Short - Top' measurements are about half the allowable AK Geo. standard limits. In other words, it would appear that the dip in the track could have been twice the depth before triggering an AK Geo. standard 'Top' exceedence.

Figure 16: AK Car reported 'short' 'top' data

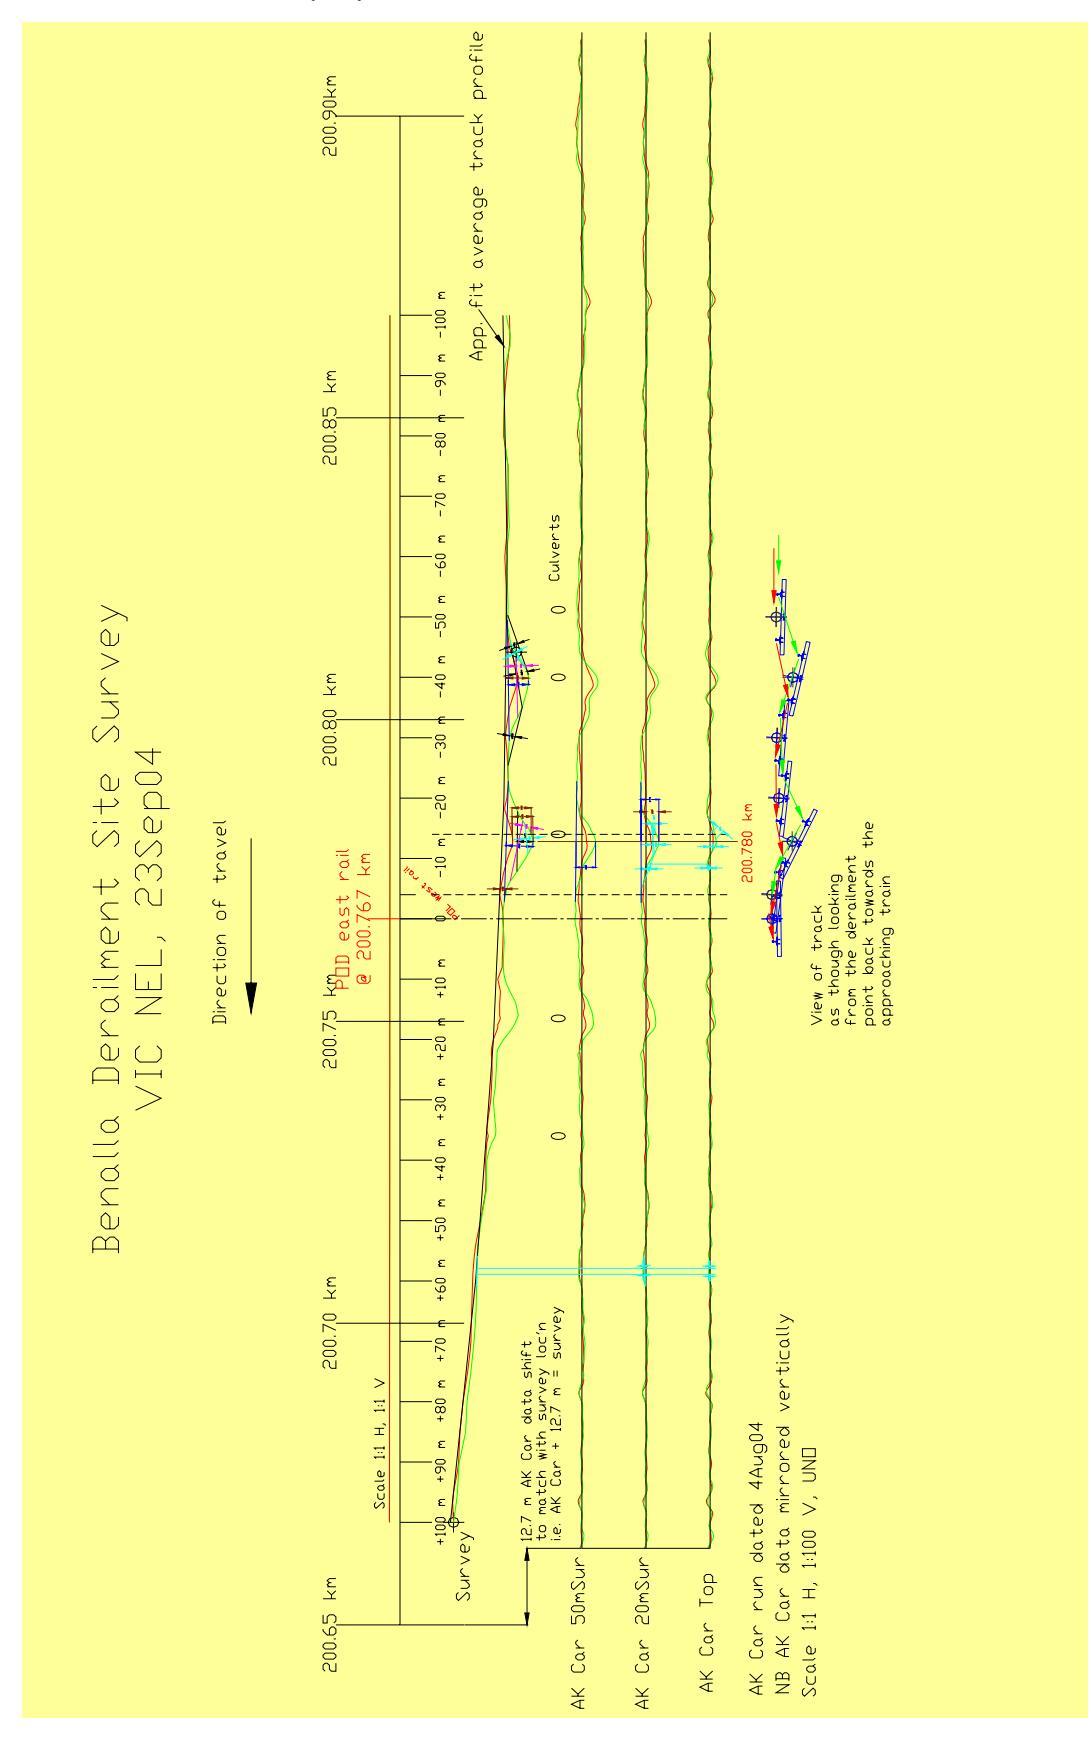
Figure 17 shows the area of the derailment with several data plots. The upper-most shows the site survey at 1:1 vertical scale, the next down at 1:100 vertical scale, followed by three AK Car plots. The plots marked 'AK Car 50mSur' and 'AK Car 20mSur' show approximately the same track profile as the plot marked 'Survey'. The plot marked 'AK Car Top' however shows little resemblance to the 'Survey' plot.

The AK Car '20mSur' data approximately matches the survey data, though the latter shows a much deeper dip, (28 mm compared to 42 mm, using the AK Geo. standard 20 metre 'Long - Top' measure).

Figure 17: Survey plot and AK Car vertical profiles of east rail (green) and west rail (red)

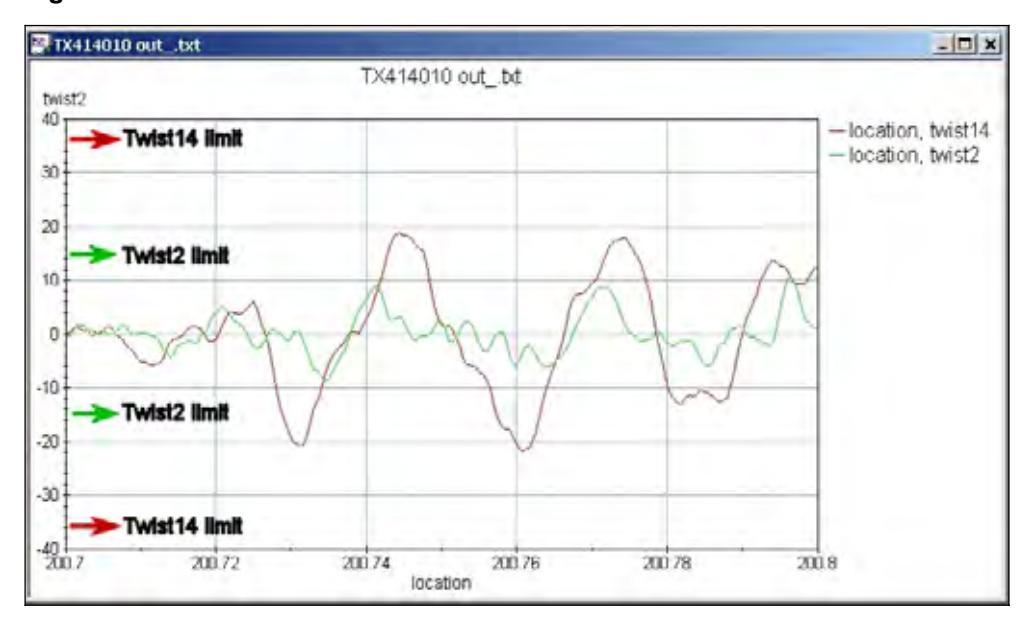
Figure 18: AK Car twist data at derailment site

The AK Car long and short twist data, shown in Figure 18, also does not produce measurements indicating an exceedence of limits.

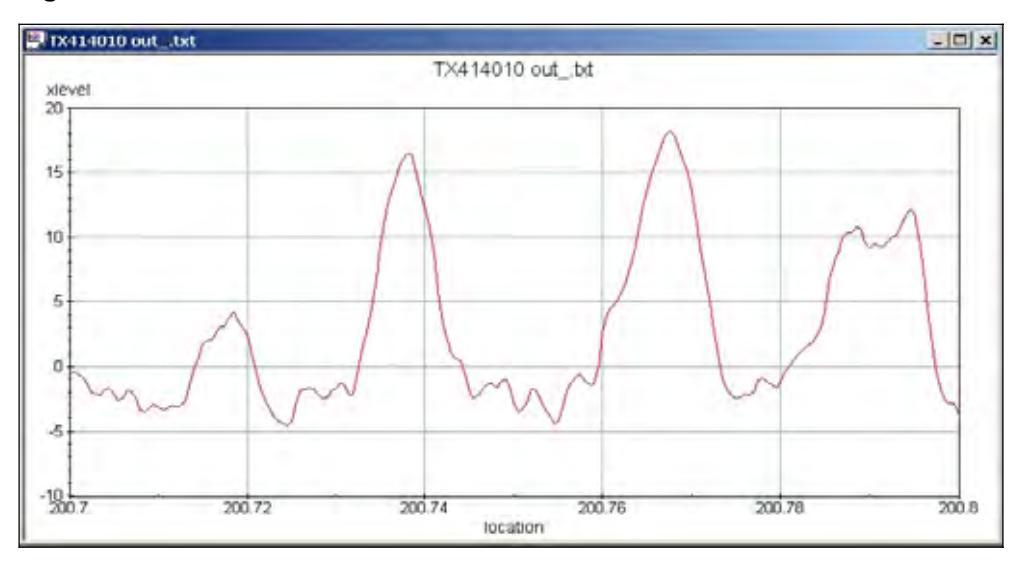
The cant or cross-level data shows a pattern that also raises concern in a vehicle/track dynamic interaction context. Figure 19 shows the variation in cant at the derailment site. Over a distance of 10 kilometres of AK Car data, the derailment site was found to be one of the worst areas for cross-level.

Figure 19: Track Cant or Cross-level at derailment site

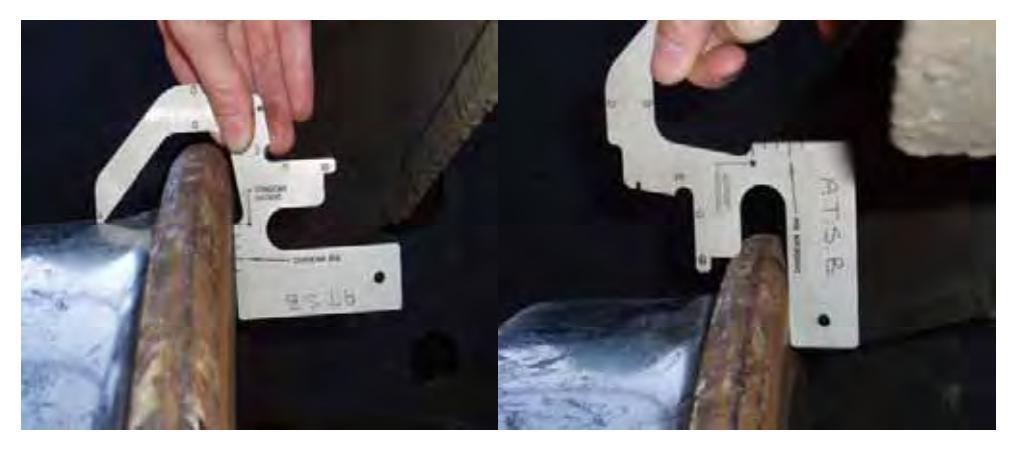
Figure 21: Flange height and tread thickness (left) and flange thickness (right) of the leading right-hand wheel of wagon VPBX 155-S

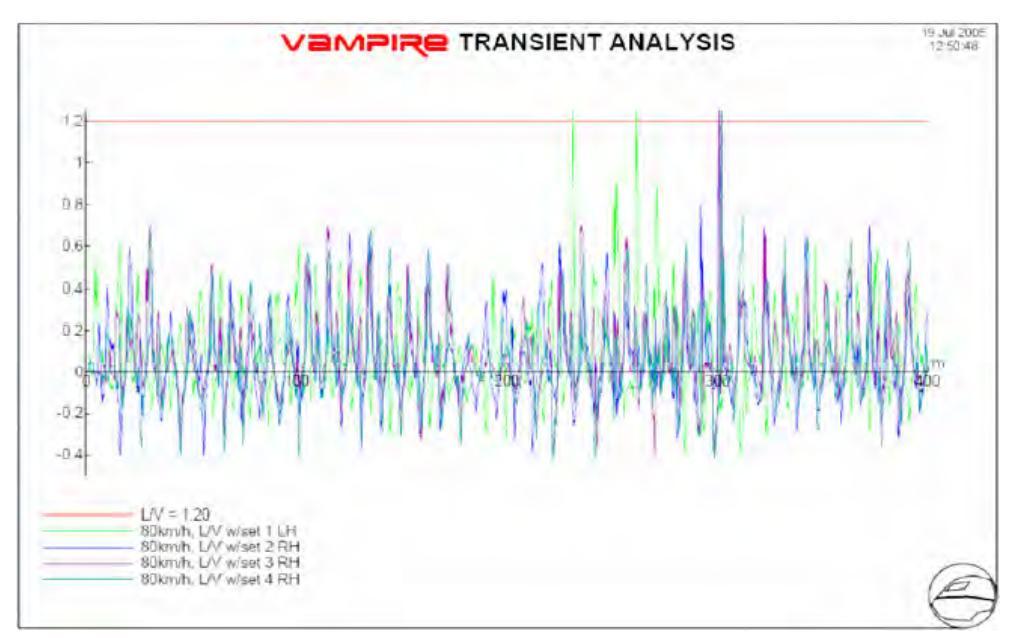
Figure 22: Vampire output of L/V – Using AK Car track data. Including: gauge (lateral) irregularity on left-hand rail; VPBX wagon worn and hunting; and 80 km/h speed of wagon

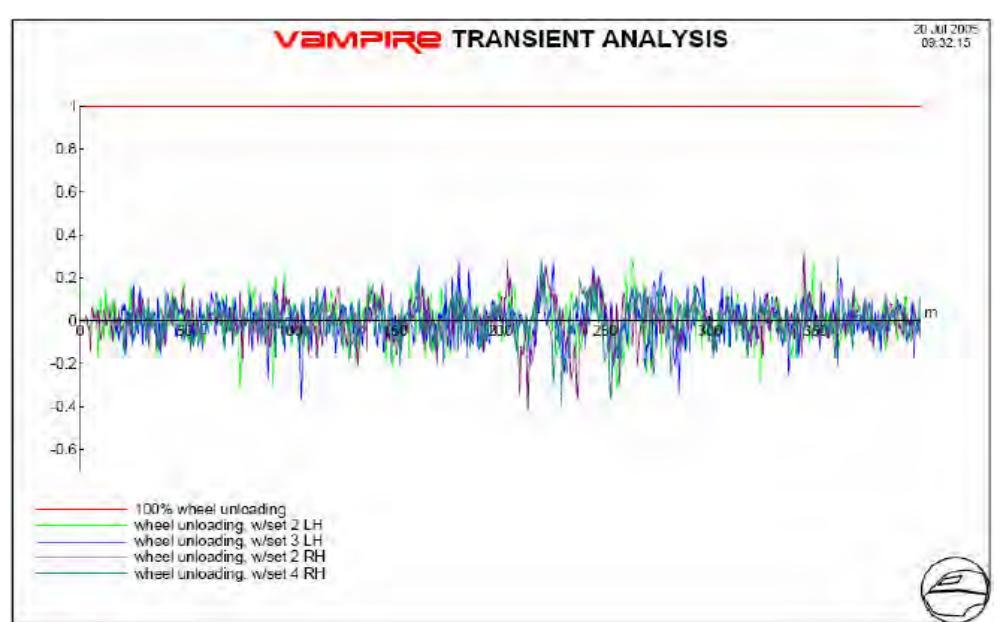
Figure 23: Comparison Mk3 coach wheel unloading on AK Car data track

Very little wheel unloading occurs on the Mk3 coach, around 25 per cent maximum compared to 100 per cent for the VPBX wagon. The passenger vehicle has much better performance than the freight wagon, since the passenger vehicle has a more compliant suspension and hydraulic damping. This also serves to illustrate that
