ATSB TRANSPORT SAFETY INVESTIGATION REPORT

Aviation Safety Occurrence Report – 200701033 Preliminary

Loss of Control Clyde North, Victoria 23 February 2007 Van's Aircraft Inc. RV-4, VH-ZGH

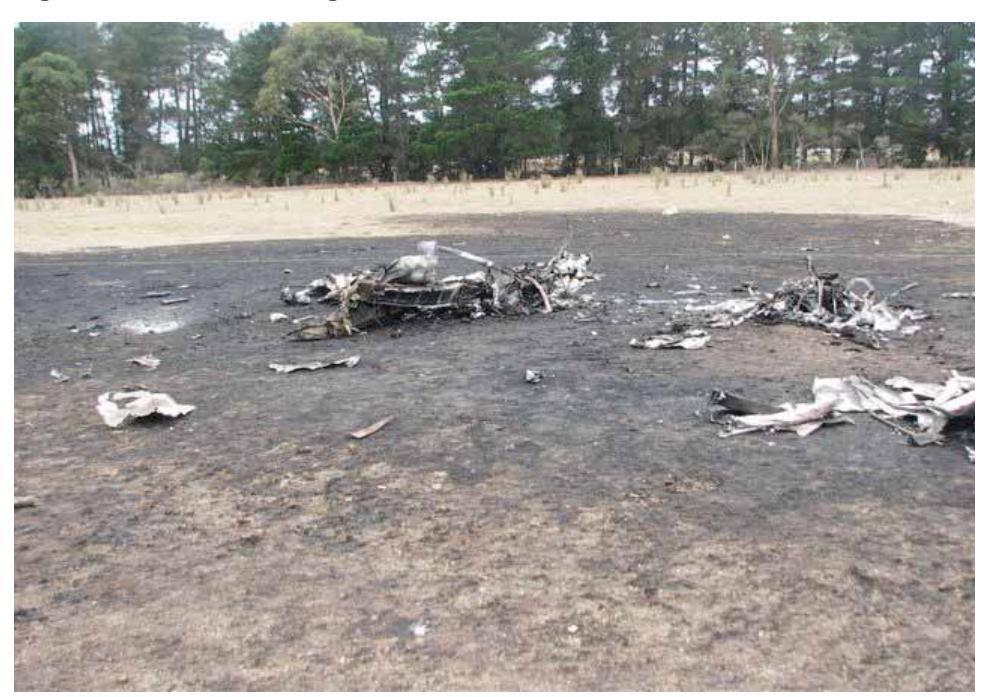
The terrain at the accident site was flat and open. Examination of the site revealed that the aircraft had impacted the ground in a very steep nose-down attitude at high speed. Both right and left tailplanes, the fin and rudder were recovered in trees approximately 117 metres from the main aircraft impact point. The left and right elevator balance weights were recovered either side of the burnt area of the accident site.

The force of the impact and the subsequent fire resulted in disintegration of the aircraft structure (figure 2). No instrumentation was recovered from the wreckage. Examination of the engine and propeller showed that the engine was developing significant power at the time of impact.

Figure 2: View of wreckage

An examination of the ground witness marks and twisting of the tailplane rear spar indicated that the aircraft had been rotating in a clockwise direction at the time of impact.

Examination of the separated tail structures indicated twisting and tearing of the attachments fittings.
