ACCIDENT INVESTIGATION REPORT

DH114 2E/A1 Aircraft VH-CLS, near Cairns Airport, Queensland, on 23 October 1975

Special Investigation Report 76-1

Connair Pty Ltd Heron DH114 2E/A1 Aircraft VH-CLS near Cairns Airport, Queensland on 23 October 1975

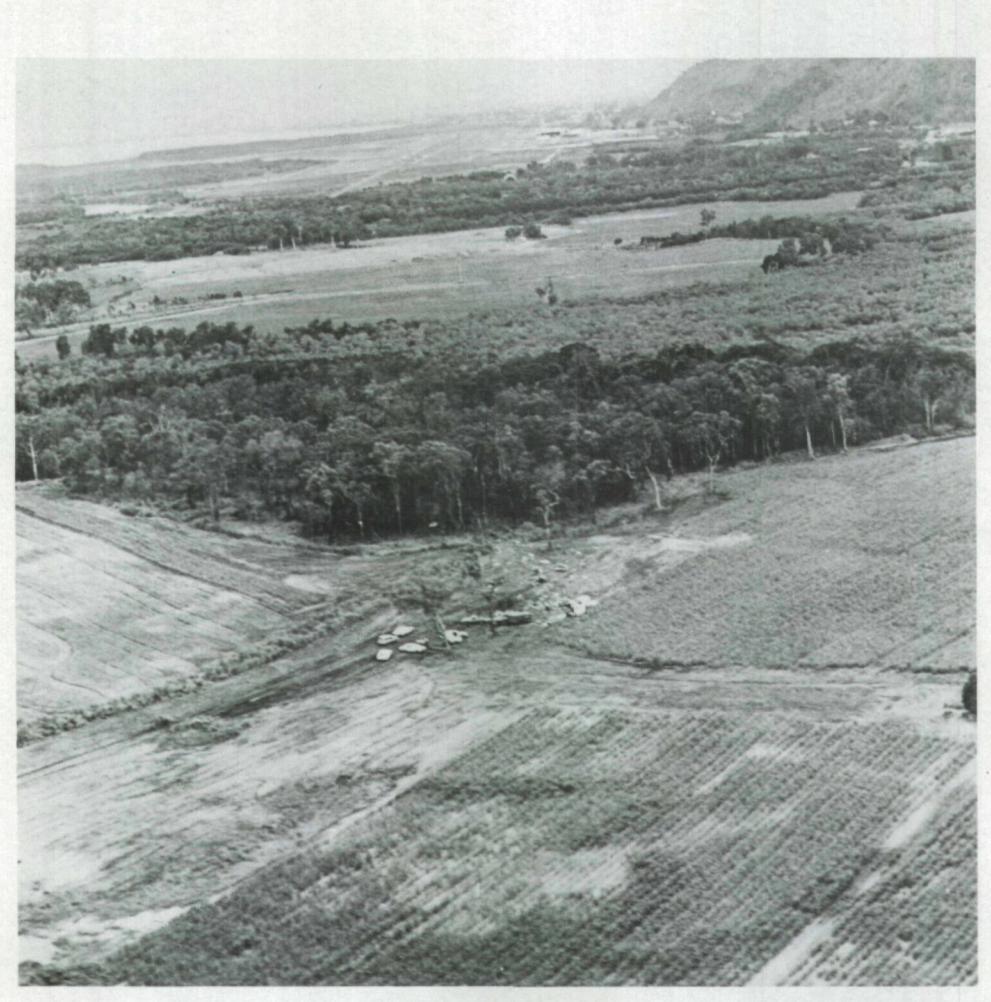
Accident Site (Airport in background)

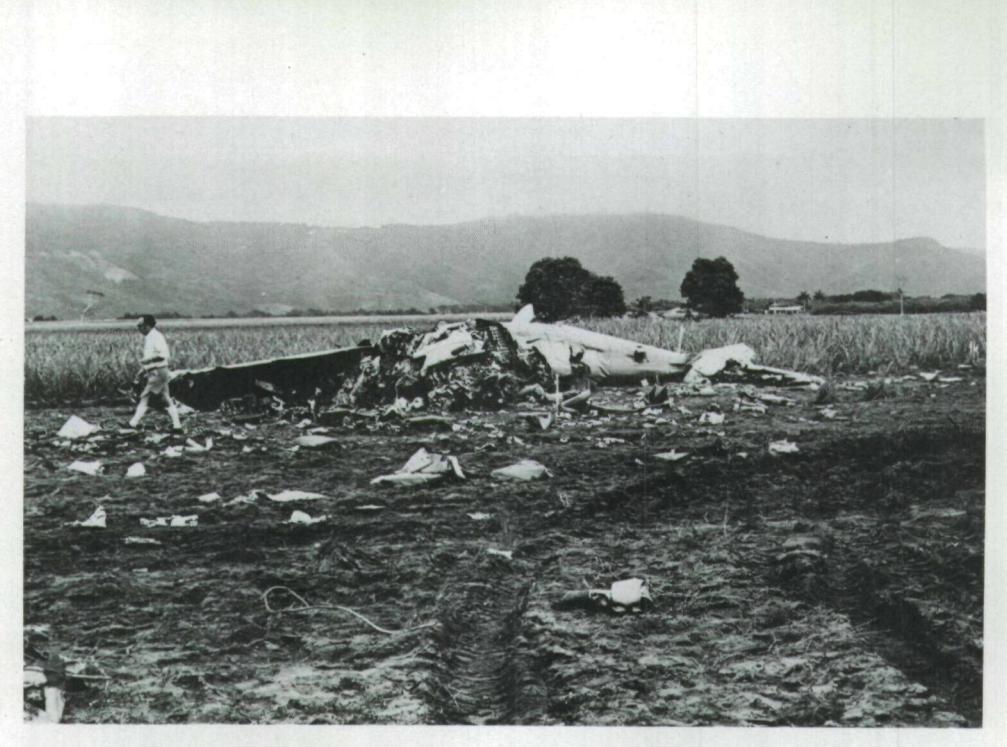
Large portions of both wings and part of the port tailplane were detached from the aircraft during its passage through the trees. The nature of this damage, and the damage to the trees, indicates that the aircraft was banked about 40 degrees right wing down and that it was descending along a flight path approximately 14 degrees below the horizontal in a normal flight attitude. There was no evidence of yaw.

General view of main wreckage

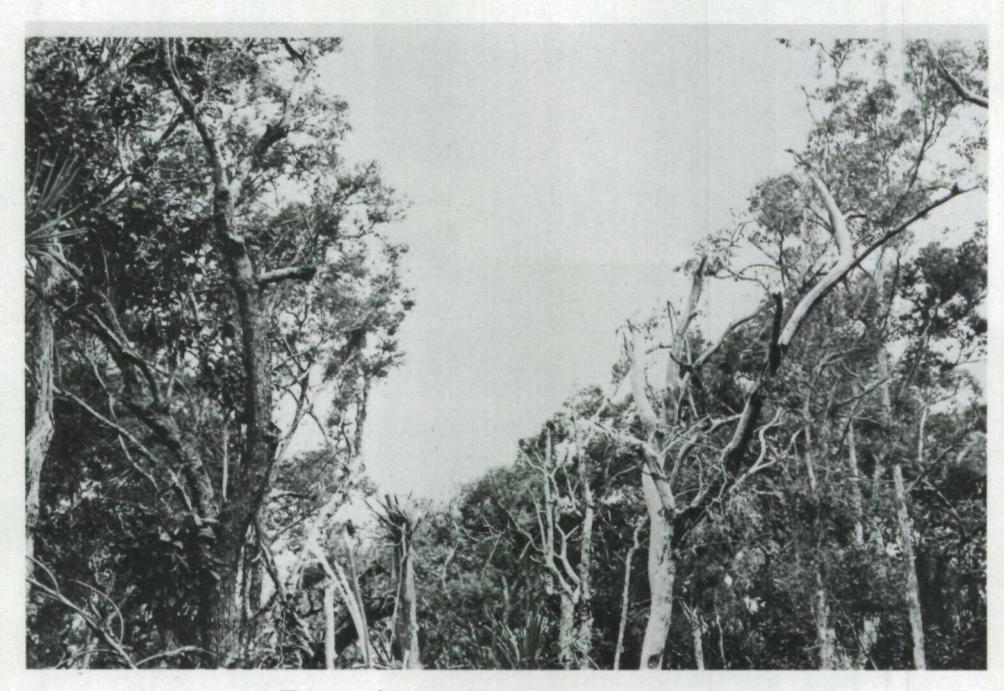
Tree swathe viewed from ground impact point
