Departmental investigation into cargo hold bulkhead failure aboard the Malaysian flag bulk carrier GIGA 2 on 5 November 1996

Report No. 101

### GIGA 2

#### on 5 November 1996

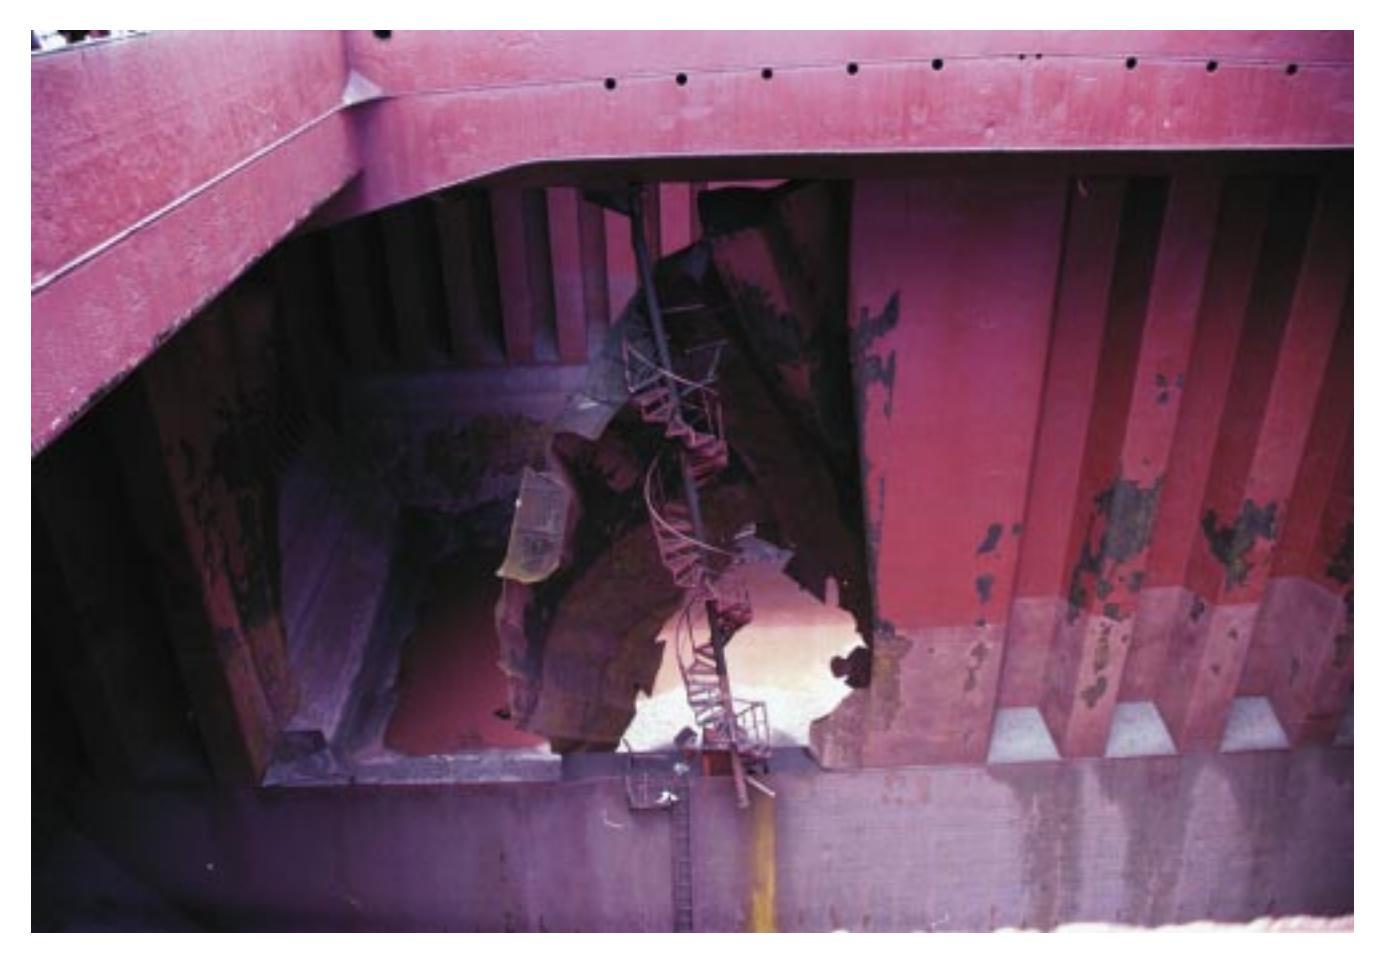
The collapsed bulkhead at frame 193 (the after-end bulkhead of No. 4 hold)

After the water had been pumped from Nos. 4 and 5 holds, the collapsed bulkhead at frame 193 (the afterend bulkhead of No. 4 hold) was examined. It was found that the corrugated bulkhead to the starboard side of the centreline stiffener had become completely detached from the upper and lower stools and had torn from bottom to top, about 8 m in from the ship's side. It remained attached only down its inboard side adjacent to the centreline stiffener. The lower half was bowed well out into No. 5 hold and the bulkhead had been stretched to the point where the corrugations in the lower half of the detached section had been smoothed out and virtually disappeared.

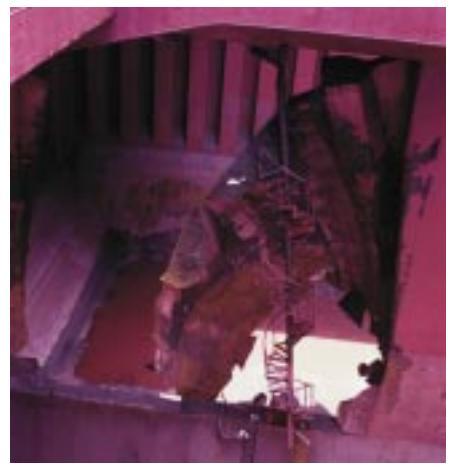
Starboard side of bulkhead at frame 193, looking aft from No. 4 hold

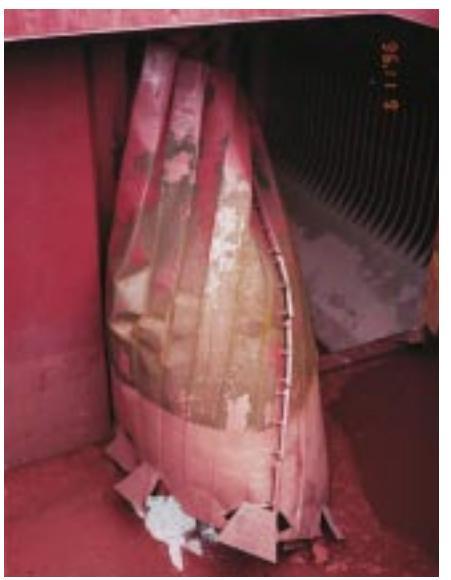
# Starboard bulkhead at frame 193 viewed from No. 5 hold

Note: Flattening of corrugations at lower half and detachment of shedder plates. Horizontal line along bulkhead indicates level of water in Nos. 4 and 5 holds

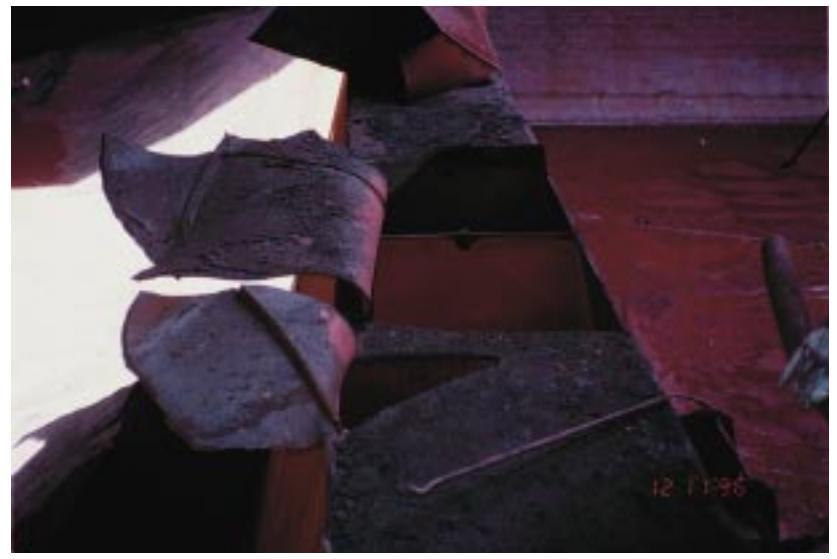
Lower stool shelf plate showing area in which failure was initiated

A visual inspection indicated that along the lower edge of the corrugated bulkhead, the collapse was initiated by failure of the welds securing the shelf plate of the lower stool to the plating beneath it. Once this plate had torn, the failure was propagated by following the continuous weld along the top surface of the shelf plate (lower stool) at the lower edge of the corrugations.

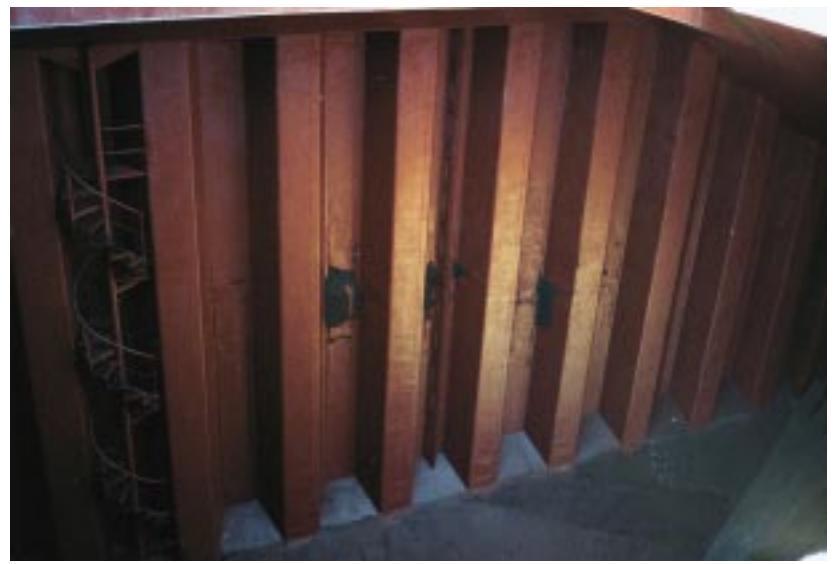
Visual evidence indicated that No. 4 hold forward bulkhead at frame 222 (forward bulkhead No. 4 hold) had bulged into No. 3 hold, although it had not failed. Large areas of paint midway up the bulkhead had flaked off, with the majority of the superficial surface rust on the resulting exposed metal extending only up to the level at which the water had settled after the incident showing that the flaking of the paint had occurred very recently and, most probably, at the time of the incident. From within No. 3 hold evidence of buckling could be seen on the forward parts of the corrugations above the lower stool, indicating a compressive loading consistent with the bulkhead having bowed forward into No. 3 hold.

Bulkhead at frame 222 – forward bulkhead of hold showing paint loss and signs of buckling, viewed from No. 3 hold

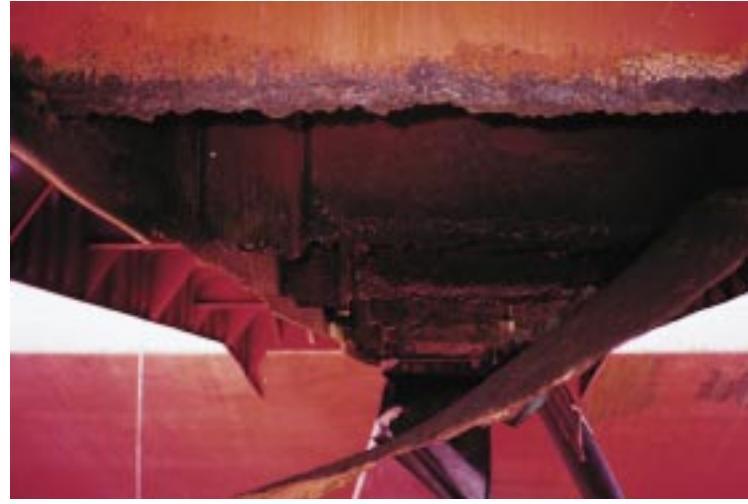
Upper stool showing corroded vertical webs and detached shelf plate

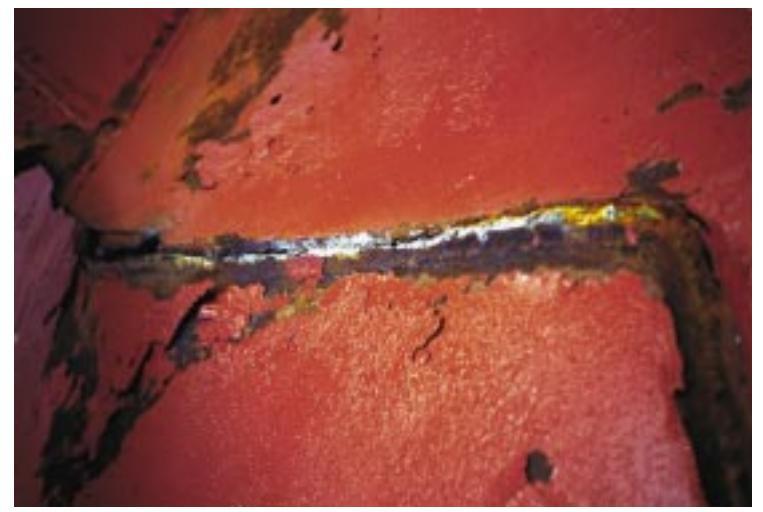
Starboard upper hopper tank in No. 4 hold showing failed welding where corrugated bulkhead was connected

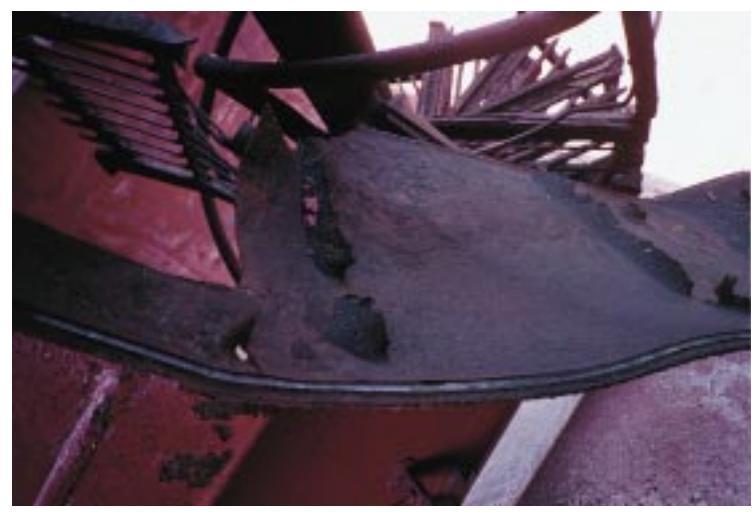
Along its top edge, the bulkhead had become detached from the upper stool from a point 1 m outboard of the centreline stiffener (approximately 3.4 m from the vessel's centreline) to the outboard end of the upper stool and to another point part-way down the underside of the upper hopper (approximately 12.3 m out from the centreline). Severe corrosion was found along the lower edge of all the deep webs within the upper stool, extending to a height of some 75 mm to 150 mm up the webs, indicating that water or damp sludge had been lying in the bottom of the stool for a lengthy period. The corrosion was such that most of the webs were virtually detached from the bottom plate of the stool, leaving the load on the top of the bulkhead to be carried almost entirely by the two continuous welds running along the forward and after edges of the bottom plate. These welds had failed and most of the bottom plate of the upper stool had come away with the bulkhead.

Shelf plate detached from upperstool Note: remaining corroded edges of deep webs and failure of continuous weld along edge of shelf plate

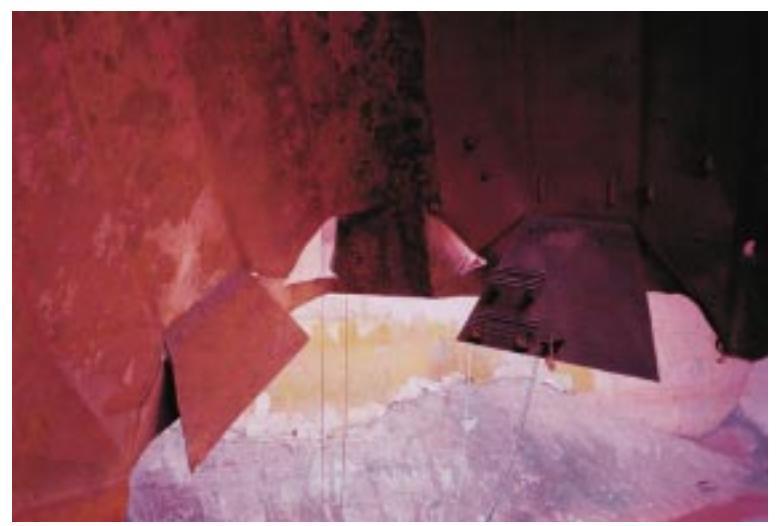
The welds connecting the shedder plates to the corrugations and to the shelf top plate of the lower stool had failed. Examination of the shedder plates showed that the edges were left in the condition as when flame cut and had not been ground or prepared for welding. Visual examination of the welds and the plate preparation indicated that the welding was of a nominal rather than structural nature.

Detachment of shedder plates at bottom of corrugated bulkhead

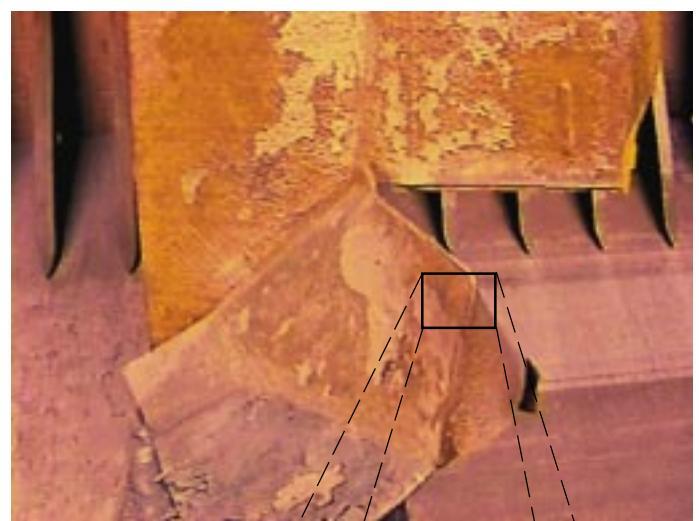
Shedder plate (video capture)

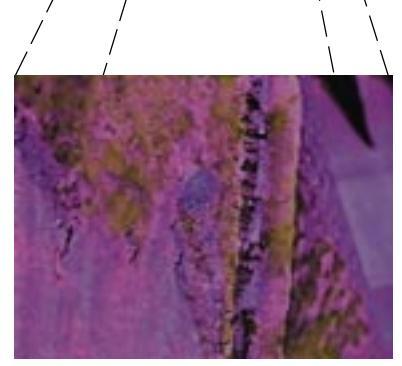
Shedder plate showing flame-cut edge unprepared for welding (video capture) It must be recognised that the bulkhead and weld dimensions relate to a bulkhead designed to withstand a 14 m head of water. However, these welded connections, between the bulkhead and the lower stool, appear to have been the weak link in the system and were identified in the Monash report as being sufficiently deficient in size for collapse to occur with only a small increase in water level above the allowable 14 m.
