Shortly after 1700 hours on 2 March 1992 the Philippine registered bulk carrier Longevity, on passage from Kimitsu, Japan, to Newcastle, NSW, was in collision with the British yacht Blue Goose of Arne some 50 miles to the east of Sandy Cape. The Blue Goose of Arne was dismasted and also holed on the starboard hull.

Sequence of Events -Longevity

Sequence of events -Blue Goose of Arne

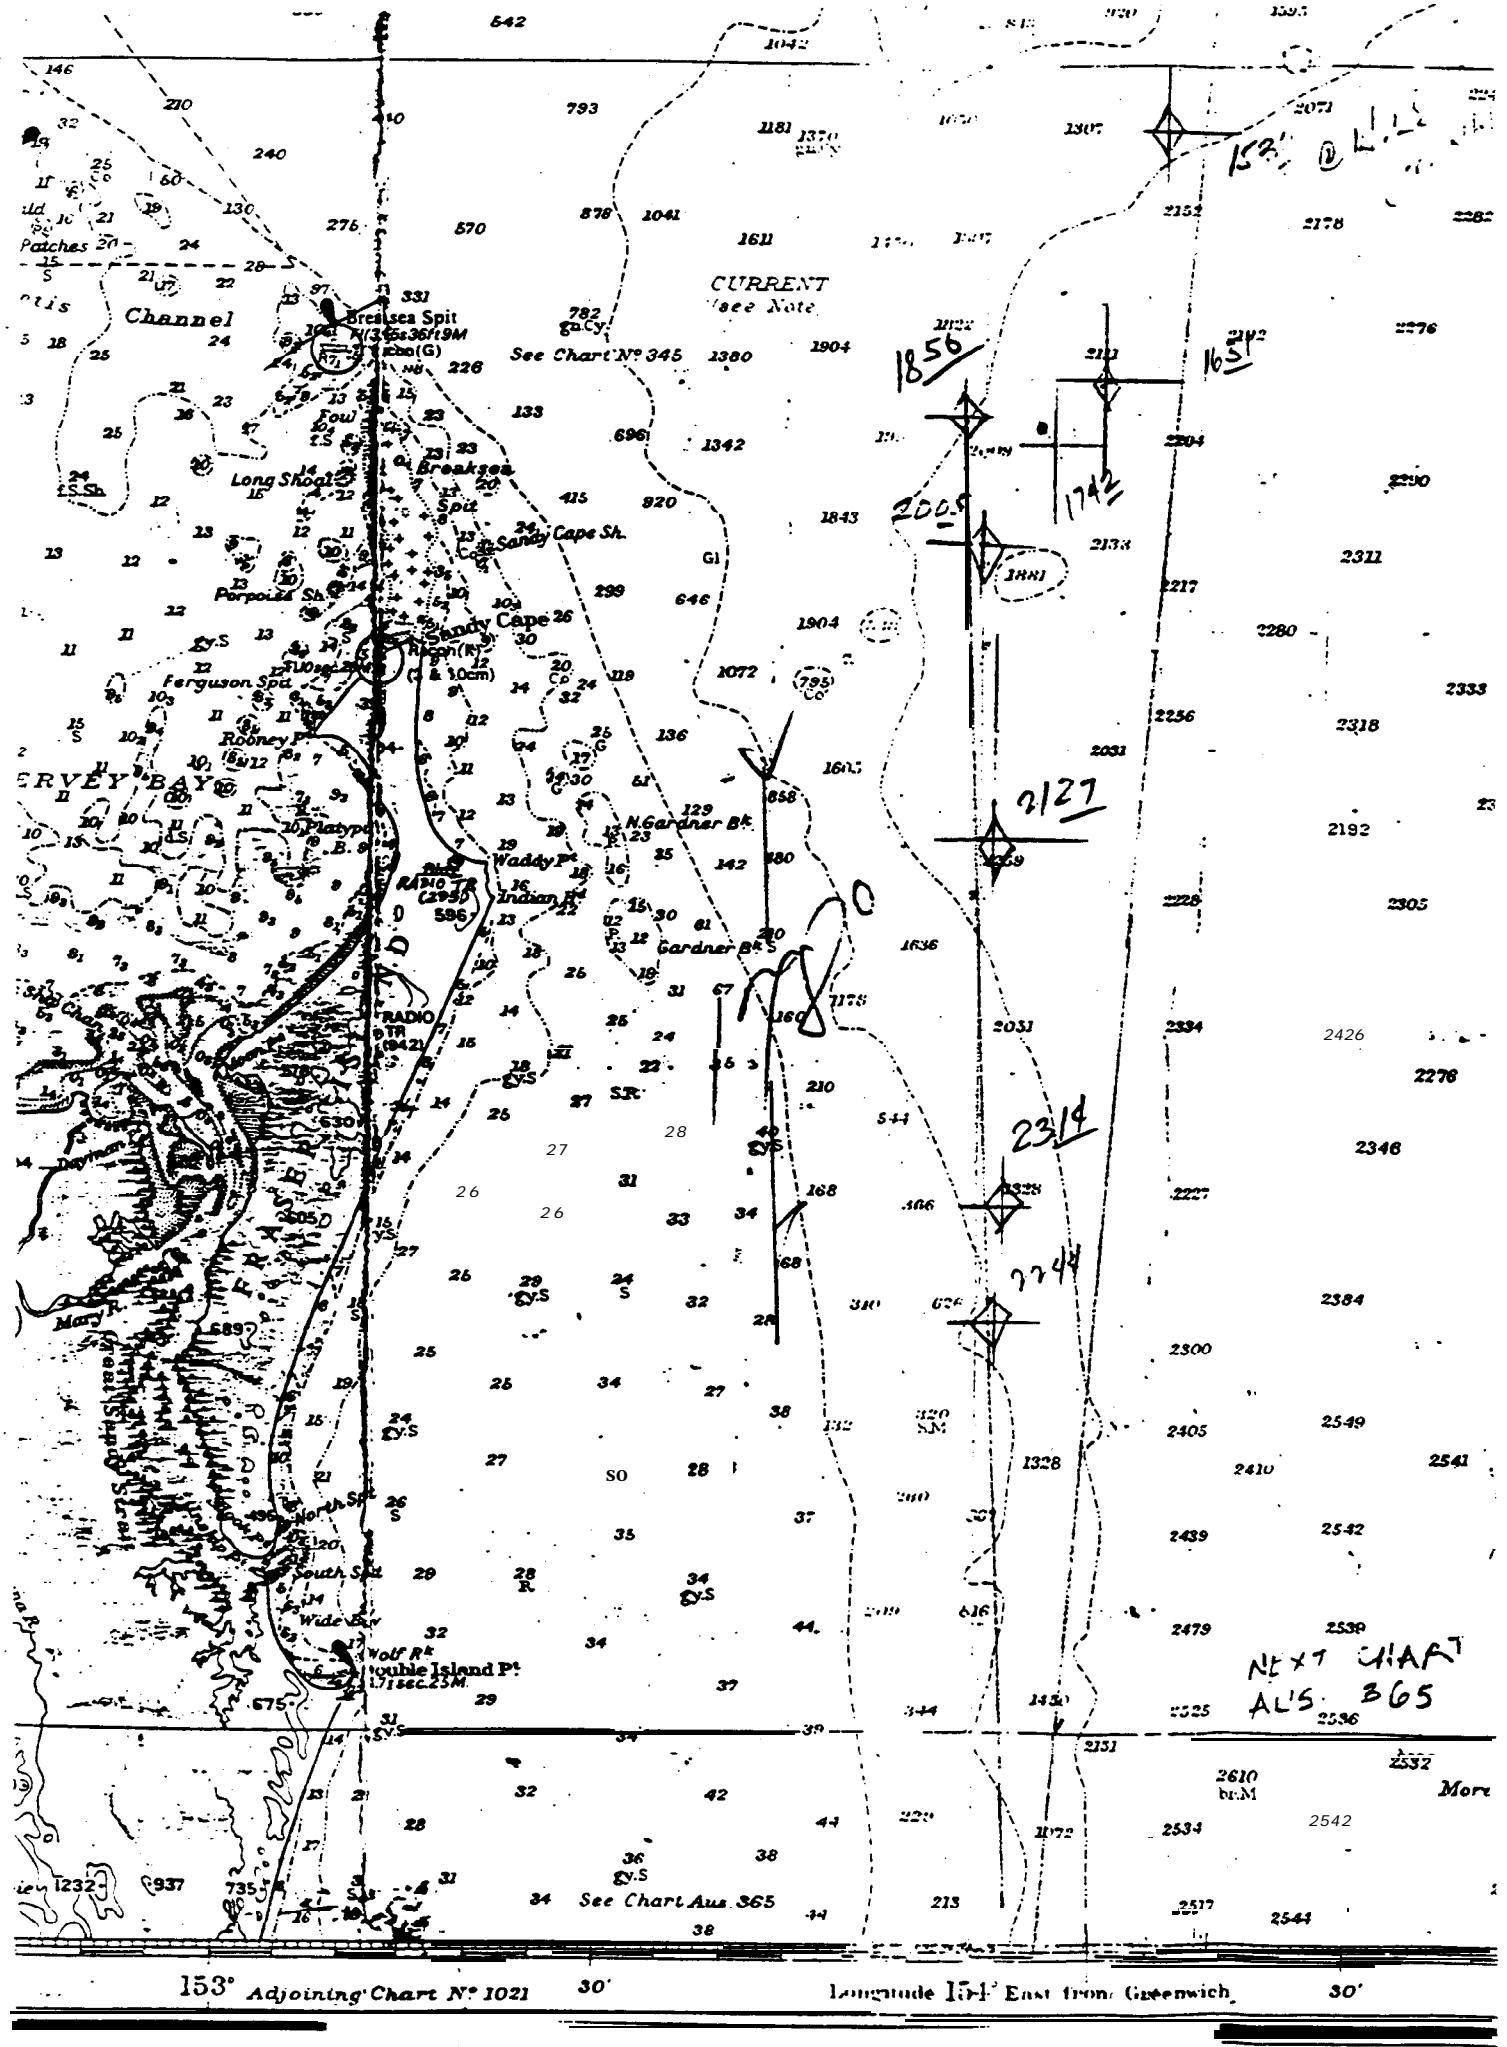
PORTION OF CHART IN USE BY LONGEVITY

The Master altered back to the correct course at this time, but because the ship was now to the west of the course line, set the course at 180 degrees. According to the Second Mate, when he arrived on the bridge the Master was instructing the helmsman to steady the ship on the 180 degree course.

The Master advised the Second Mate of the course and speed, pointed out the yacht, which the Second Mate noted to be between 1.5 and 2 points on the port bow, and told him to keep clear of it, recommending that he alter course to starboard. In making this recommendation the Master took into consideration that the crew were still on deck and the hatch lids were open; an alteration of course to port would have resulted in salt water spray being blown on to the fresh paintwork on deck.

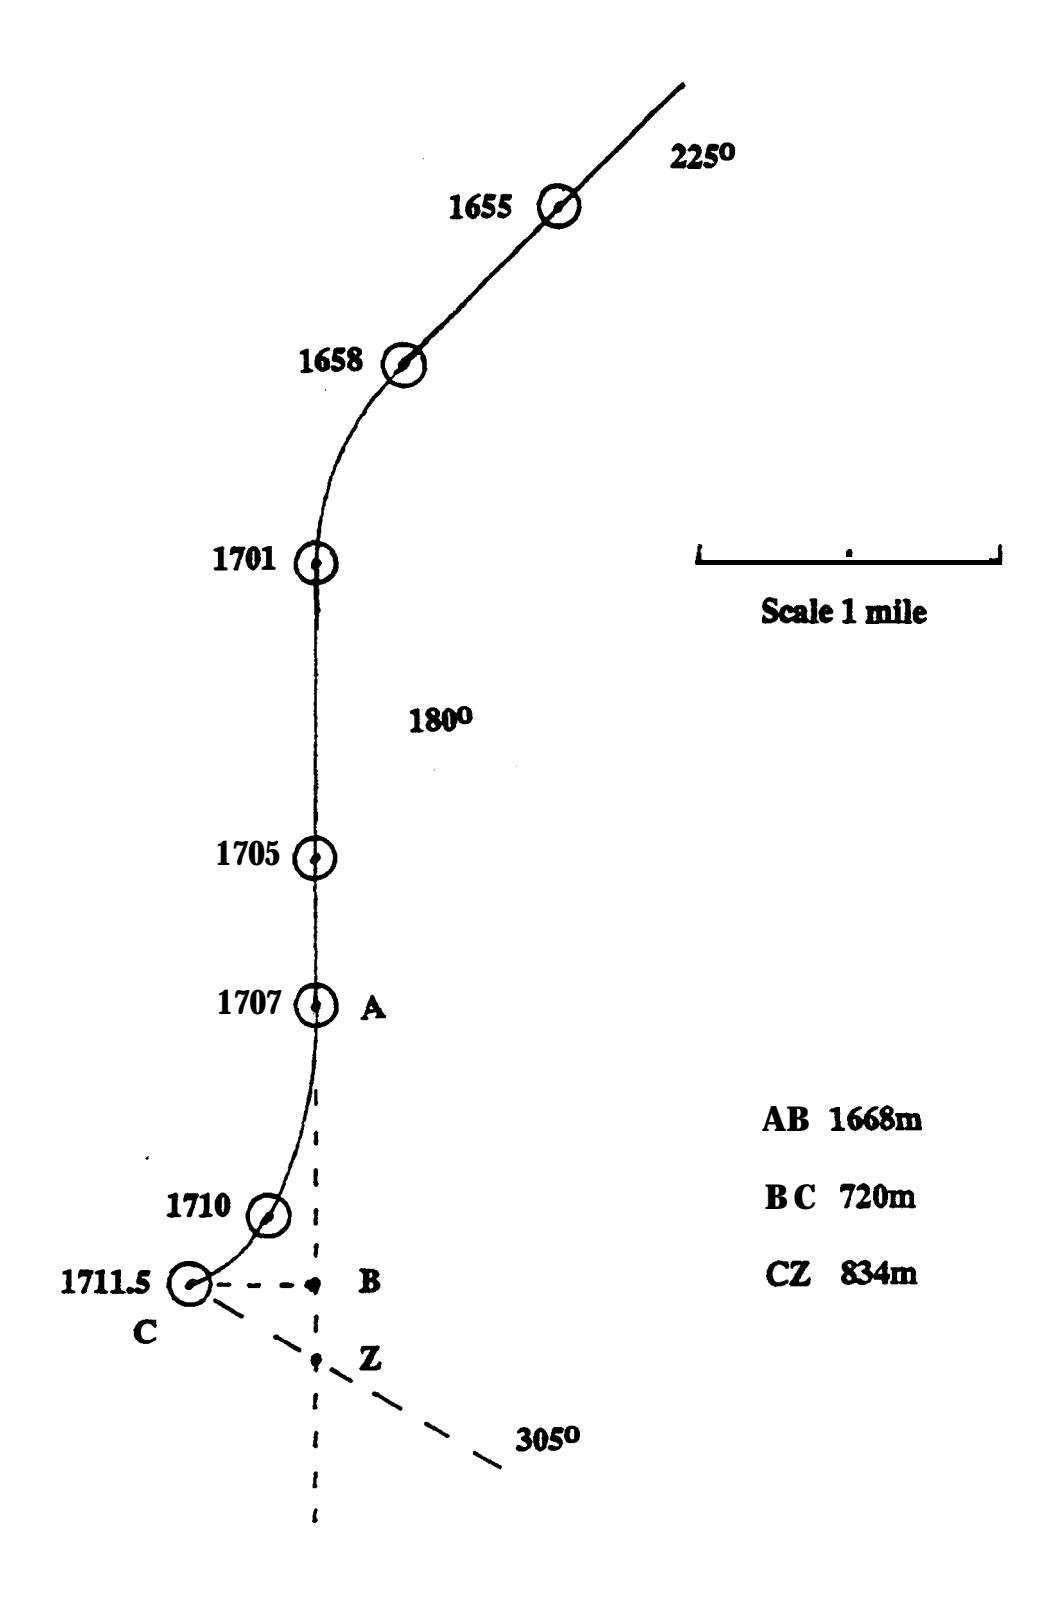
Diagram 1

From the course recorder chart, at 1630 (A) the Longevity was on a course of 178 degrees. At 1632 (B) course was altered to starboard, steadying on 225 degrees at 1635 (C). At 1658 (D) course was altered to port and at 1701 (E) the ship was steady on 180 degrees. At 1707 (F) course was altered to starboard. At 1710 (G) the trace shows an increase in rate of turn, indicating that maximum rudder was applied at that time. At 1712 (H) the ship reached a maximum alteration of course to starboard and commenced swinging back to port and was steadied on a course of 180 degrees at 1717 (J). At 1721 (K) the ship started to turn to port, around on to a reciprocal heading.

Based on the time of the increase in rate of turn at 1710 and the time of the maximum alteration to starboard at 1712, it is considered that the collision occurred between 1711 and 1711.5.

Reconstruction of Longevity's track from course recorder record

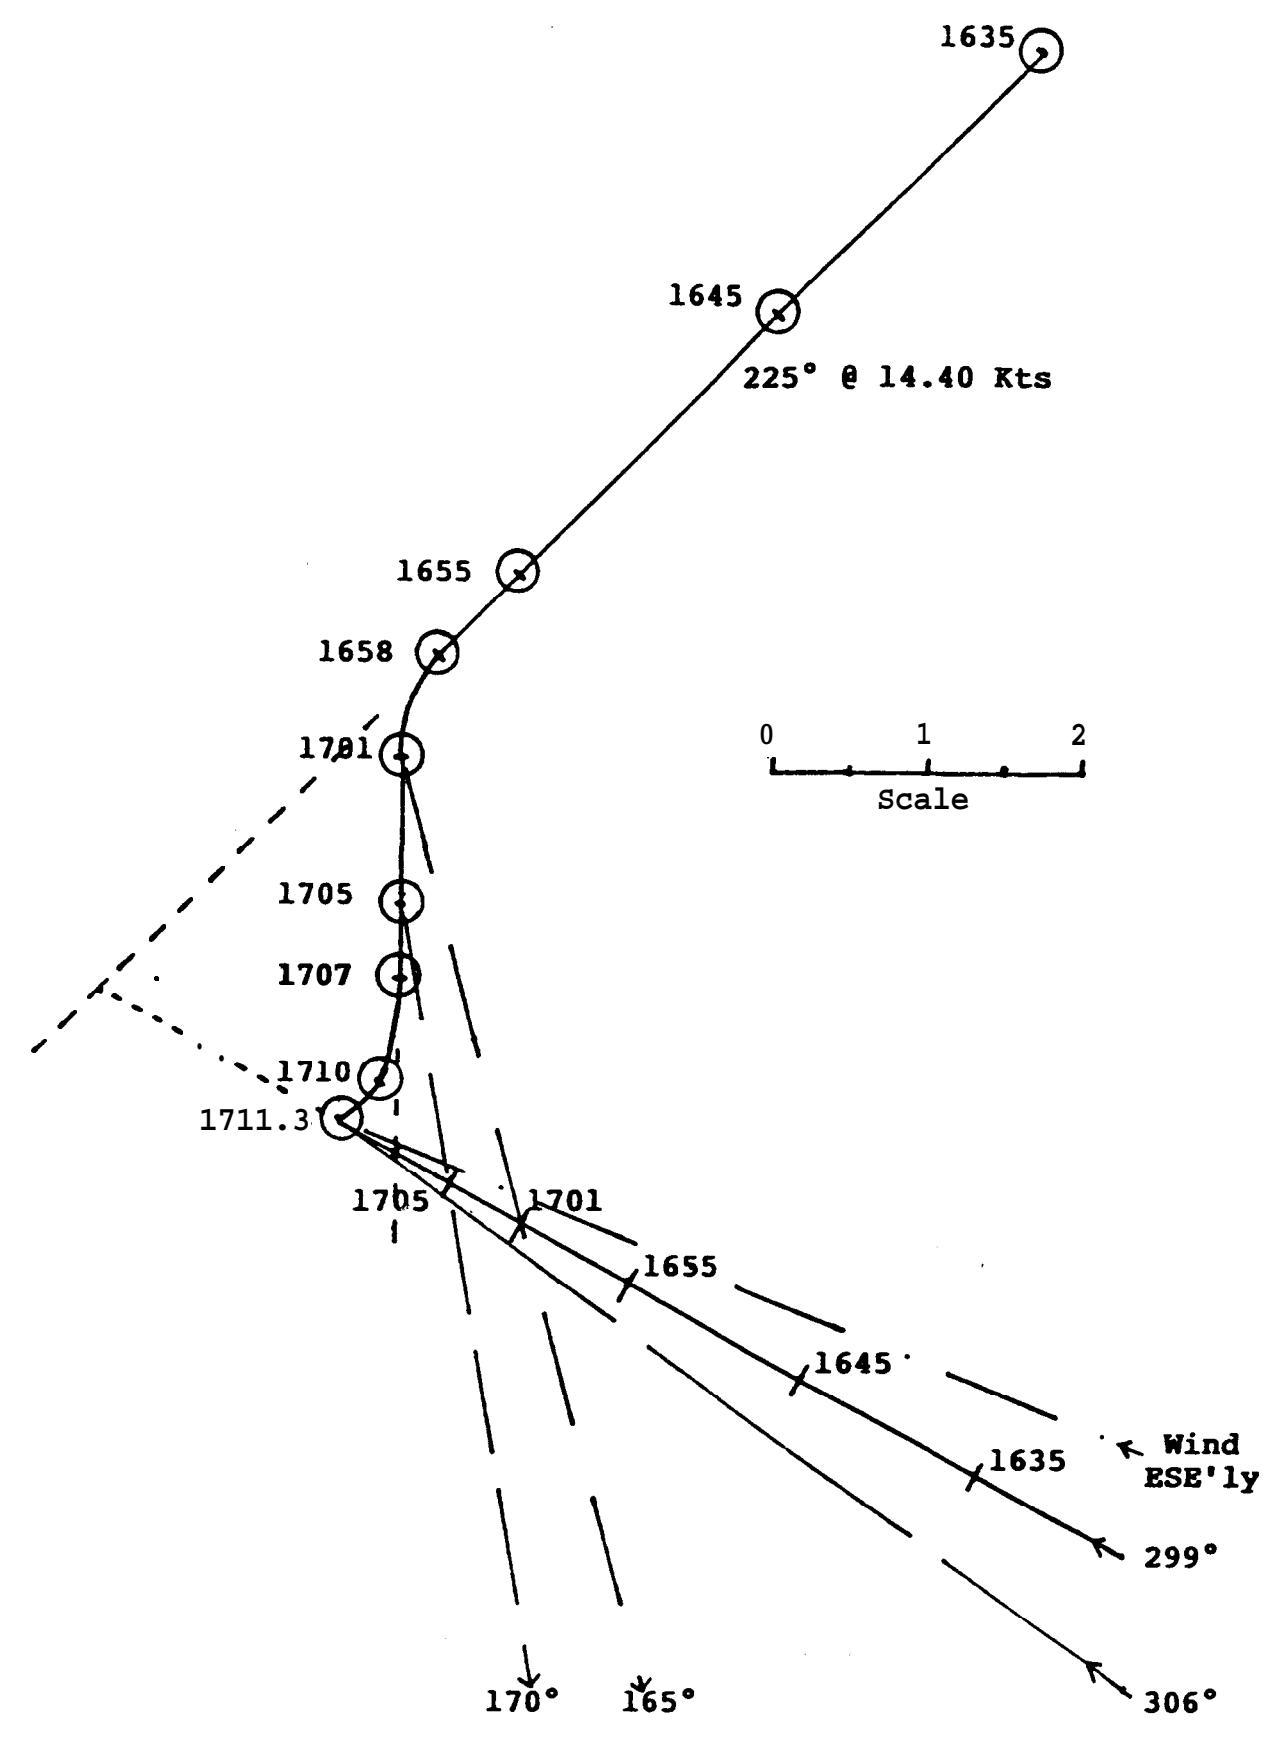
Diagram 2

Based on the bearing of 170 degrees, observed by the Second Mate at 1705, the course being made good by the Blue Goose of Arne is indicated as being about 300 degrees and the speed as about eight knots. The inspector considers these to have been reasonably constant throughout the encounter period.

Reconstruction: Blue Goose of Arne bearing 170° at 1705 The cause of the Blue Goose of Arne coming into contact with the side of the Longevity after having set off under engine power is uncertain. However, it is possible the autohelm did not engage and the Blue Goose of Arne proceeded in a circle, instead of remaining on the 295 degrees course. At that time the Longevity was lying stopped in the water, headed in the general direction of 020 degrees.
