Departmental investigation into the fatality on board the Bahamas flag vessel CLIPPER KAWA off Albany, W.A. on 22 February 1997

Report No. 108

Navigation Act 1912 Navigation (Marine Casualty) Regulations investigation into the fatality on board the Bahamas flag vessel CLIPPER KAWA off Albany, W.A. on 22 February 1997

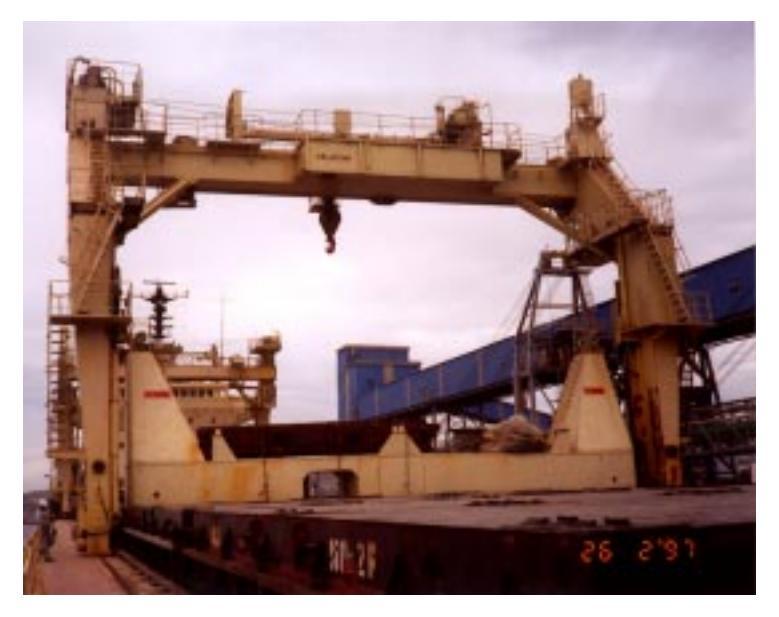
25 tonne gantry crane in stowed position over deck-house

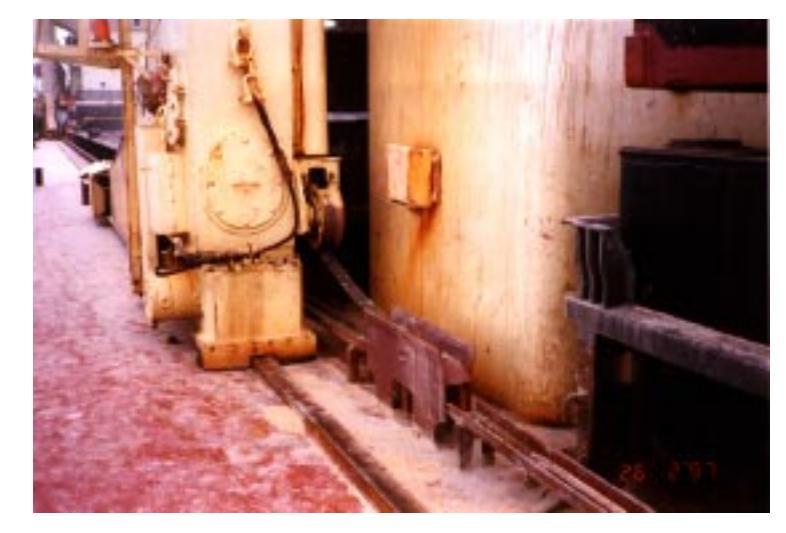
Starboard leg of gantry crane viewed from forward

Note power belt passing under idler roller and yellow warning light at top left hand corner of photo

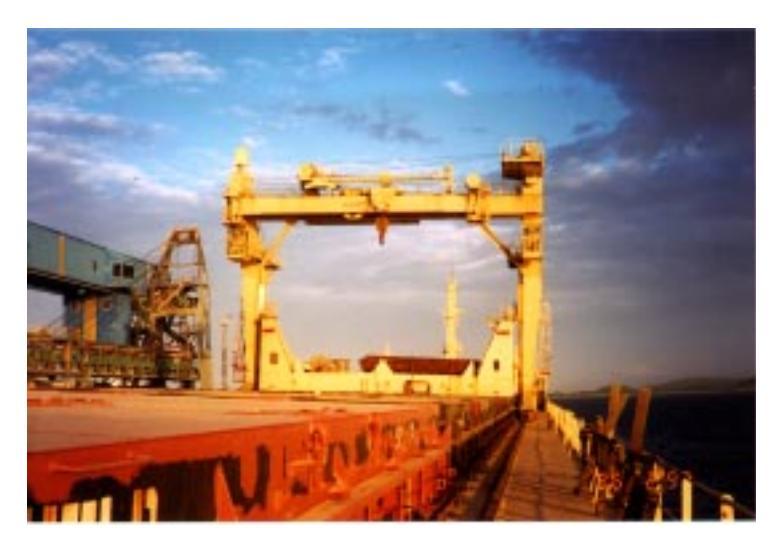
25 tonne gantry crane in stowed position viewed from aft.

Note driving cabs at the top of each leg

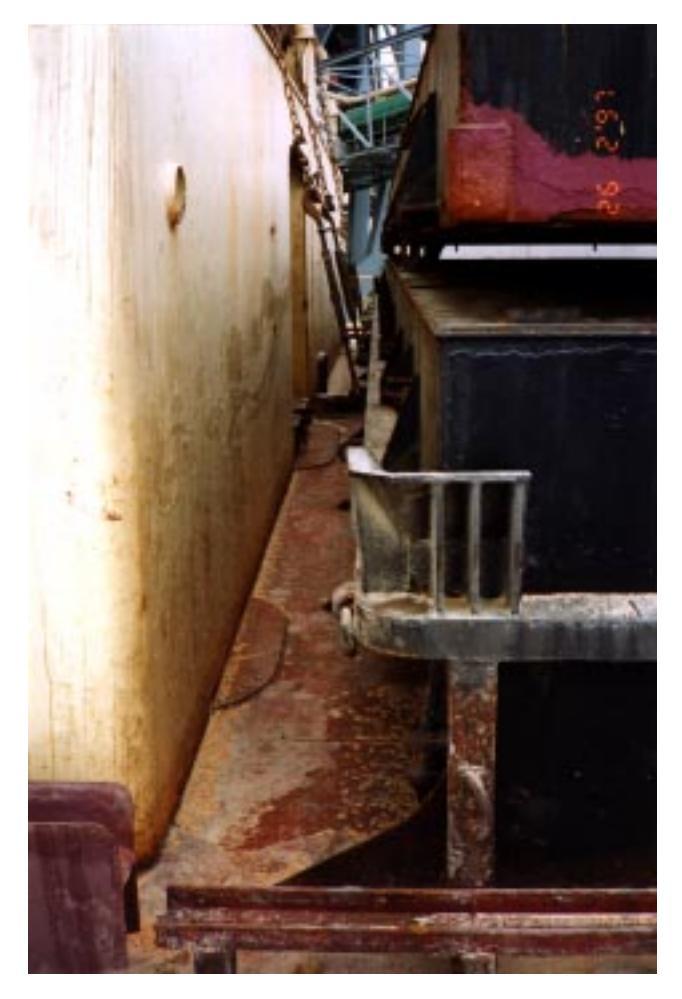
On the corner of each hatch coaming there is a cast steel guide, ribbed for stiffness, which guides the hatch cover into the correct position as it is lowered into the closed position by the gantry crane. The top edge of this guide, with a lip, protrudes a few centimetres further outboard than the hatch coaming. This guide can be seen in the photos at the bottom of this page.

Space between aft end of no.2 hold and forward end of deck house. The cast steel, ribbed, corner-guide for the hatch cover is in foreground above the track for the crane's power belt

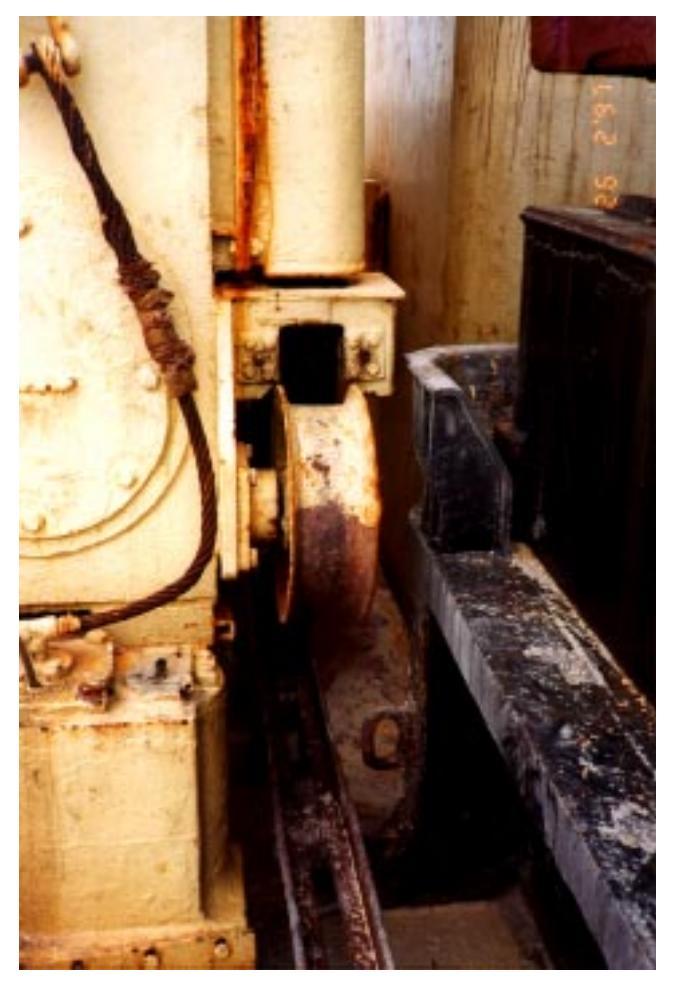
Power belt idler wheel on gantry crane

Note the narrow space in which the cadet was crushed between the wheel and the corner of the hatch coaming,

Immediately above and aft of the idler wheel, there is a housing containing rollers which guide the power belt in the vertical direction. The gap between this housing and the hatch cover guide is only about 15 mm, too small for his body to have passed through, and it appears likely that the front of this housing pushed him into the 135 mm space between the idler wheel and the hatch cover guide.

- 1. The junior deck cadet on board Clipper Kawa died from shock and haemorrhage as a result of multiple crush injuries received after being caught between the power belt idler wheel, on the starboard leg of the forward gantry crane, and the after coaming and hatch cover guide on No.2 hold.

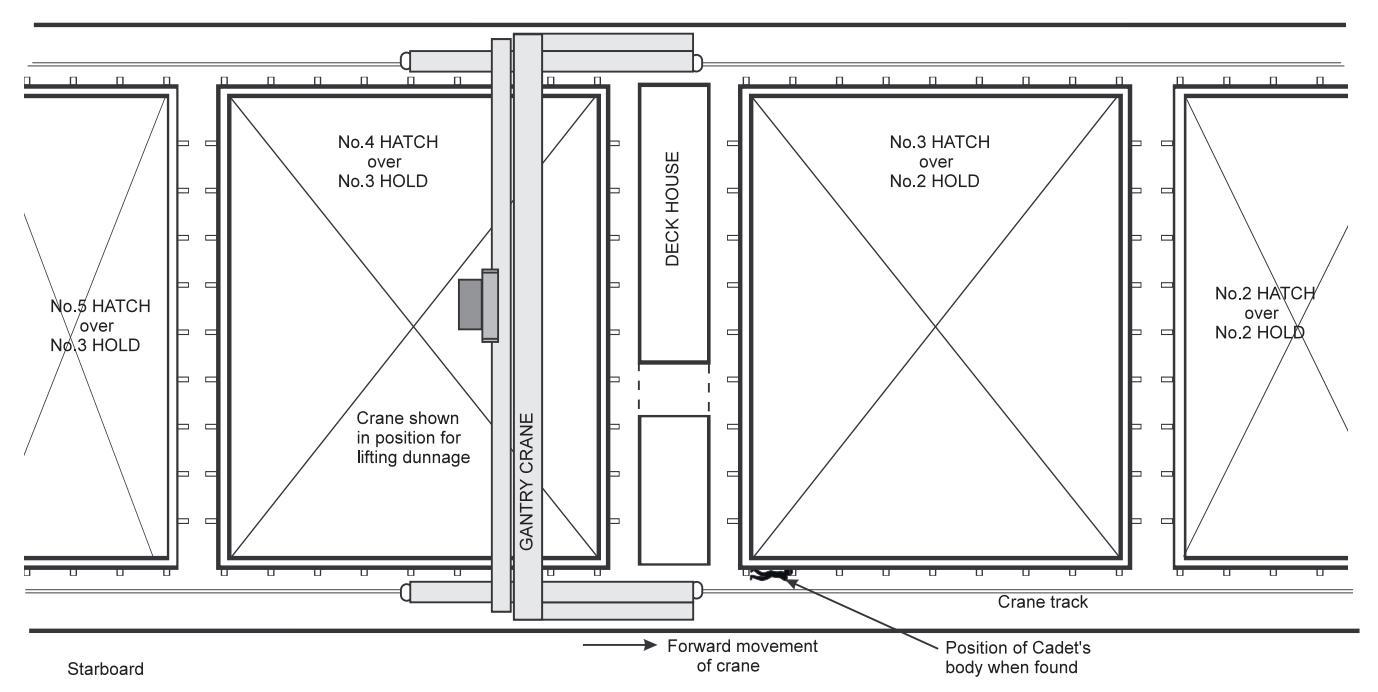
"CLIPPER KAWA" - Diagrammatic sketch of part of main deck showing location of incident

The junior cadet was last seen alive standing outboard of the gantry crane on the deck on the starboard side about half-way along No.3 hatch. The evidence is that, after signalling to the Bosun that all was clear on the starboard side, he was not again observed by anyone until his crushed body was found next to the starboard aft corner of the No.2 hold hatch covers.

For his body to have been found against the hatch coaming, he must have moved approximately eight metres forward along the deck and then, moving inboard, crossed the crane track in front of the crane. The investigation was unable to establish any sound reason for his having done this or for him to have been in the position in which he was later found.
