ATSB TRANSPORT SAFETY REPORT Aviation Occurrence Investigation A0-2010-029

# Ground strike, N-128UA Sydney Aerodrome, New South Wales 7 May 2010

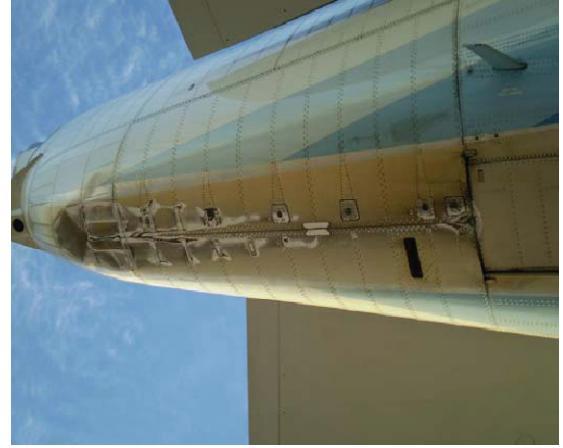
conditions. he had crosswinds from the direction of the international compression damage to the tailcone (Figure 1). terminal buildings, which had influenced the That resulted in minor damage to the auxiliary aircraft around the time of rotation, in the vicinity power unit bay access doors and lower fuselage of the intersection between runways 34L and 25. frames at the tailcone. There was no damage to The PIC conveyed that information to the other the pressure bulkhead structure. crew members as they were taxiing the aircraft for takeoff. During the pre-take-off checks, the first Figure 1: Damage to lower rear fuselage officer commented that the flight controls felt a bit lighter than normal. The PIC operated the controls and agreed that the control resistance was slightly less than normal. However, he considered that the system was within acceptable limits. All other aspects of the pre-take-off checks were normal.

A post-flight inspection revealed abrasion damage to the lower rear fuselage, which extended from

experienced variable the stabiliser access door to the tailcone, and

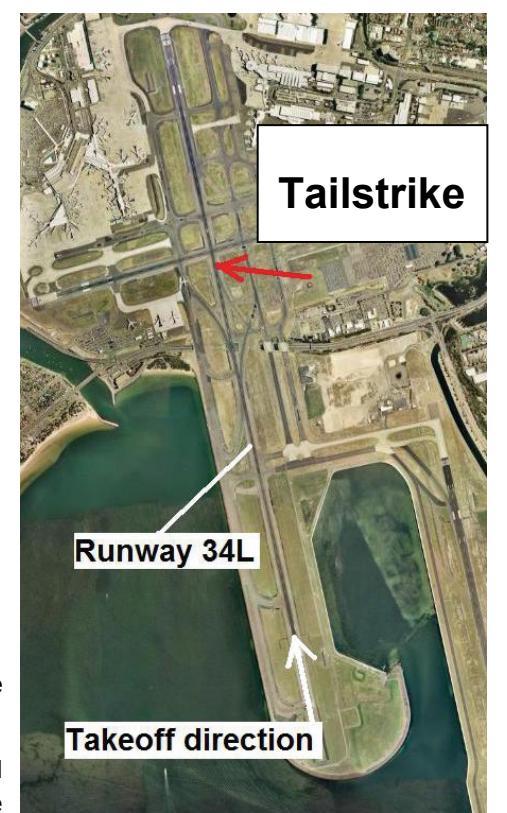
An analysis of the recorded flight data confirmed that the aircraft became airborne after a ground roll of 7,837 ft (2,389 m), or about 150 m south of the intersection of runways 34 and 25 Figure 2).

Figure 2: Google Earth image of Sydney Aerodrome. The position of the tail strike on runway 34L is arrowed

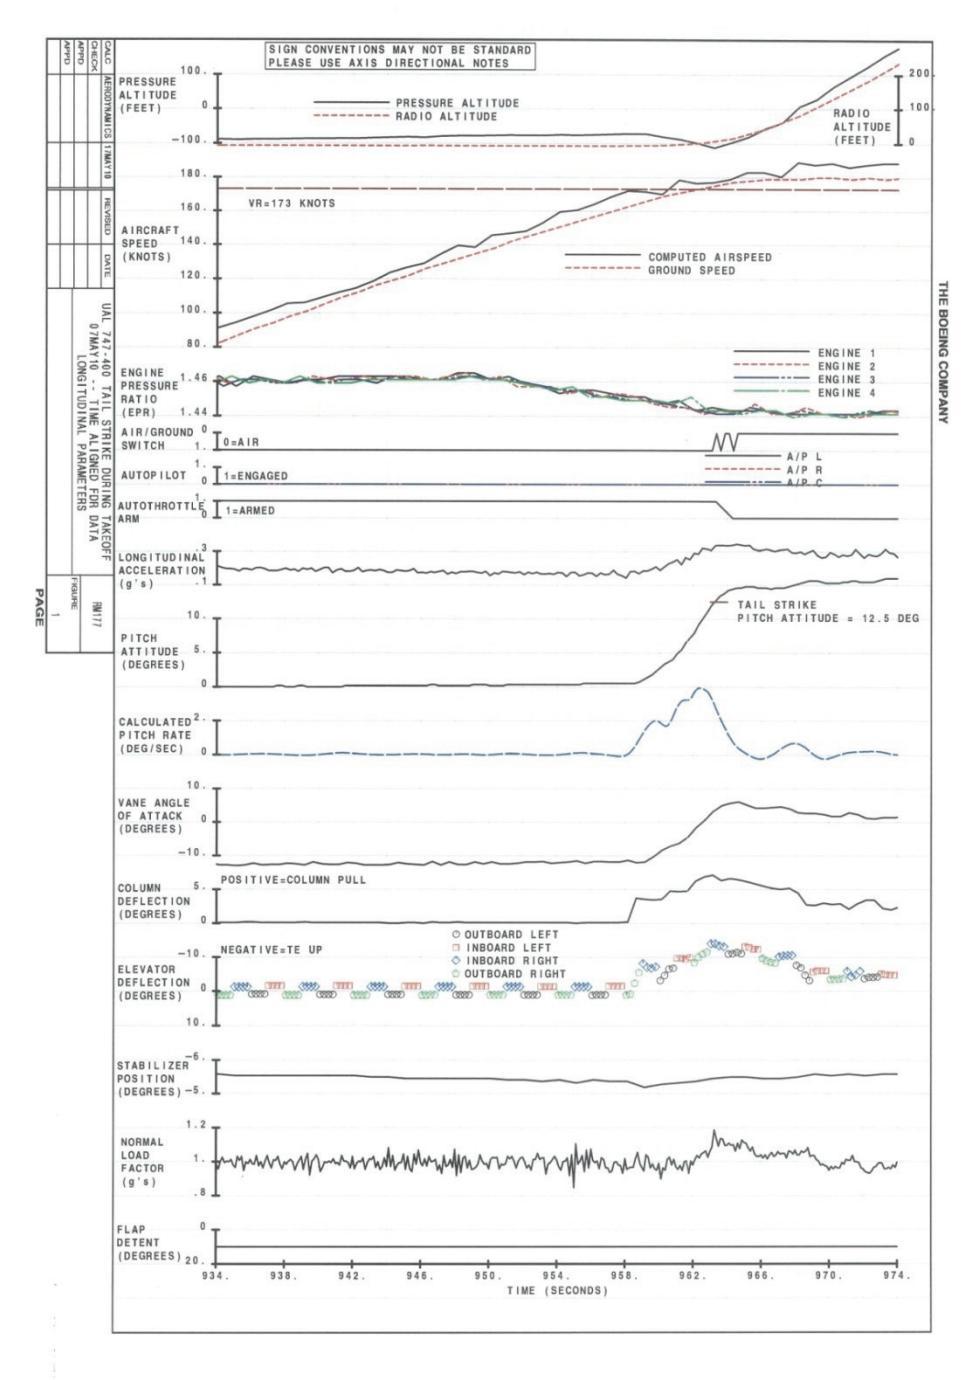
Enclosure 1 to 66-ZB-H200-ASI-18555

The FDR data show that the airplane was configured for a flaps 10 takeoff with the autothrottle armed (Figure 1). The airplane gross weight and center of gravity (c.g.) were approximately 828000 pounds and 13 percent (from provided weight and balance information), respectively. Maximum takeoff engine pressure ratio (EPR) was approximately 1.51 for the pressure altitude and outside air temperature at the airport at the time. However, the EPR was set to approximately 1.46, indicating a thrust de-rate was used for this takeoff. This is equivalent to an approximate 6 percent reduction in thrust. The recorded stabilizer setting was 0.3 units more nose-down than the recommended stabilizer setting of 9 units based on the provided aircraft weight (828,000 lb.) and center of gravity (13%)<sup>5</sup>.

The estimated takeoff rotation speed (VR) for the airport conditions and thrust de-rate was 173 knots. The crew initiated rotation at the appropriate airspeed at approximately time 958.2 seconds (Figure 1). However, computed airspeed stagnated just before and during rotation due to a wind gust. Approximately 2.5 seconds elapsed following the initiation of rotation before the computed airspeed exceeded the targeted VR speed. This stagnation resulted in lift-off airspeed approximately 6 knots below the expected value.

Nominal average rotation (pitch) rate for the 747-400 is 2.5 degrees per second per the 747 Flight Crew Training Manual (FCTM). The average rotation rate for the event flight was approximately 2.2 degrees per second (between initial column input and 10 degrees pitch attitude), which was within the recommended range. However, the calculated rotation rate reached a maximum of 4 degrees per second around lift-off. Despite achieving a nominal average pitch rate throughout the rotation, the maximum instantaneous pitch rate was higher than would be expected at lift-off. Analysis of flight test data shows that, on average, a typical commercial airplane will reach a maximum pitch rate approximately 1 degree per second higher than the recommended average pitch rate. For the 747-400, the maximum instantaneous pitch rate will typically reach approximately 3.5 degrees per second. The additional 0.5 degree per second higher instantaneous pitch rate at lift-off for the event flight contributed to the reduction in tail clearance.

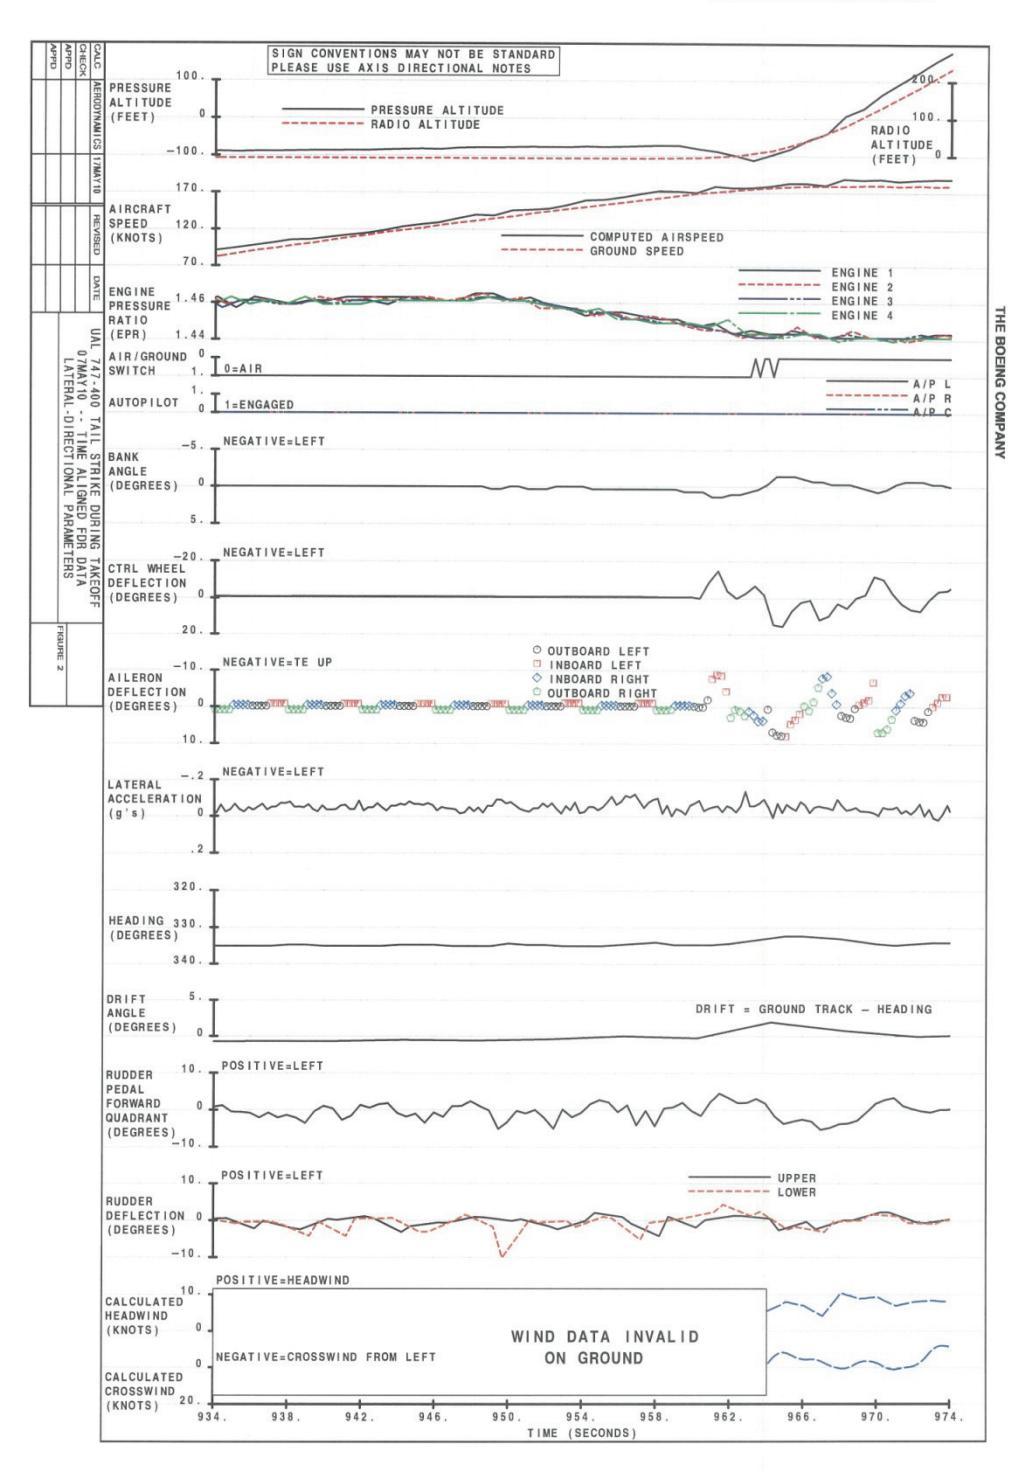
Enclosure 1 to 66-ZB-H200-ASI-18555

The crew's right rudder inputs during the takeoff are consistent with the presence of a crosswind from the left (Figure 2). Rudder inputs ranged from 0 to 10 degrees to the right during the ground roll and through rotation and lift-off. Just after the start of rotation, at approximately time 959 seconds, bank angle began increasing to the right. It reached a maximum of 1.5 degrees at time 961 seconds and was countered by a wheel input of 15 degrees to the left. This wheel deflection resulted in deployment of the flight spoilers. Although small, this spoiler deployment caused some lift loss leading to a further reduction in tail clearance.
