Australian Transport Safety Bureau

ATSB TRANSPORT SAFETY REPORT Aviation Short Investigations AB-2011-040 Final

Aviation Short Investigation Bulletin: First Quarter 2011

Issue 5

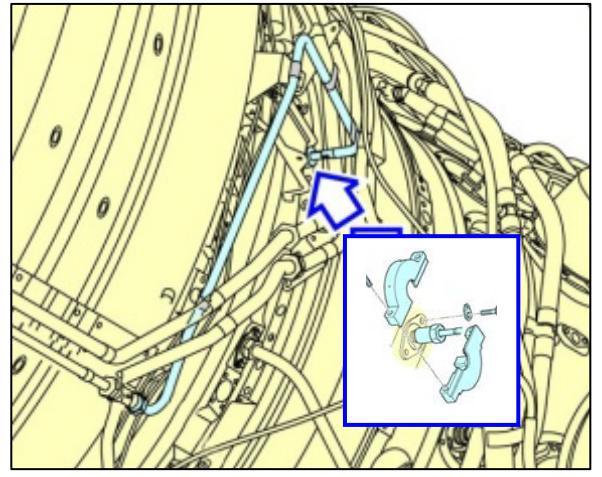
Figure 1: Leaking HP/IP oil tube

Upon arrival at the destination, only 0.7 quarts of oil remained. An inspection of the number-4 engine identified an oil leak as being from an external high pressure/intermediate pressure (HP/IP) oil tube at its connection to the engine case (Figure 1).

A torque check of the tube revealed the attaching Bnut was at 80 pound force/inch (lbf/in). The correct torque value for the B nut was 240 lbf/in. The tube was replaced with no further leaks found.

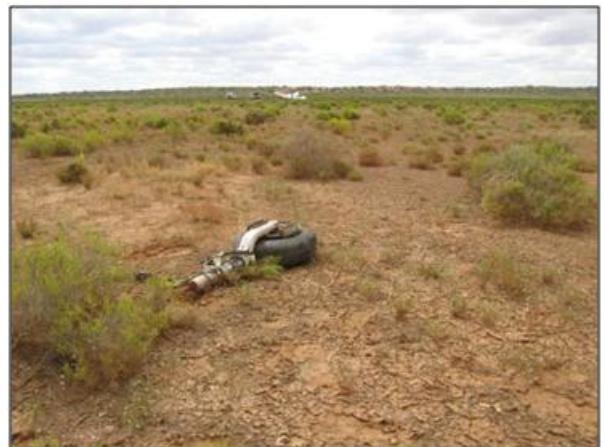
Figure 2: Damaged landing gear

During the flare phase of the landing, the pilot discussed the symptoms of a windmilling propeller closed both throttles and the mixture levers. On touchdown, the right main landing gear sheared off and the right wing, right propeller and tailplane were damaged (Figure 2).

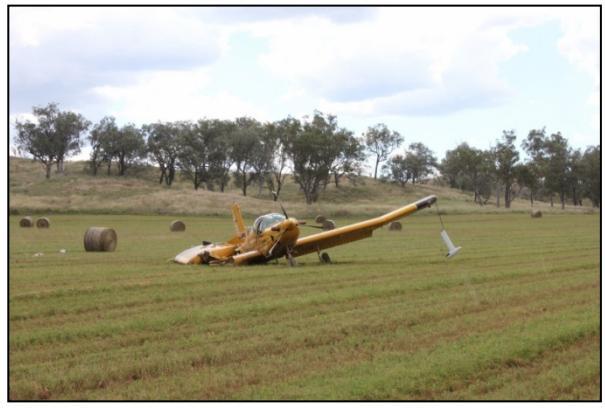
Figure 1: Accident Site

full back elevator pressure to arrest the rate of descent. After touching down in the field, the aircraft collided with a hay bale (Figure 1).

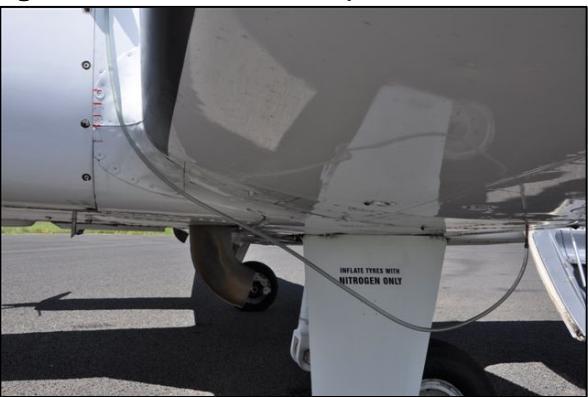
The manometer (Figures 1 and 2) used by the pilot was designed and manufactured under the operator's parent company maintenance authority.

Figure 1: The manometer the pilot used.

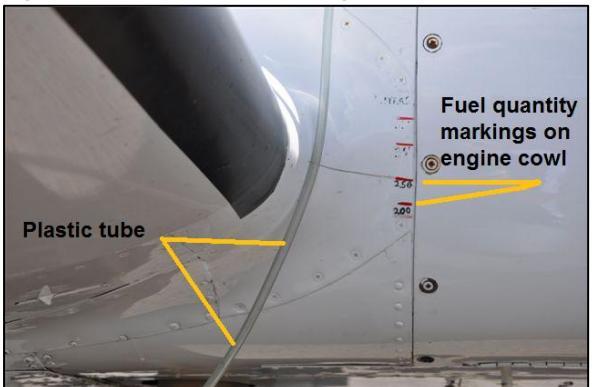
Figure 2: Fuel quantity markings on cowls.
