ATSB TRANSPORT SAFETY REPORT Aviation Short Investigations AB-2011-077 Final

## Aviation Short Investigation Bulletin: Second Quarter 2011

Issue 6

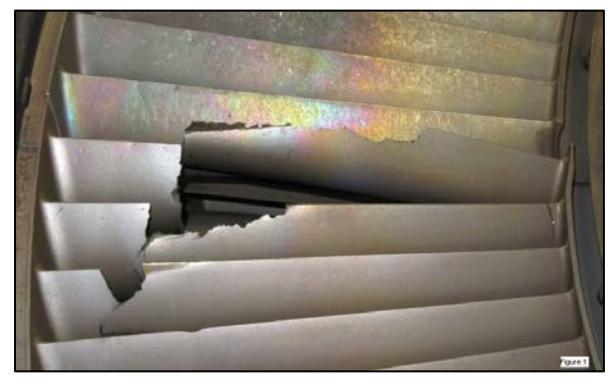
Figure 1: Damaged LPT stage 3 nozzle segment

- one LPT stage 3 nozzle segment was found, with cracking to 4 airfoils
- the distance of the cracks from each aerofoil's outer platform, ranged between 1 and 2 inches
- three of the airfoils were found to be partially liberated and severely damaged (Figure 1).

There was also significant damage to an LPT stage 3 blade and two LPT stage 3 shroud segments. Other damage was noted on LPT stages 4 and 5 nozzles and blades, which included small holes, dents and scratches. A bulge and a slight crack were also noticed on the LPT case. No damage was detected upstream of LPT stage 3. The LPT stage 1 and 2 blades and nozzles and the high pressure turbine (HPT) stage 2 blades, were found to be in good

The engine manufacturer conducted an investigation into the failure of the LPT stage 3 nozzle segments. The investigation identified that the most probable reason for the failure was a transient mean stress of the segments during take-off, coupled with other operational stress and mechanical factors.

In the interim, the operator has introduced additional inspections for pre service bulletin 72-1354 LPT stage 3 nozzles that should detect any signs of airfoil cracking well in advance of a potential operational event.

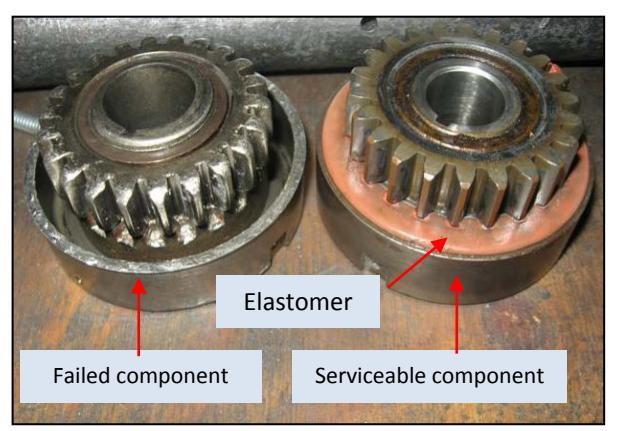
#### Figure 1: Alternator drive coupling with missing elastomer

The alternator drive coupling contained a red rubber 'elastomer' material that provided vibration As a precaution, the pilot assumed that an engine dampening and a form of 'shear' relief if the alternator failed. This material had become separated from the alternator drive coupling (Figure 1).

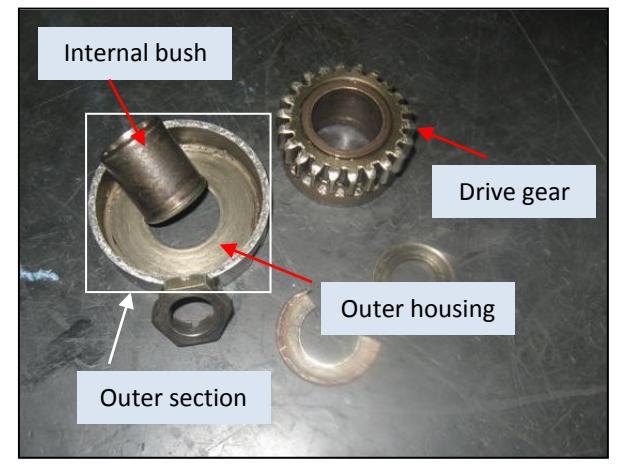
Figure 2: Alternator drive coupling components

As a result, the alternator drive gear and outer section were no longer connected (Figure 2). The alternator drive gear, which was still engaged with the aircraft engine's drive gear, continued to rotate,

The four 5/16 inch attachment bolts on the engine drive gear face became overloaded, resulting in the engine drive gear becoming dislodged.

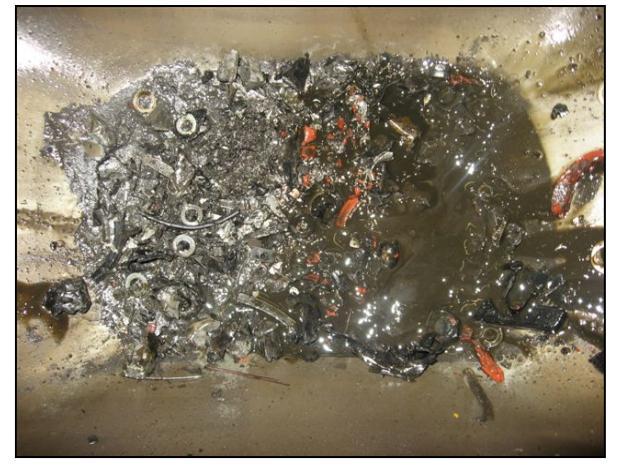
#### Figure 3: Debris in oil sump

Liberated pieces of the alternator drive coupling's elastomer material were ingested into the engine's oil system and sump (Figure 3).

The oil pick-up strainer became blocked and starved the engine of oil required for lubrication and cooling, resulting in its failure.

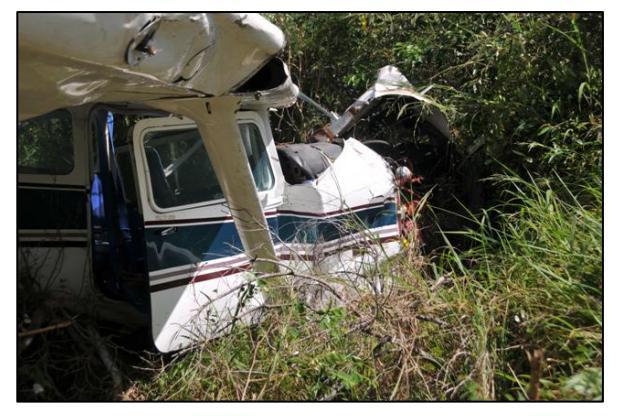
#### Figure 3: Aircraft wreckage

The pilot reported that the stronger than anticipated tailwind component during the landing resulted in the round-out and flare being much longer than expected. Also, when full power was applied for the go-around, the tailwind and full flap configuration prevented DOK from achieving an adequate climb performance in order to clear the trees at the end of the runway.

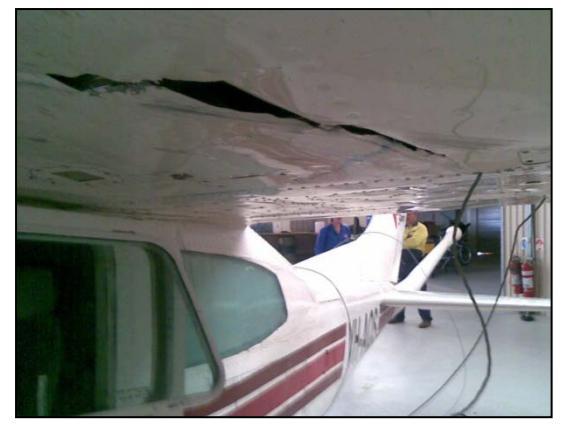
#### Figure 2: Wing damage

The wire sliced through the leading edge of the left wing (Figures 2 and 3) and punctured the windscreen. The flap and aileron on the left wing were also damaged.

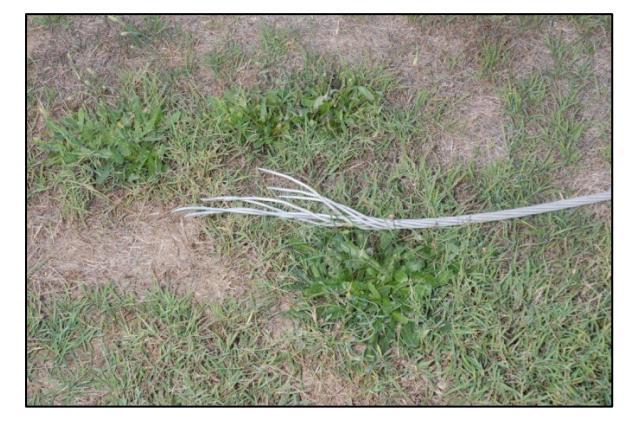
#### Figure 1: End of severed 11kv power conductor

An electrical discharge from the section of power conductor that fell onto the safety railing, was transmitted through the railing and resulted in a full thickness burn to one leg and burns to the hands, of a 3 year old child, that was in contact with the railing, about 156m south of the bridge.

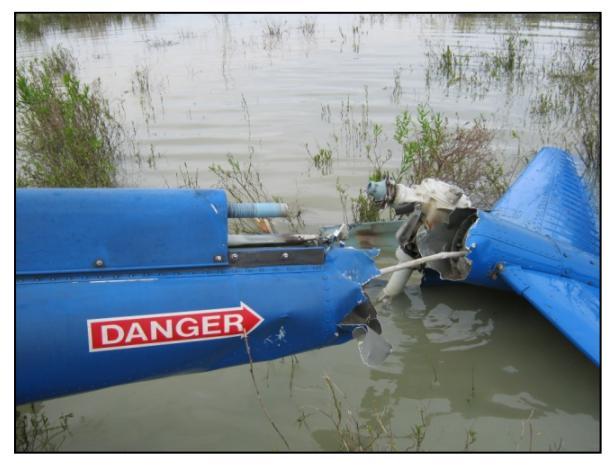
#### Figure 1: Damage to tail section

(Figure 1). Later inspection confirmed that the tail rotor had contacted the pipes associated with the well-head pressure regulating system that protruded above the other pipe work (Figure 2).
