Aviation Short Investigation Bulletin: Third Quarter 2011

Issue 7

Aviation Short Investigations AB-2011-128 Final

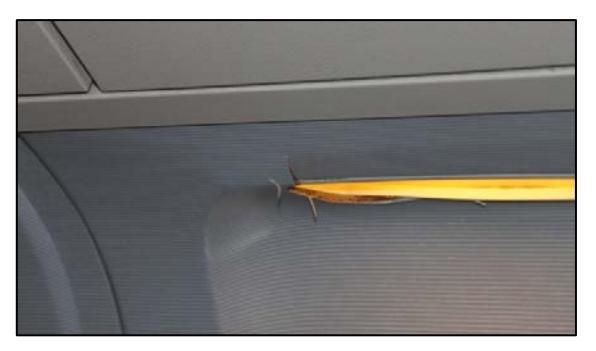
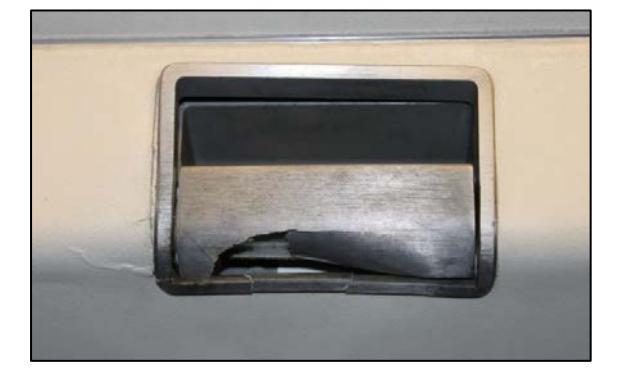
Further turbulence was experienced and the flight crew elected to conduct a go-around. The aircraft was levelled off at 3,000 ft and the PIC made an announcement to reassure the passengers and cabin crew. The cabin crew then contacted the flight crew and advised that two passengers, who were reportedly not wearing their seat belts at the time, had sustained injuries from coming into contact with a window reveal and an overhead locker (Figure 1). The two passengers were seated separately.

Figure 1: Damage to window reveal and overhead locker

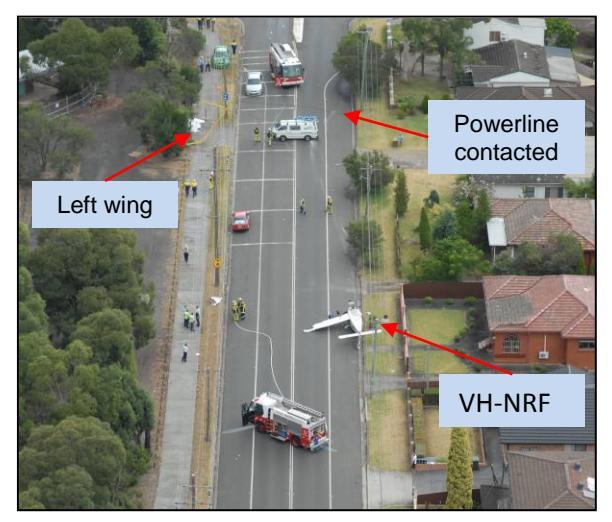
About 1 minute later, in preparation for the landing, the pilot attempted to turn the fuel selector off and positioned the aircraft to fly between powerlines that ran across the street, but due to vehicles in the area he had to slow the aircraft. He determined he had insufficient height to fly over the powerlines so attempted to fly between two powerlines that were about 2.5 m apart. During the manoeuvre, the left wing contacted the lower powerline and became separated from the aircraft. The aircraft then rolled to the left and became inverted. It continued airborne along the street before the right wing collided with a power pole. The aircraft spun around and impacted the ground at about 1232 Eastern Standard Time<sup>6</sup> (Figure 1).

#### Figure 1: Accident site

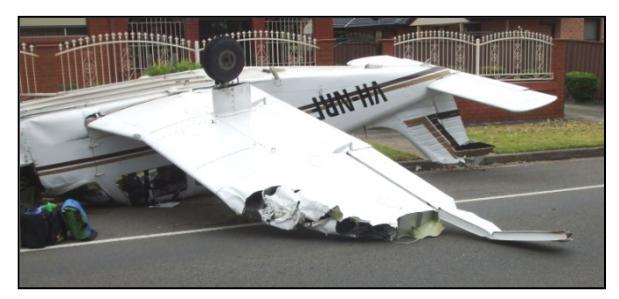
The pilot and passenger released their seatbelts. The door could not be opened, so the pilot kicked the door window out and both egressed. The pilot and passenger sustained minor injuries, the aircraft sustained serious damage (Figure 2).

#### Figure 2: Aircraft wreckage

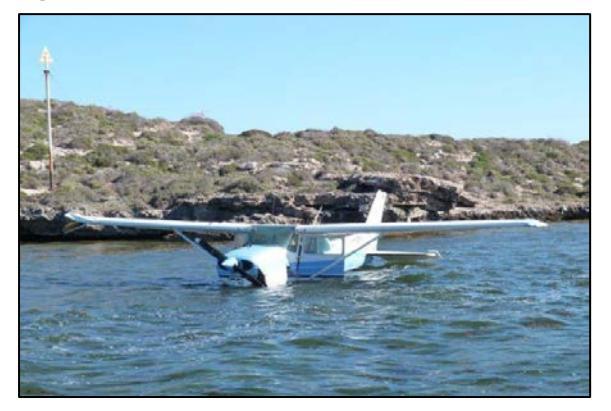
Figure 2: VH-SMY

The reason for the degraded engine performance was not determined.

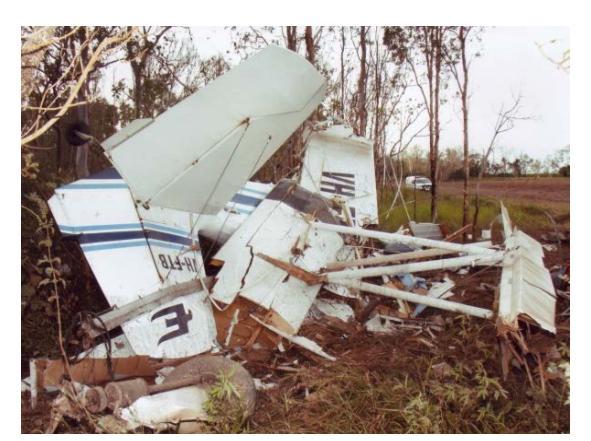
had split and was deformed to the right. The pilot believed that it was the hopper that caused the injuries to his right leg

Figure 2: Wreckage

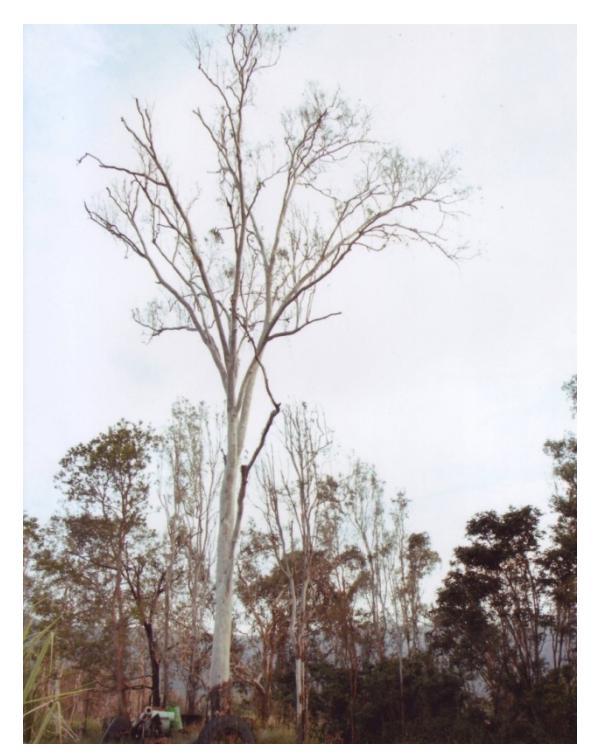
The pilot also commented that a cyclone had passed through the area recently which may have contributed to the condition of the impacted tree (Figure 3).

#### Figure 3: Bare tree

The tree's position and lack of foliage against the backdrop of green trees and mountain ranges, made it difficult to see from crop level. The pilot commented that while FTB still had a near full payload on board, a decision not to dump the load was made for fear that its release may have resulted in an uncontrolled inversion of the aircraft due to the sudden change of centre of gravity. The pilot believed that had the aircraft been inverted at ground impact the injuries sustained would have been fatal.

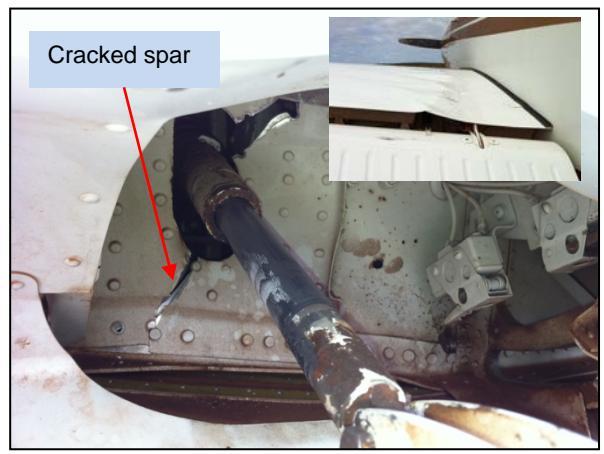
#### Figure 1: Aircraft damage

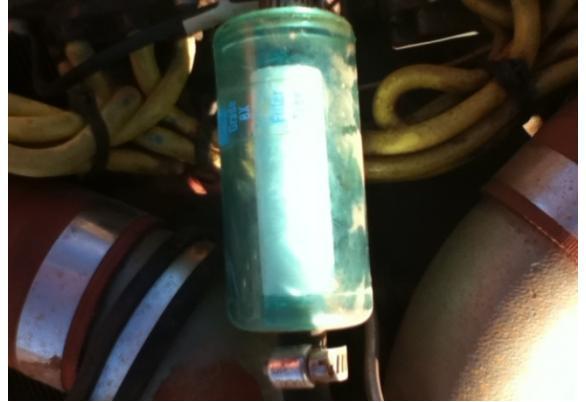
The fuel from both wings was found to be clean, bright and free of visible contaminants. The aircraft fuel filter, contained within the engine bay, was found intact but empty of any fuel (Figure 2).

Figure 2: Empty fuel filter in engine bay.

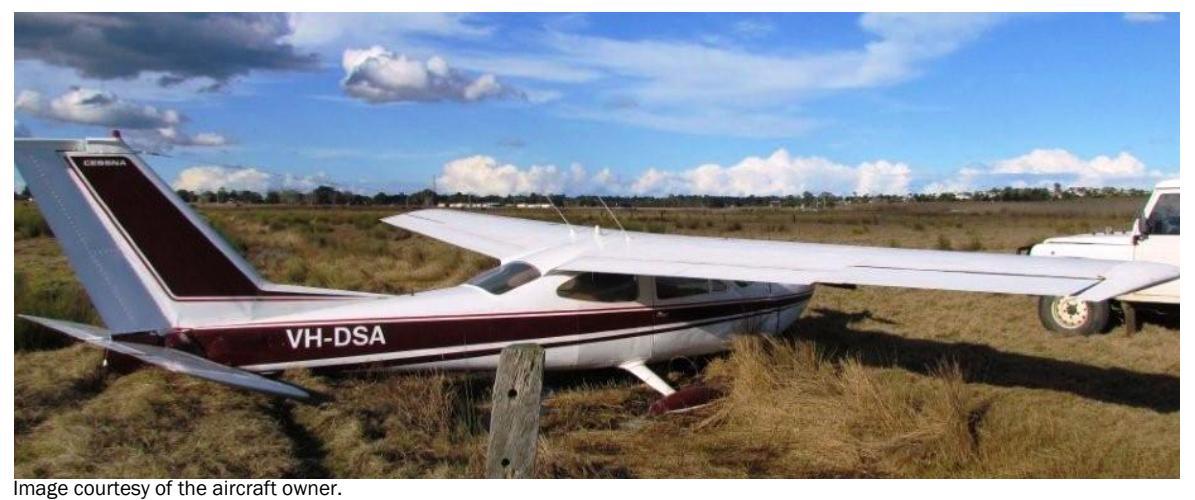
Figure 1: VH-DSA in the shallow earth drain.

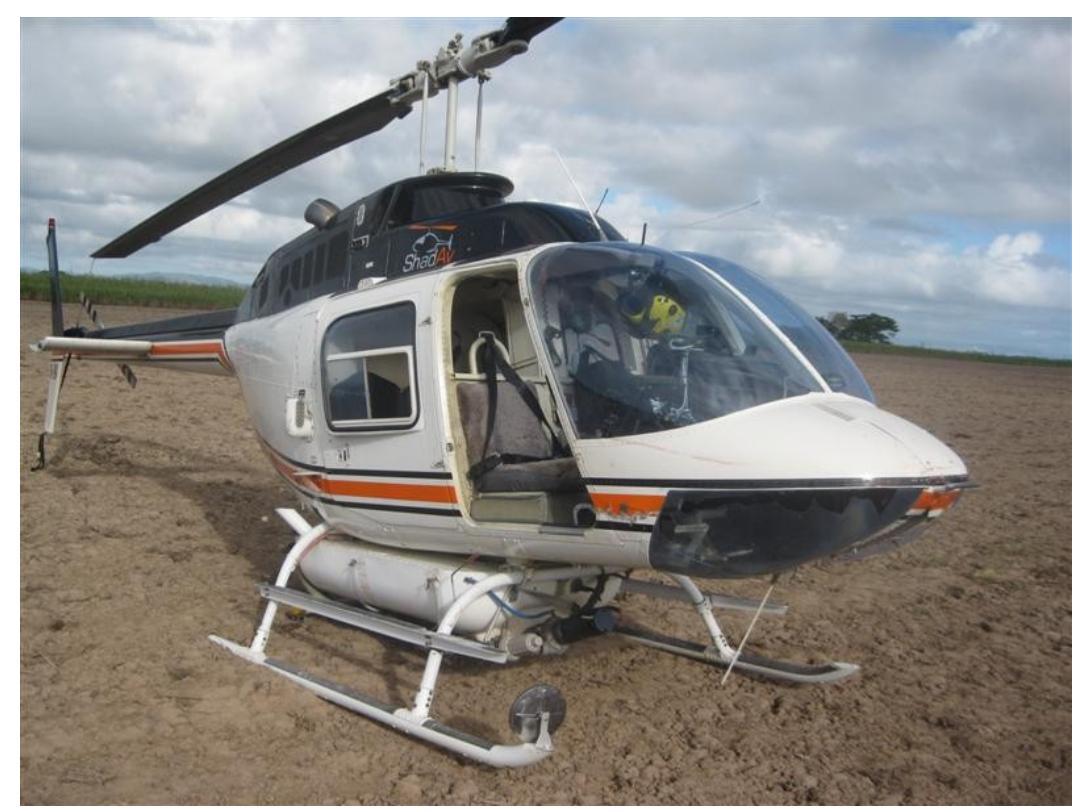
http://www.atsb.gov.au/media/2487114/ar20110 28.pdf Figure 1: VH-BNG after wirestrike.

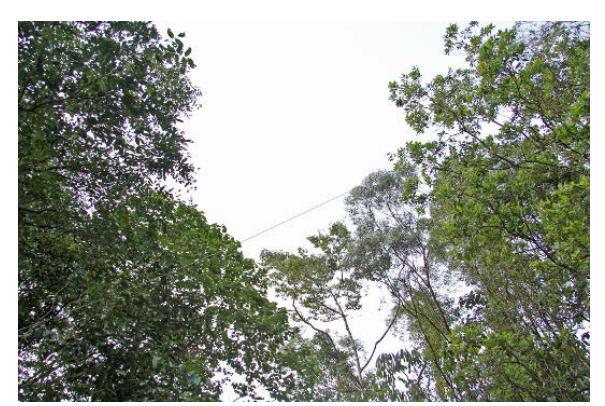
Figure 1: Powerline

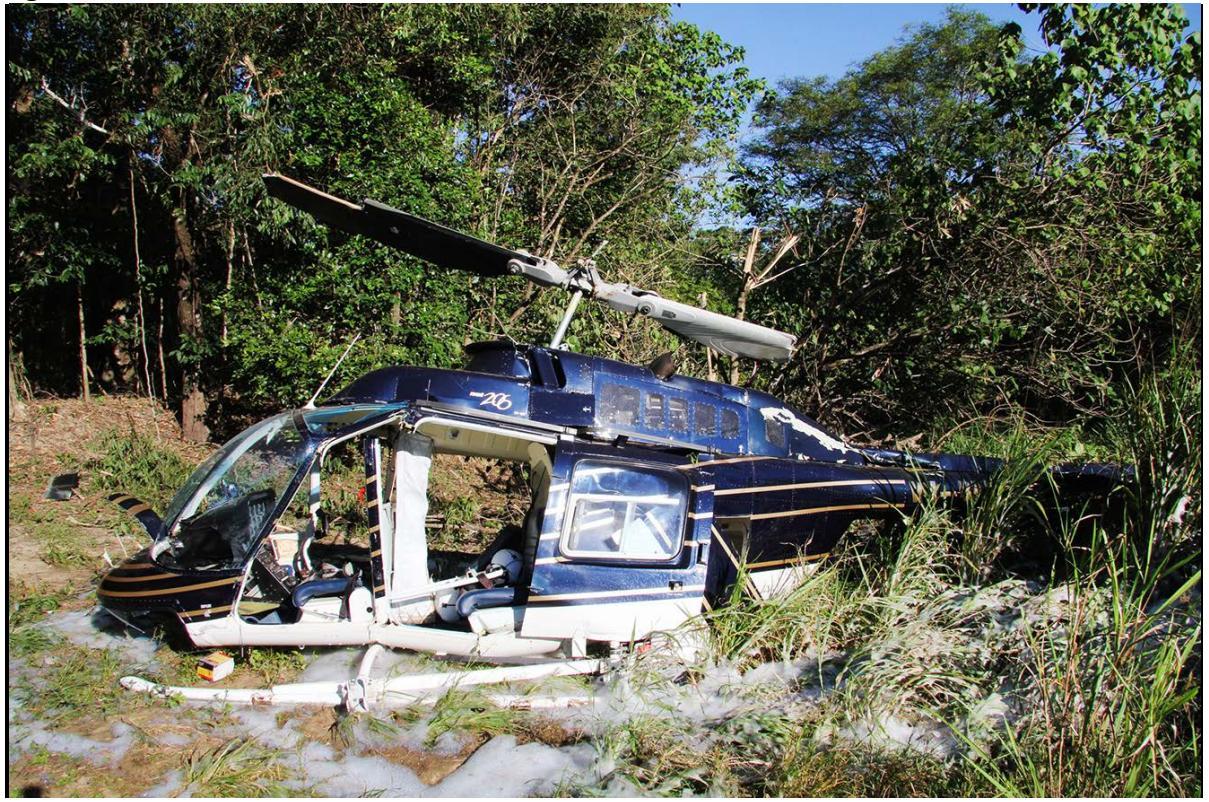
Figure 2: VH-BHU accident side

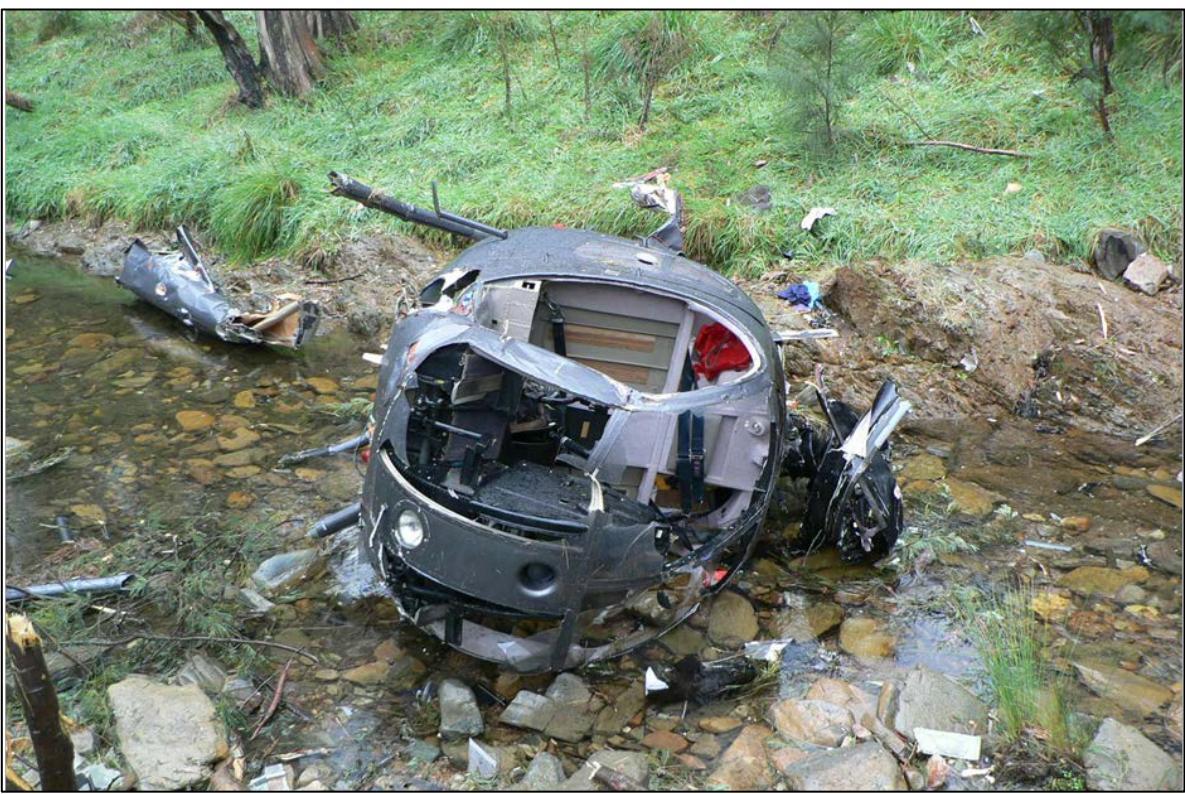
#### Figure 1: Wreckage of VH-XAA

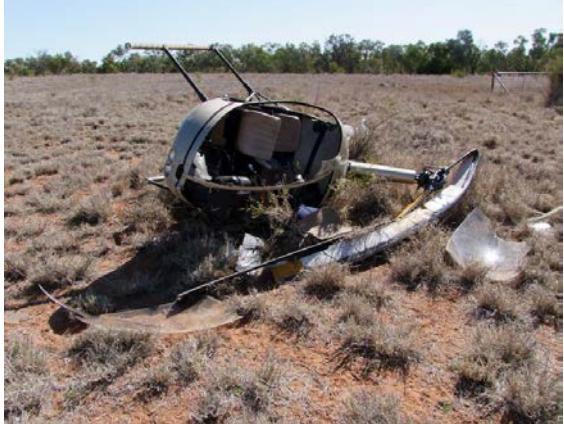
Figure 2: Accident Site

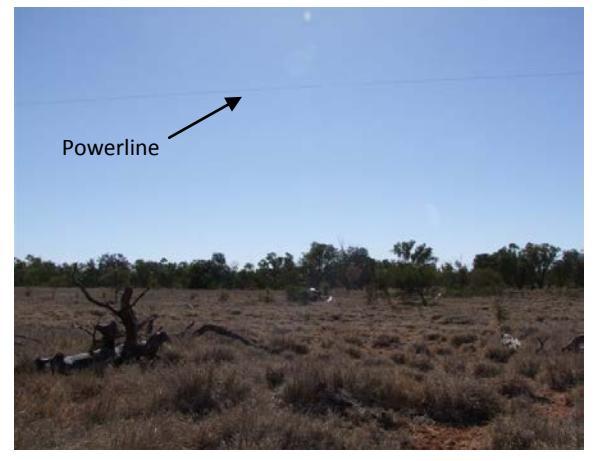
#### Figure 3: Powerline above ground level

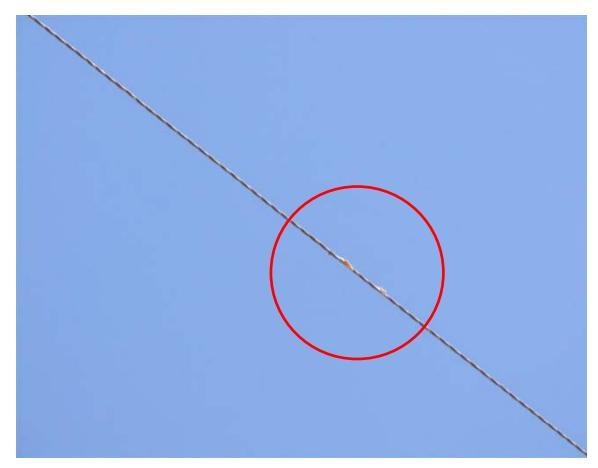
Figure 4: Contact point with powerline
