ATSB TRANSPORT SAFETY REPORT Rail Occurrence Investigation RO-2007-006 Final

# **Derailment of Freight Train 6413**

near Stewart, Western Australia

17 August 2007

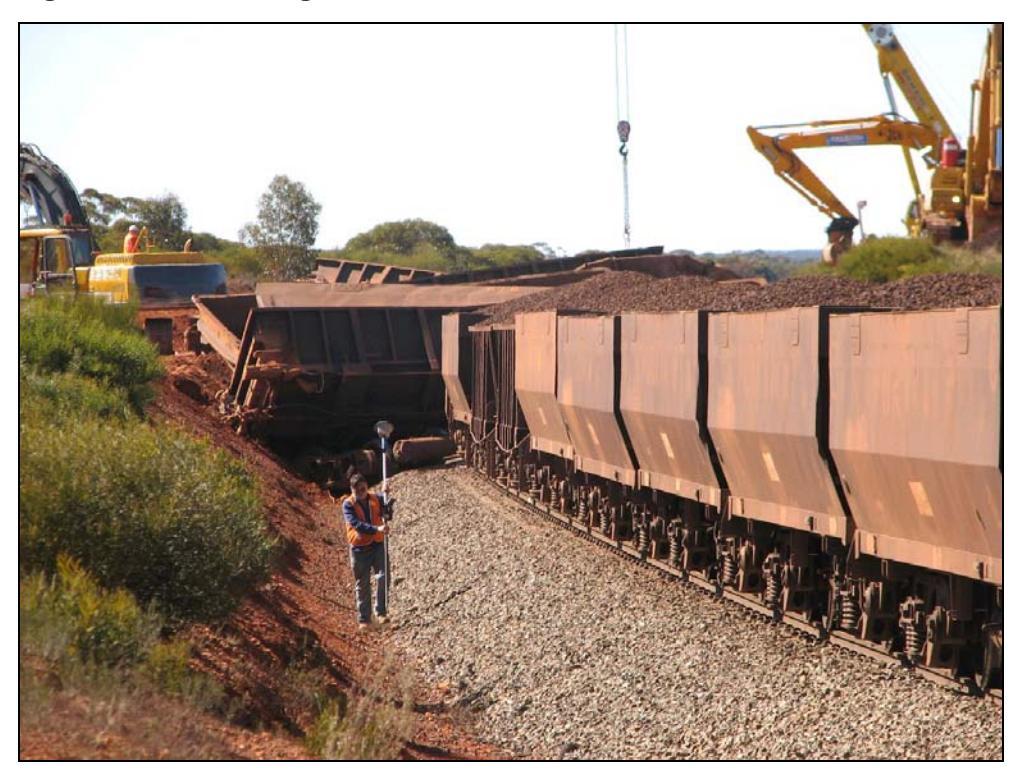
Figure 4: View looking east into derailment site

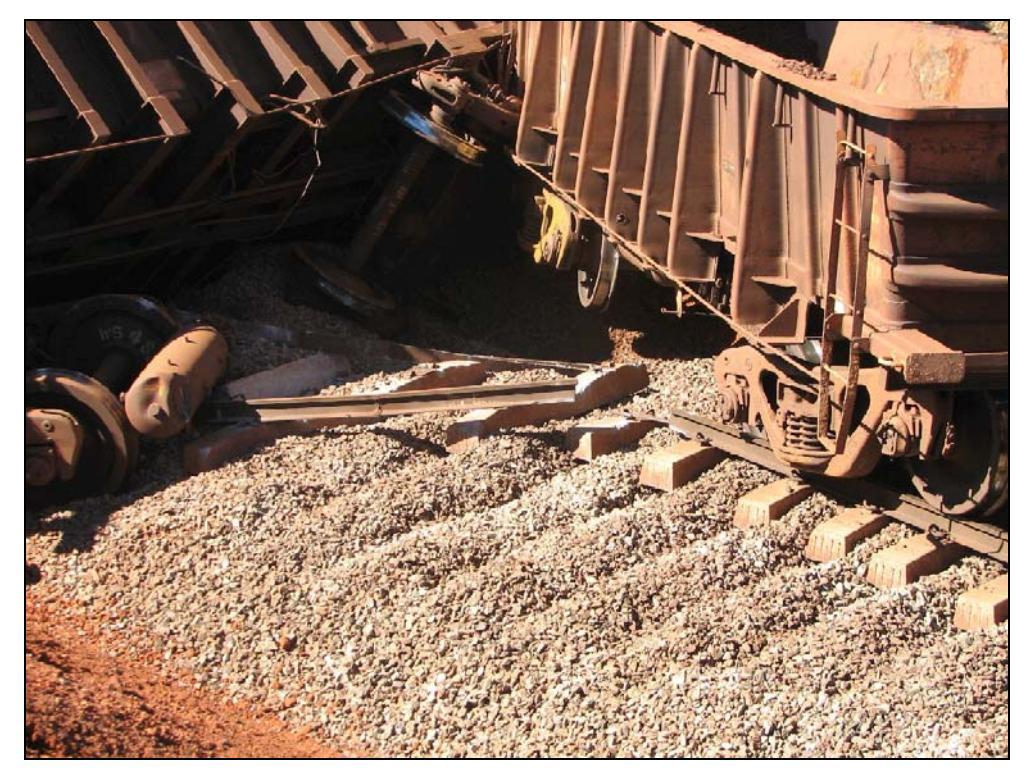
Figure 5: View from embankment showing some track damage

Due to the extent of damage to rolling stock and track (Figure 5 and Figure 6), the collection of site evidence needed to be co-ordinated along with site recovery operations. Evidence from the locomotives and the 45 wagons that had not derailed was gathered first. The undamaged vehicles were released and were able to proceed to Kalgoorlie. Following this, evidence was collected from the damaged section of track and the detached group of 7 wagons located on the Kalgoorlie side of the cutting. This part of the site was then released for recovery and track reconstruction. Rail from this section was recovered and set aside.

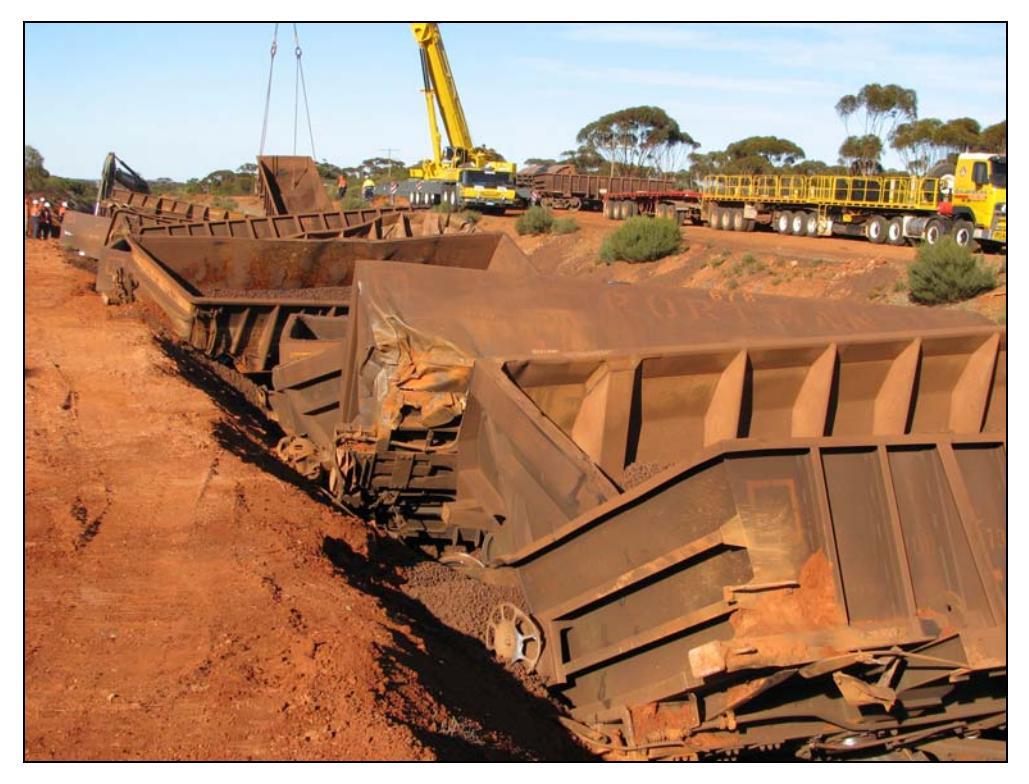
Figure 6: View from embankment showing damage to wagons

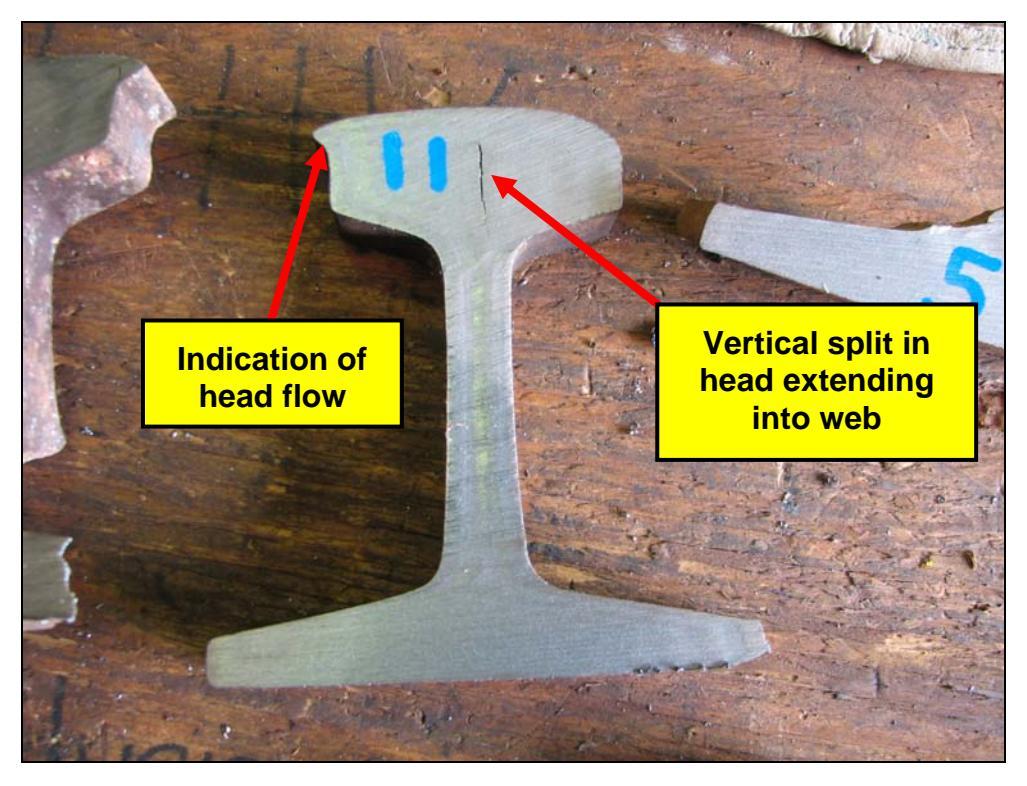
The heavy loading on the low leg of the rail caused considerable head flow<sup>7</sup> (Figure 8) on the curve in this section. The rail at the location of the derailment exhibited considerable deformation, which probably facilitated the widening and propagation of a vertical split head crack.

Some of the pieces of rail that exhibited a vertical split head (Figure 8) defect were removed by ATSB investigators for subsequent examination. Those pieces were fragmented and damaged in ways that indicated they had probably been at or near the initial break and point of derailment (POD).

#### Figure 8: Vertical split in rail head

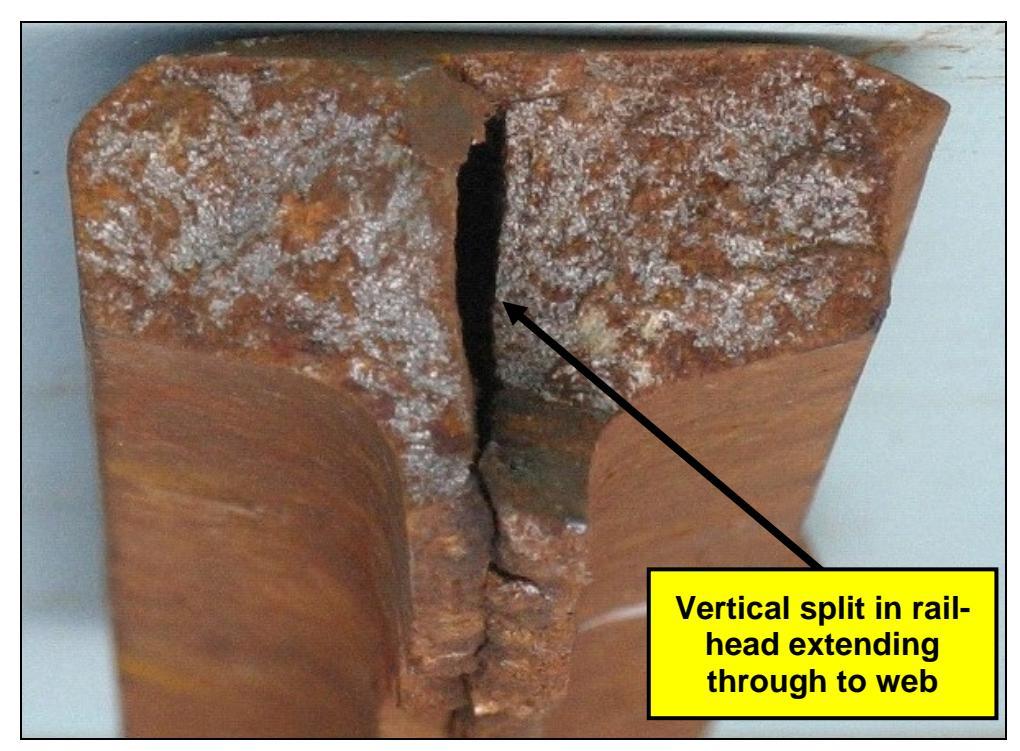
Figure 9: Vertical split in rail head with secondary cracking into rail web

It was likely that the vertical split opened up over a considerable period of time and spread longitudinally along the rail length as well as vertically through the rail web.

Cracks then emanated from the split in the rail, both along the horizontal plane through the web and transversely through the rail head, resulting in the liberation of significant sections of rail.

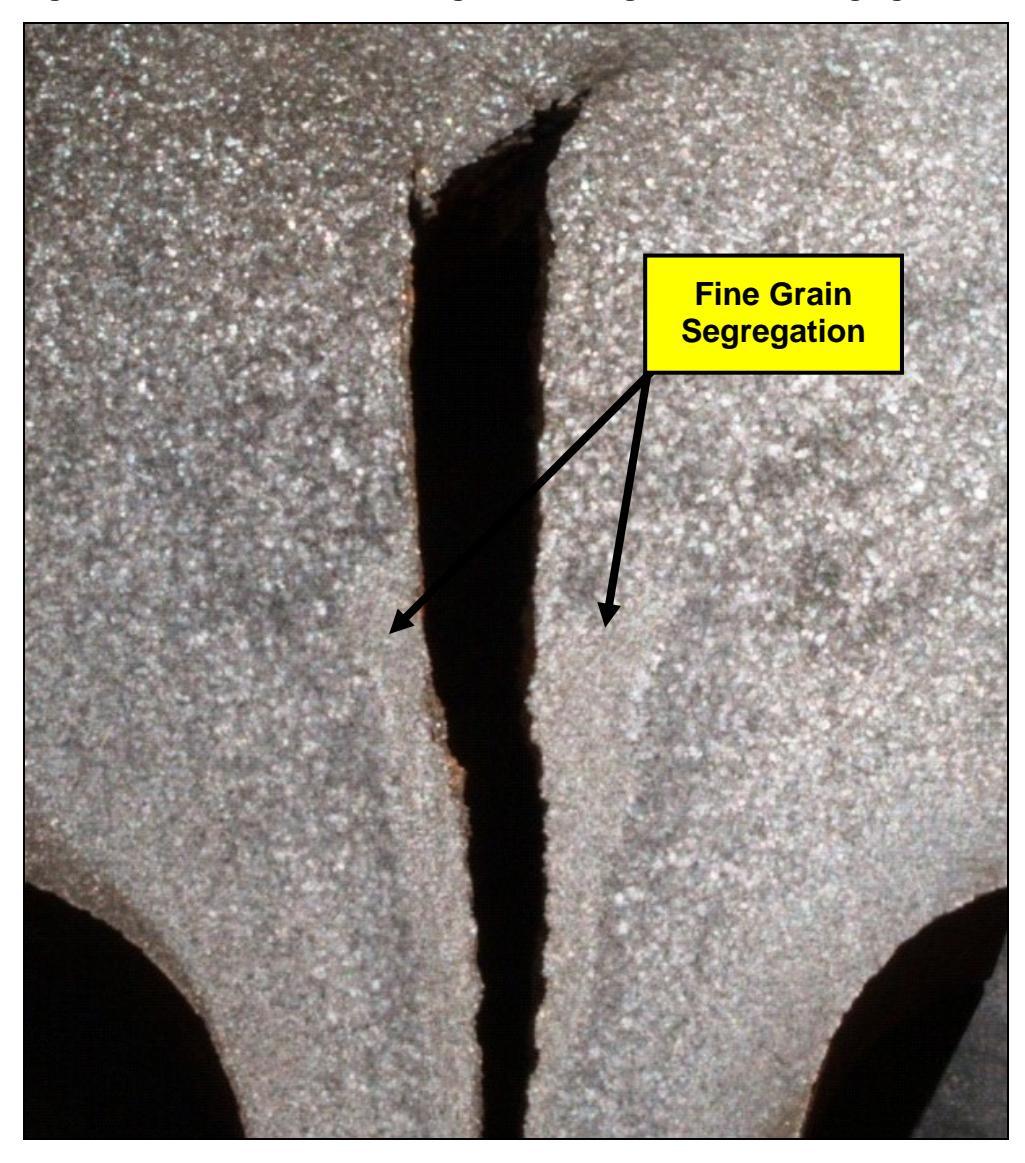
Selected samples were also taken to the ATSB test facilities in Canberra for further examination. A metallographic section was prepared through the split rail head (Figure 10). There was a significant difference in grain size locally adjacent to the split, compared to the bulk of the material. This indicated possible alloy segregation.

Figure 10: Cross section showing coarse/fine grain structure segregation

The origin of the vertical split head was probably a pre-existing manufacturing defect such as the grain segregation shown in Figure 10. There were no other obvious material flaws detected and the chemistry of the rail was in accordance with the manufacturing specification, AS E22-1964.

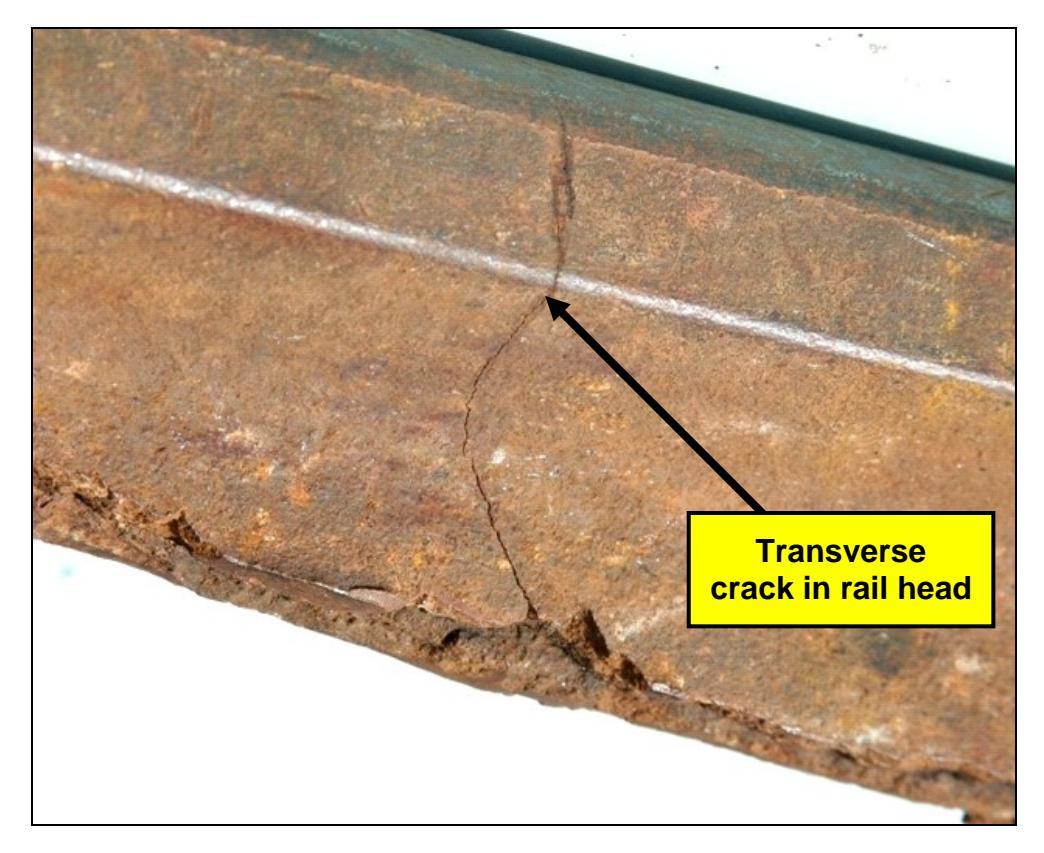
Visible in the same section of rail were secondary cracks, progressing from the web section through to the running surface (Figure 11). Those cracks were opened to expose the fracture surface by cutting the opposite side of the head (Figure 12).

Figure 11: Secondary/transverse crack in rail head

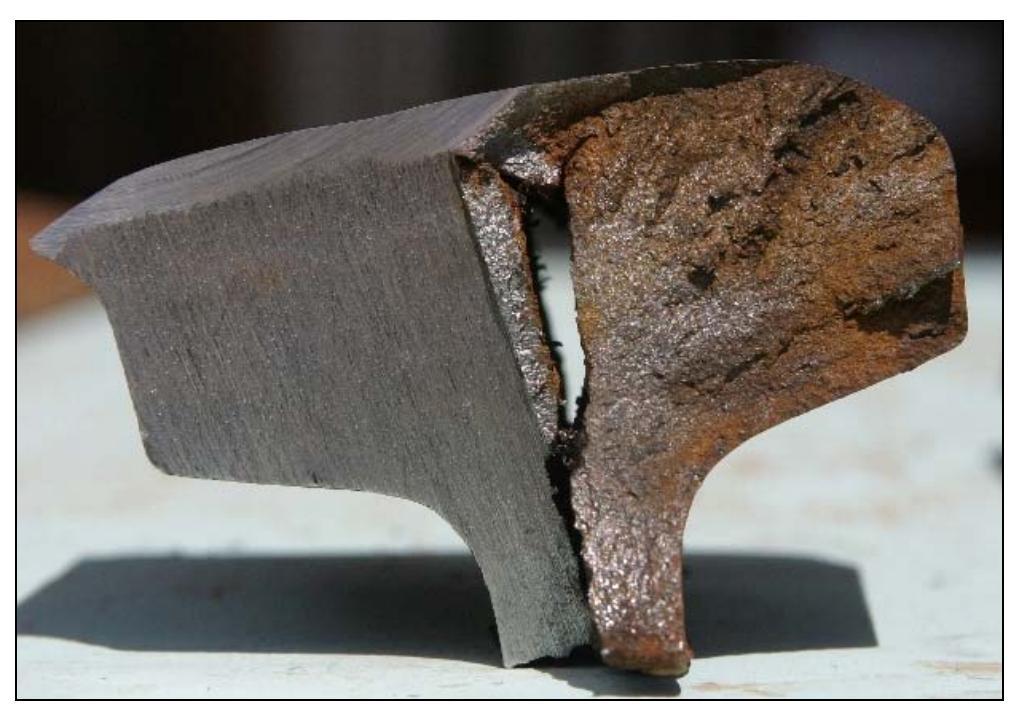
Figure 12: Section through crack shown in Figure 11

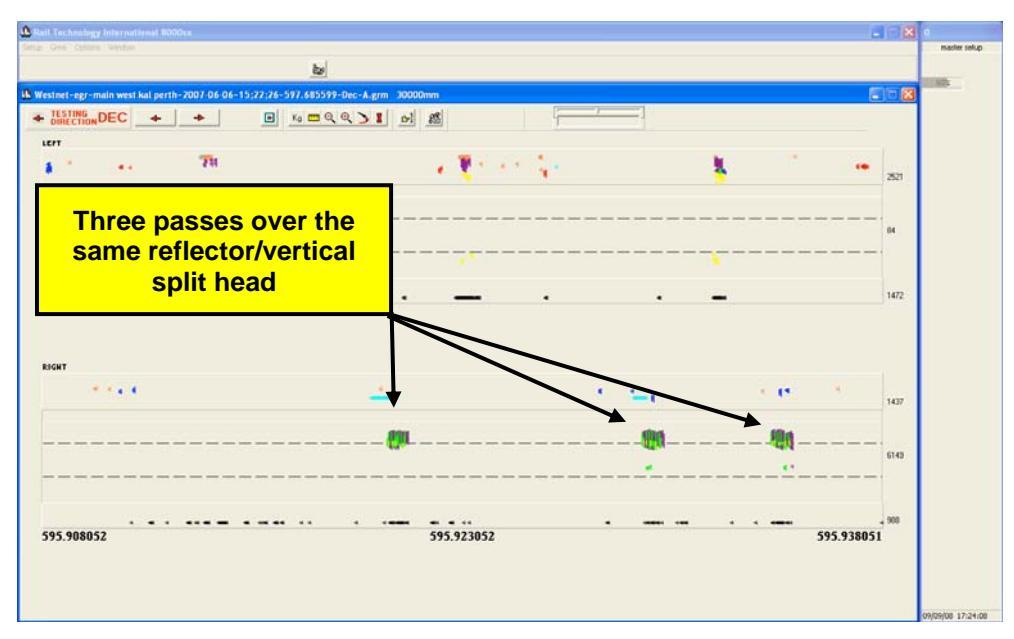
The data resulting from the RTI inspection run of 6 June 2007 is shown at Figure 14. The three passes over the vertical split head are highlighted. The disparity in location on track is due to inaccuracies in the spatial location parameters of the recording vehicle. The recording system overlays the results of multiple runs into a composite picture based on kilometerage.

Analysis of the data confirms that the three traces were from one vertical split head fault. As the fault was below the minimum reportable size it was documented by RTI within a summary of the work carried out during the inspection run, but not reported to WestNet Rail.

Figure 14: Portion of RTI inspection run of 6 June 2007
