Released in accordance with section 25 of the Transport Safety Investigation Act 2003 Breakdown of separation, VH-YVA/VH-CGF 59 km NE Armidale, New South Wales 8 October 2011

ATSB TRANSPORT SAFETY REPORT

Final

Aviation Occurrence Investigation A0-2011-127

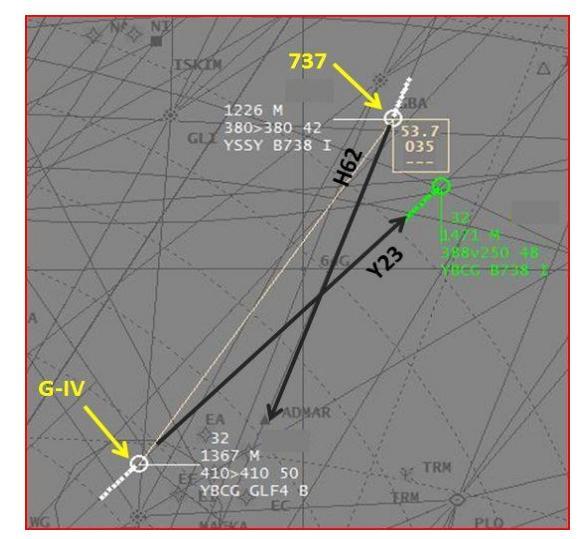
Figure 1: Proximity of the aircraft at 1457:38

> At this time the G-IV was maintaining FL410 with a groundspeed of 500 kts and the occurrence 737 was maintaining FL380 with a groundspeed of 420 kts. The lateral distance between the G-IV and the occurrence 737 was 53.7 NM (99.5 km) (Figure 1).

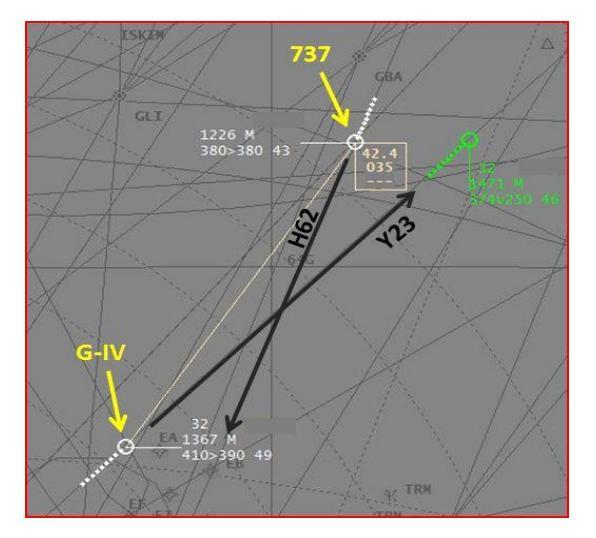
Australian Advanced Air Traffic System (TAAATS).⁶ Shortly after, the distance between the aircraft was 42.4 NM (78.5 km) (Figure 2).

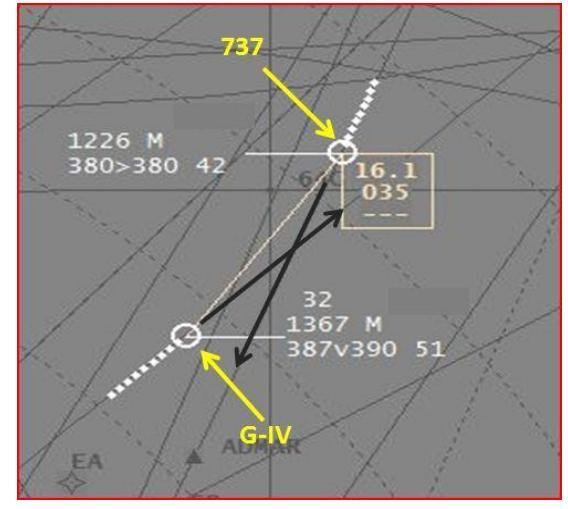
Figure 3: Proximity of the aircraft at 1500:11

On noticing the CLAM alarm, the controller requested confirmation from the pilot of the G-IV that the aircraft was only descending to FL390. The pilot responded '... negative we were given FL310 and read back'. At this time the lateral distance between the occurrence 737 and the G-IV was 16.1 NM (29.8 km) (Figure 3).

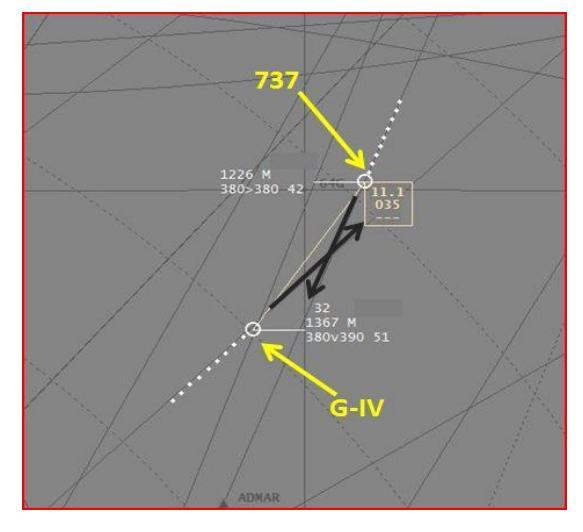
Figure 4: Proximity of the aircraft at 1500:31

At 1500:31 the occurrence 737 was maintaining FL380 and the G-IV was passing through FL380. The aircraft were 11.1 NM (20.5 km) apart, with a closing speed of 930 kts (Figure 4).

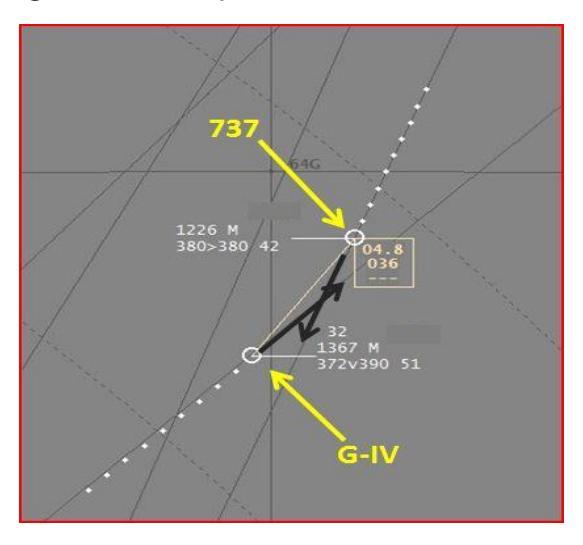
Figure 5: Proximity of the aircraft at 1500:51

A breakdown of separation occurred at 1500:51 (Figure 5), when the radar distance between the aircraft reduced to 4.8 NM (8.9 km) with a coincident vertical separation of about 800 ft (244 m). The appropriate separation standards required either 5 NM (9 km) distance by radar, or 1,000 ft vertically.

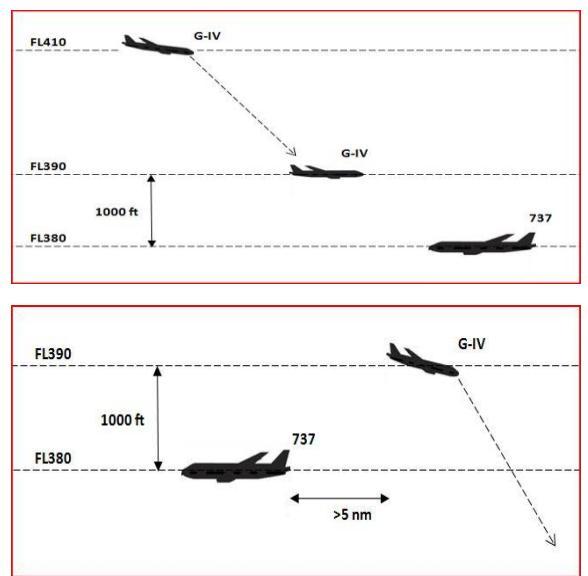
Figure 6: Controller's intended separation plan

descend the G-IV to FL390 (1.000 ft above the 737), until both aircraft had passed each other. The controller intended then issuing further descent to the G-IV (Figure 6).

The controller reported intending to initially

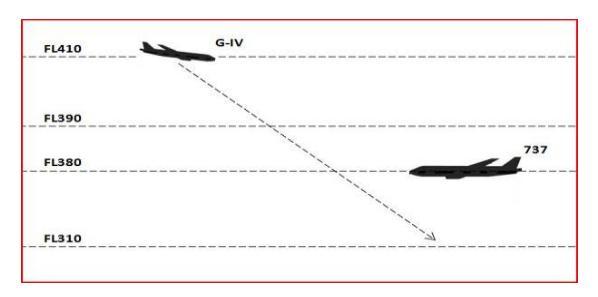
Figure 7: Level assignment and resulting descent as issued

While the controller's separation plan was to initially limit the G-IV's descent to FL390, the controller verbally assigned FL310. This level assignment contradicted the controller's plan and authorised the G-IV to descend through the occurrence 737's level (Figure 7).

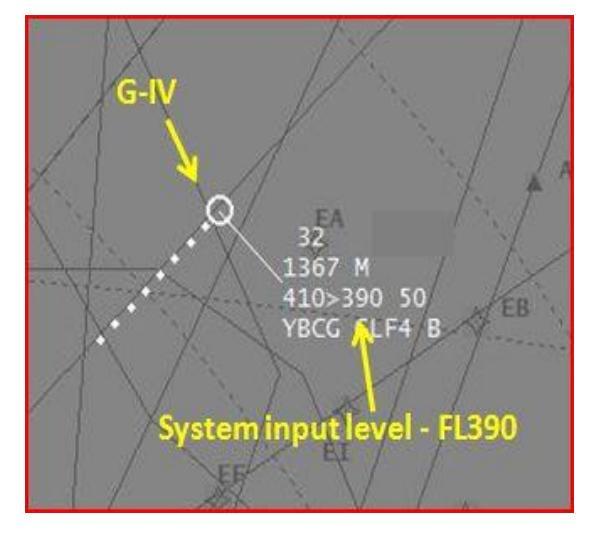
Figure 8: G-IV flight data block at 1458:23

In this incident the controller verbally issued descent to FL310 but deselected the highlighted FL390 (the intended and correct level) on the ASD (Figure 8).
