Loss of main rotor drive – Robinson Helicopter Company R44, VH-ZWC

83 km E of Darwin Airport, Northern Territory | 28 July 2011

ATSB Transport Safety Report Aviation Occurrence Investigation AO-2011-088 Final

Loss of main rotor drive 83 km E of Darwin Airport, NT – 28 July 2011 VH-ZWC Robinson Helicopter Company R44

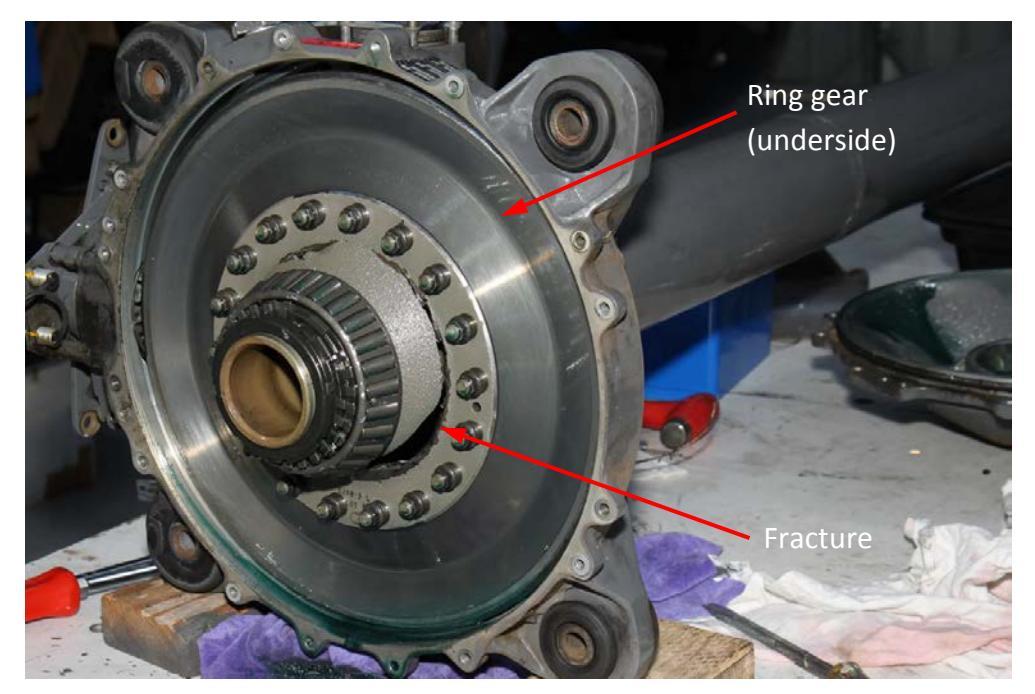
Removal of the main rotor gearbox sump revealed a fracture within the gear carrier (Figures 1 and 2). The bulk of the oil had been drained prior to removal of the gearbox from the helicopter. However, examination of the remnant oil showed liquid water droplets and pools within the lubricant.

Figure 1: Gearbox sump removed showing fractured gear carrier

Figure 2: Two halves of the gear carrier (ring gear attached)

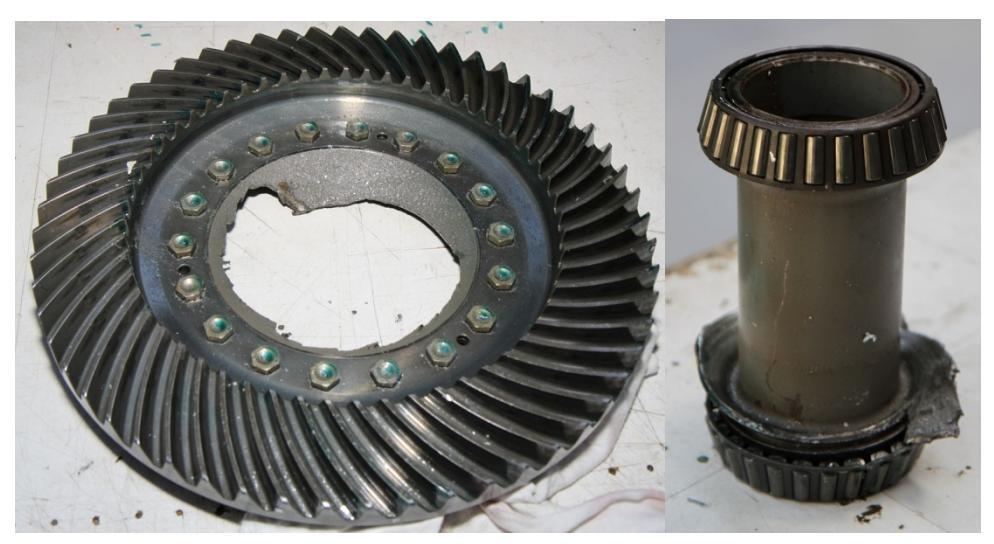
The gear carrier exhibited small paint blisters over much of the part surfaces (Figure 3) and paint adhesion to the steel substrate in some of these areas was very low. The general appearance of the steel substrate was consistent with an as-machined surface and showed minimal paint surface preparation. Each of the paint blisters was associated with an underlying corrosion cell, and as a result, extensive corrosion pitting was evident across the steel surfaces (Figures 4 and 5).

Figure 3: Paint blisters

The helicopter manufacturer has modified the gear carrier design to improve the corrosion resistance by cadmium plating the part.

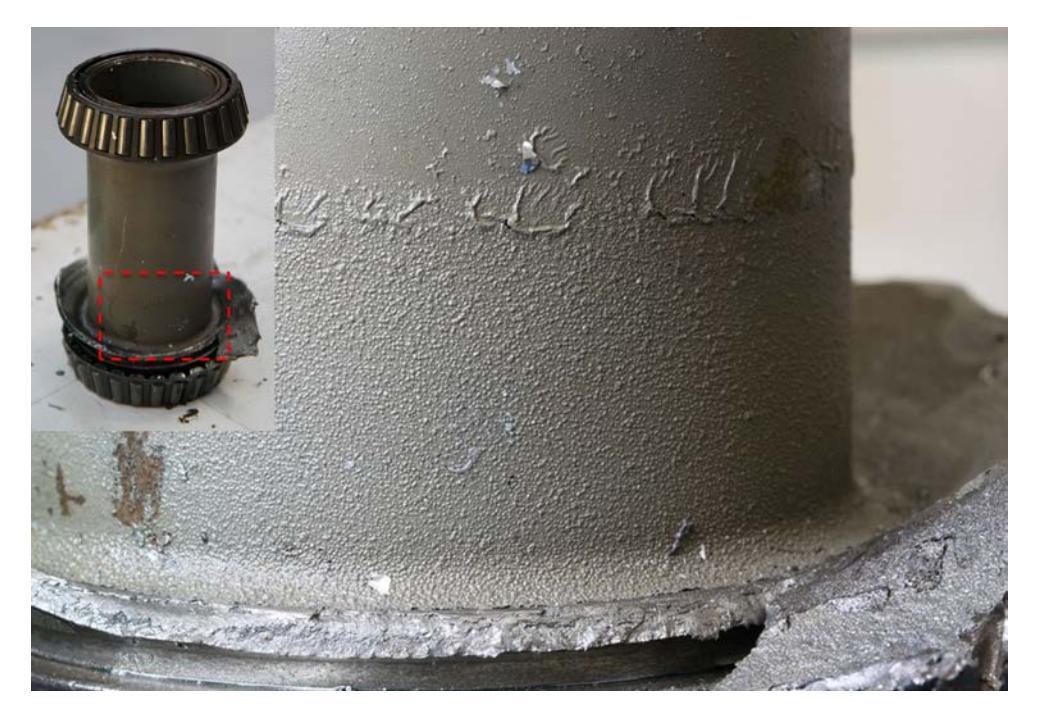
Figure 4: Corrosion pitting on gear carrier flange

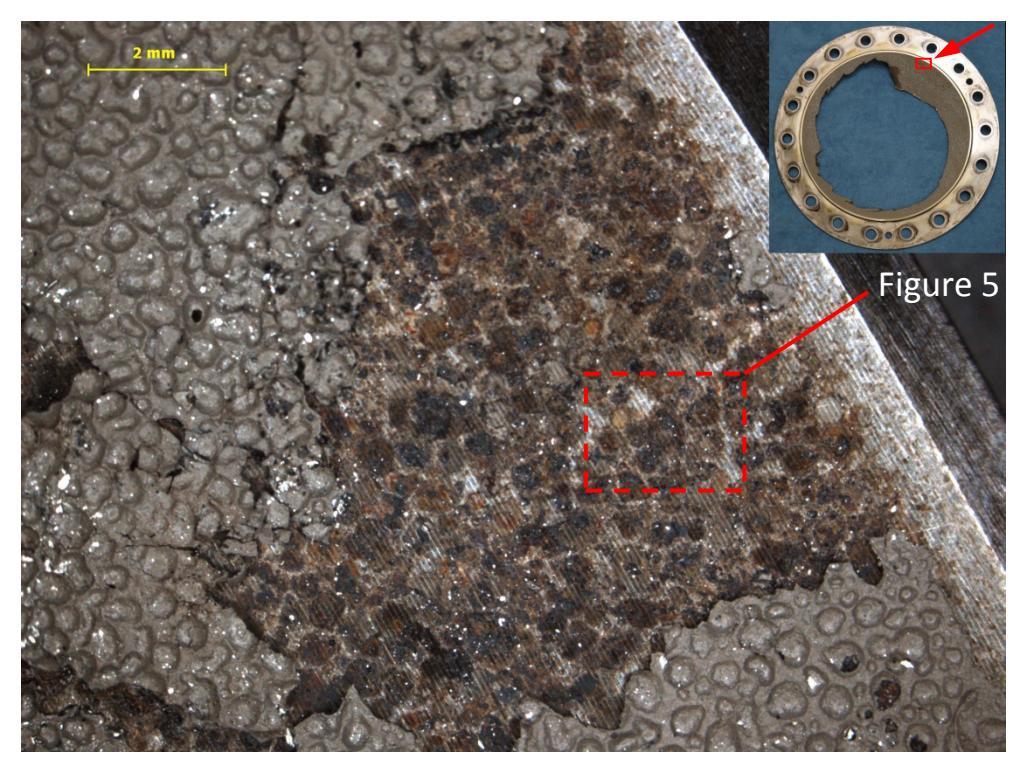
Figure 5: Detail of Figure 4

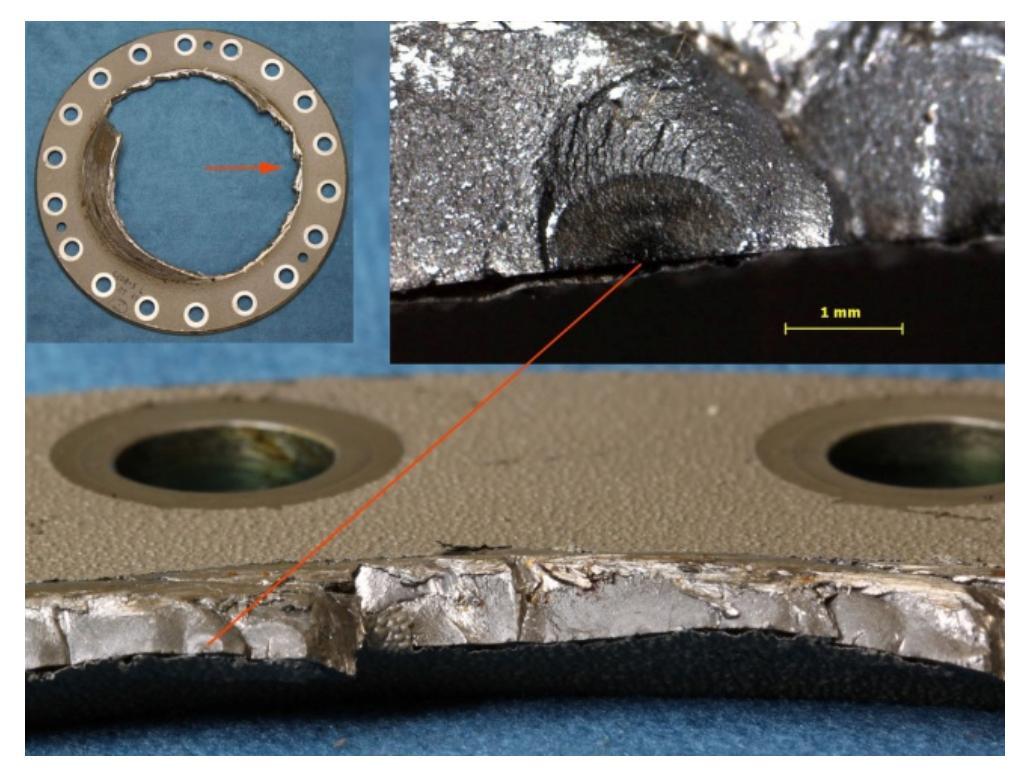
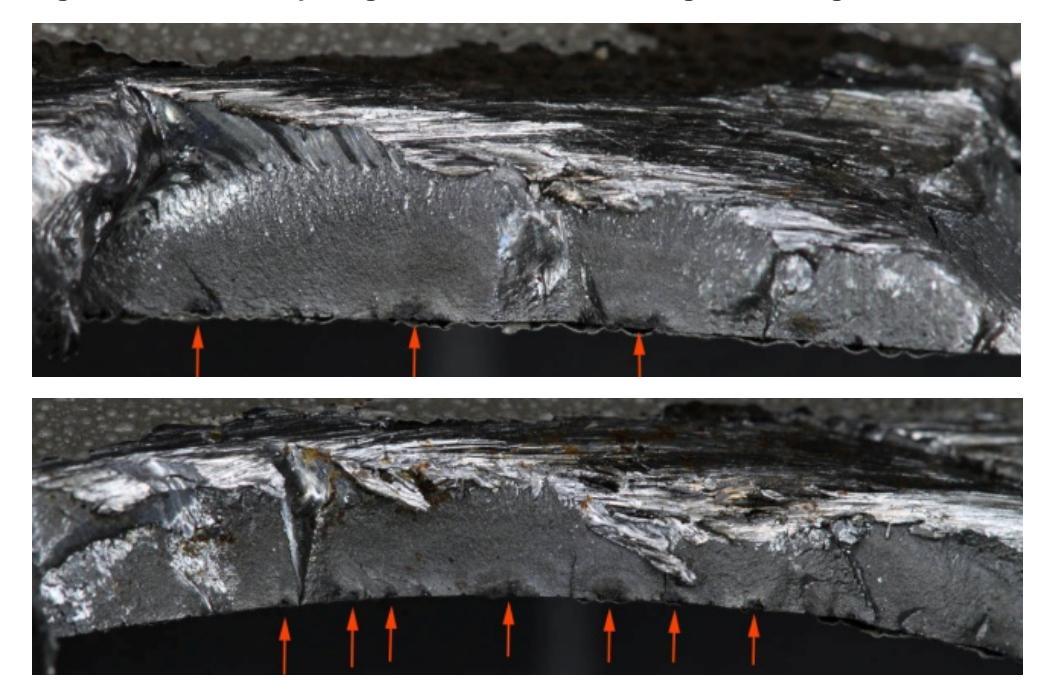
Figure 7: Corrosion pitting associated with the fatigue cracking
