# Collision between an XPT passenger train and a track-mounted excavator

near Newbridge NSW | 5 May 2010

Rail Occurrence Investigation RO-2010-004 Final

Report No. RO-20010-004 Publication date 20 April 2012 ISBN 978-1-74251-258-7

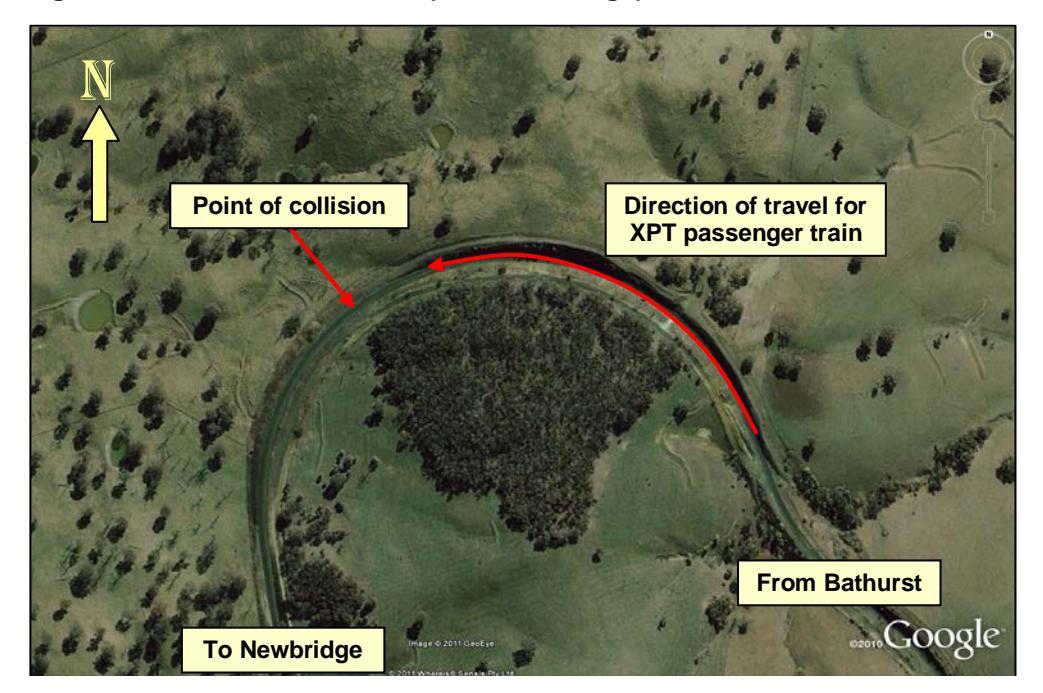
### Figure 4: Location of collision (near Newbridge)

The collision occurred on a tight (290 m radius) left-hand curve, in the direction of train travel, with a descending gradient of 1:77. The point of impact was at the

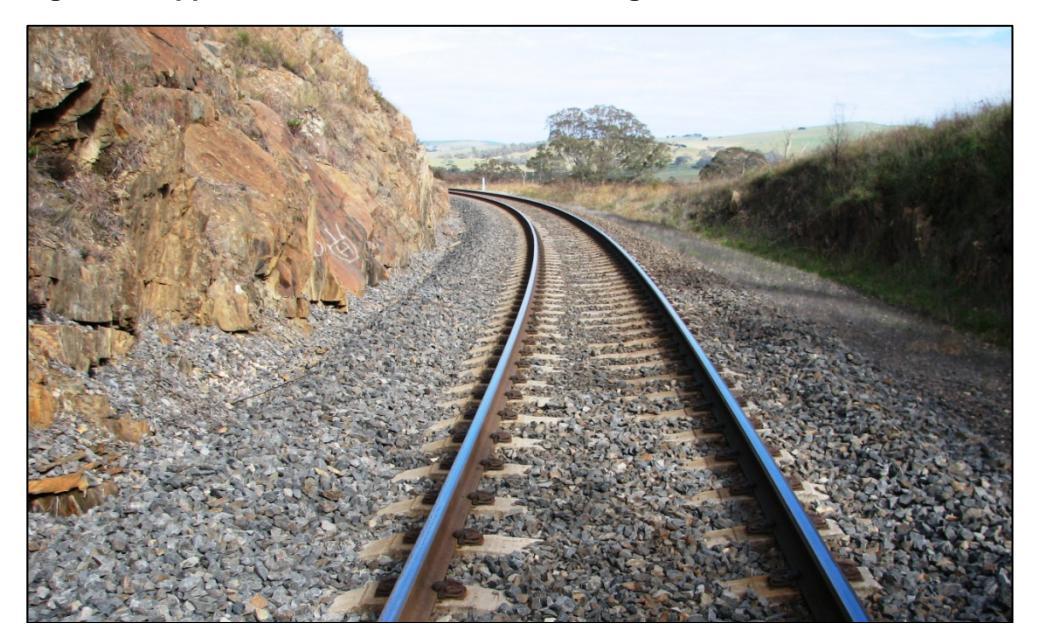
### Figure 6: Approach to collision site at Newbridge

Meanwhile, train WT27 continued to travel towards the worksite at speeds of between 50 km/h and 75 km/h. At about 1116, XPT passenger train WT27 approached from the east, through the left-hand curve and cutting immediately before the collision site. Figure 6 illustrates the train driver's view at about the point where the excavator would have been just visible, about 95 m from the point of collision. Based on recorded data, at 1116:05 train WT27 was travelling at 69 km/h as the throttle was moved to idle and the brake cylinder pressure increased, indicating that the train brakes had started to apply. Considering the limited sighting distance due to the track curvature and the cutting height, the train driver reacted quickly on sighting the track obstruction. However, there was insufficient time for the XPT to stop and a collision was inevitable. About 4 seconds and 66 m later, train WT27 collided with the excavator. The collision occurred at 1116:09, about 26 minutes after train WT27 departed Bathurst (at 1050) and about 18 minutes after the issue of the TOA (at 1058).

Neither the PO (who was still at the truck), nor the hot-work labourer (who had already cut two portions of rail) heard the train approaching. However, both heard a loud noise and looked up to see the excavator being pushed by the train.

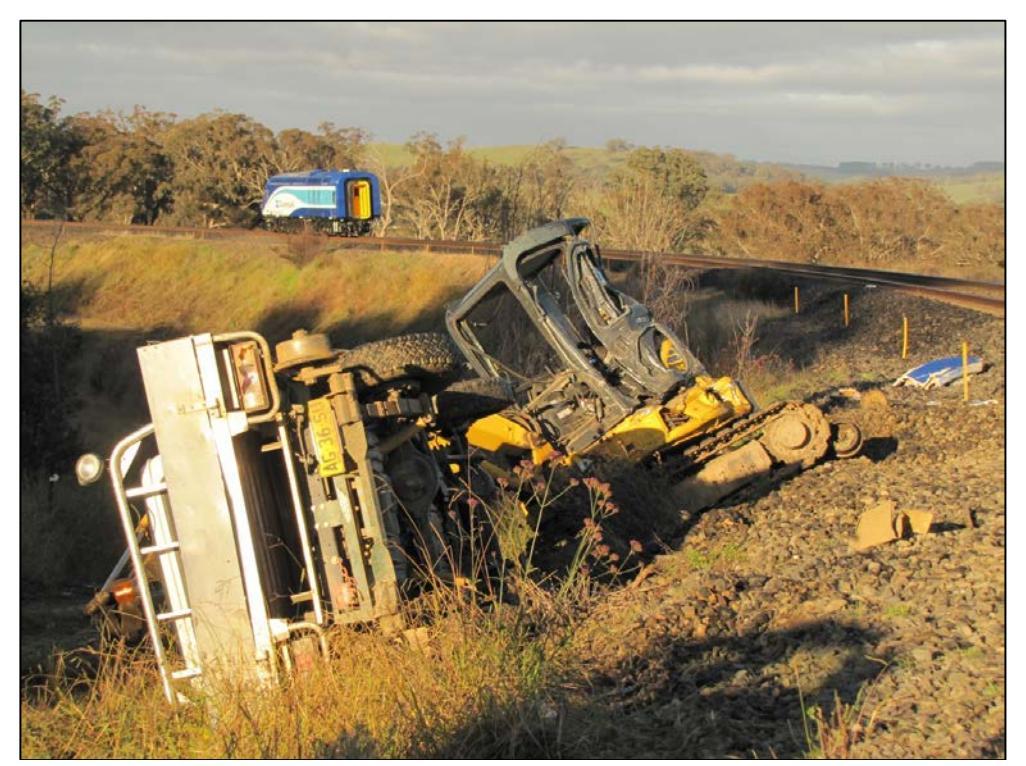
Figure 7: Incident site at Newbridge

The track infrastructure received very minor damage. Power car XP2008 received moderate frontal damage. Both the ARTC utility vehicle and excavator were essentially unrepairable.

Site observations by investigators revealed that the excavator had been propelled along the track for a distance of about 20 m until the extended boom struck the utility vehicle parked alongside the southern side of the track. The excavator derailed and, while entangled with the utility vehicle, was pushed off the track and came to rest on the formed embankment about 38 m from the point of initial impact (Figure 7). The operator of the excavator was ejected from the excavator sometime during the collision sequence and sustained fatal injuries. The leading end of train WT27 stopped about 196 m beyond the initial point of impact.

Note: At the time of photo, the XPT passenger cars and trailing power car had been uncoupled and removed from the incident site.

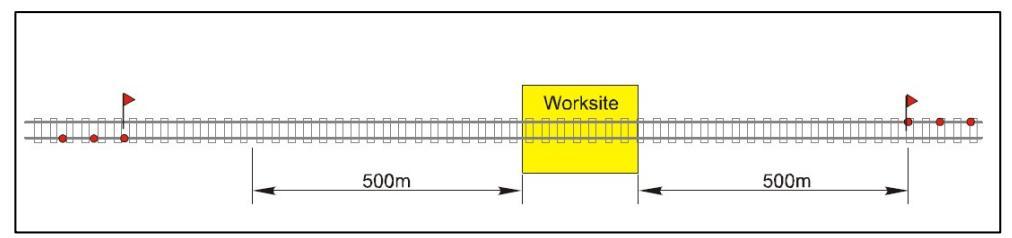
### Figure 8: Additional site protection

In addition, the hot-work labourer and excavator operator accessed the danger zone before the additional site protection measures (detonators and flags) had been put in place. The hot-work labourer and excavator operator were relatively inexperienced and may have assumed that having received a TOA they were safe to enter the danger zone as no trains would be approaching the worksite. The ATSB found that the minimum level of training provided to the track workers did not specifically cover the hazards and protections that were relevant when working under a TOA. While the PO told the track workers that a TOA had been received, he did not explicitly communicate that they should not occupy the danger zone until all site protection measures were put in place. The workers were aware of this requirement, but without having attained the experience or training to become fully aware of the risk associated with working under a TOA, the track workers were less likely to protect themselves by not entering the danger zone until the appropriate measures were in place.

With respect to the incident at Newbridge, the workers entered the danger zone before site protection measures (warning flags and detonators) were put in place. The train driver responded very quickly and appropriately, especially considering he was not expecting to see workers on the track. Examination of site evidence found that on sighting the excavator there was insufficient time for the XPT to stop and it was unlikely that the driver could have done anything to diminish the consequences of the inevitable collision.
