Collision with terrain – MD Helicopters Inc. 369D, YJ-HEL

Unua village, Malekula, Vanuatu | 26 August 2011

ATSB Transport Safety Report Aviation Occurrence Investigation AO-2011-108 Final

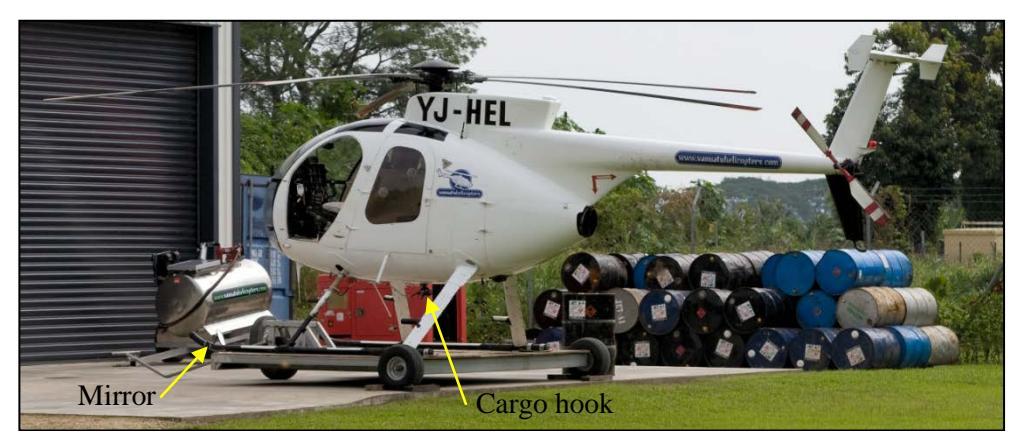
The MD Helicopters Inc. 369D is a five-seat⁵, single main and tail rotor-equipped helicopter that is powered by a gas turbine engine and equipped with skid-type landing gear. The accident aircraft was fitted with high skids, a cargo hook and a mirror, which was attached to the toe of the left skid and enabled the pilot to view the helicopter's cargo hook and a segment of the attached sling (Figure 2).

The helicopter was being operated with the left-front door removed to enable the pilot to view the underslung loads. A 5 m long wire rope was connected to the helicopter's cargo hook at one end and to a yellow swivel/hook assembly at the hook end of the rope to allow for those operations (see the section titled *Wreckage examination*).

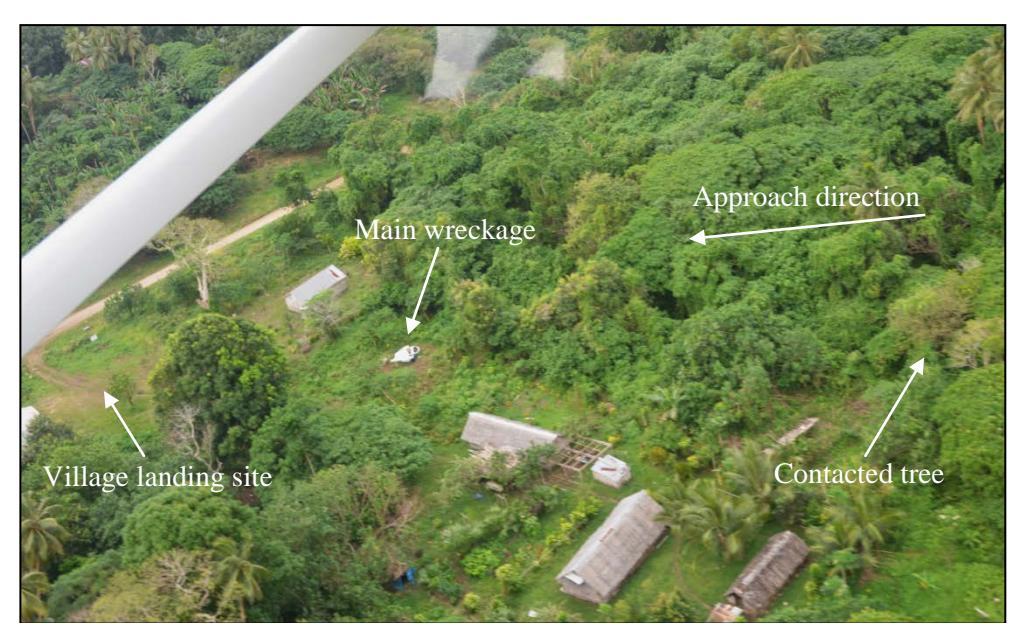
Figure 3: Accident site⁶

The main wreckage came to rest in the village about 73 m along the approach direction from the tree that was reported to have been contacted by the sling (Figure 3). A number of components, including segments of two of the main rotor blades and the tail boom detached during the accident sequence and were found up to 108 m from the main wreckage (Figure 4).

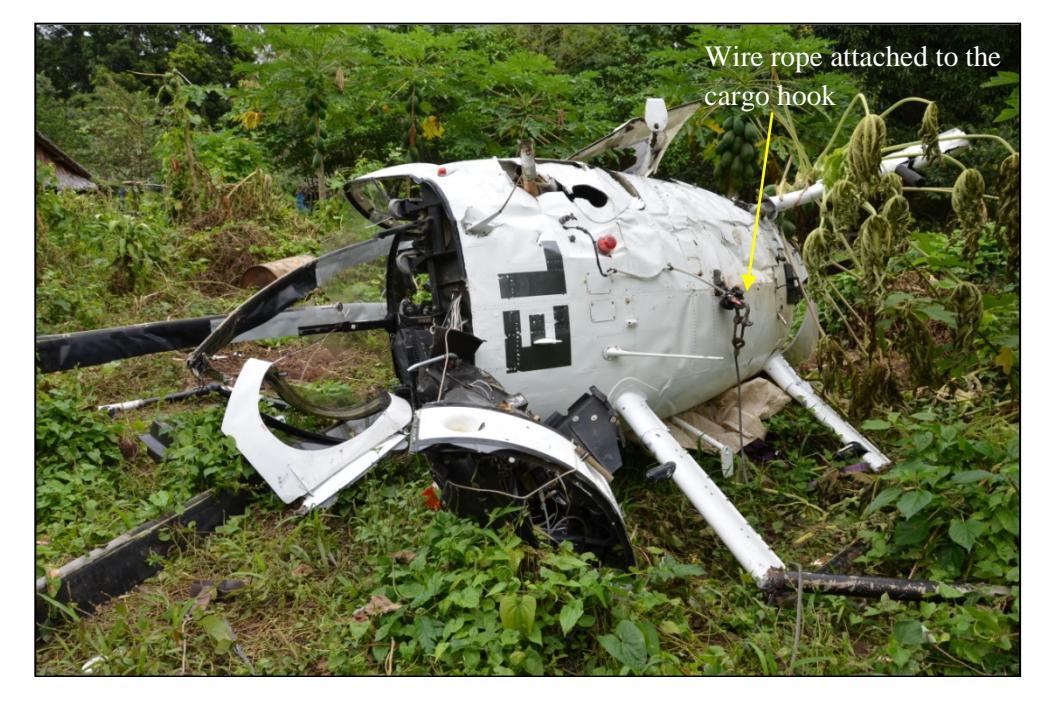
Figure 5: Main wreckage

Examination of the helicopter identified that it initially contacted the ground on its left-rear side before coming to rest on its right side (Figure 5). There was extensive damage to the forward fuselage/cabin area, landing gear and main rotor blades. The tail boom had detached about 47 cm from the fuselage attachment point and was found about 29 m from the main wreckage. The relative lack of damage to the tail

rotor and stabilisers, together with contact/paint transfer marks on the fuselage, tail boom and one of the main rotor blades identified that the tail boom detached while the helicopter was airborne.

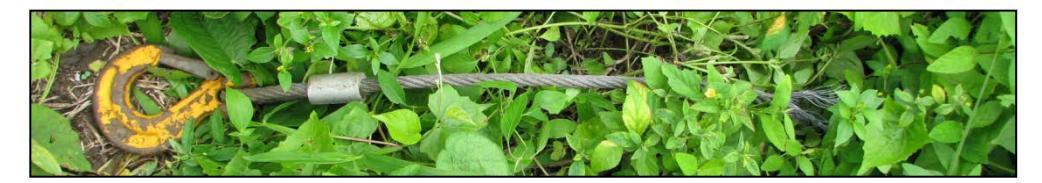
The wire rope was found connected to the helicopter's cargo hook; however, the last 70 cm of the rope, including the hook, had separated and was identified several meters from the wreckage (Figure 6). Examination of the rope identified that it had failed due to overstress.

Figure 6: Detached 70 cm segment of the wire rope, including the yellow hook

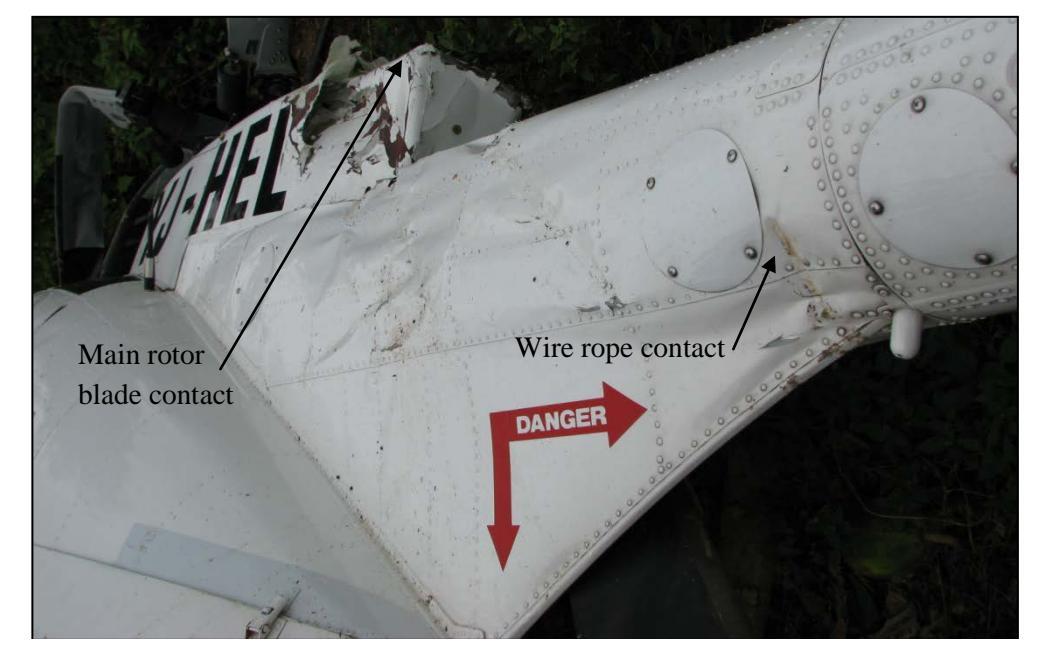
Numerous marks on the main rotor blades and fuselage indicated that the wire rope and main rotor blade/s had contacted the fuselage (Figure 7). Additionally, examination the leading edge of one of the main rotor blades showed evidence of contact with the wire rope. A large segment of the blade separated at that point (Figure 8). Examination of the engine and the main and tail rotor systems did not identify any defect or pre-existing damage that would have affected the normal operation of the helicopter. A quantity of clear fuel was recovered from the engine fuel filter.

Figure 7: Fuselage contact marks

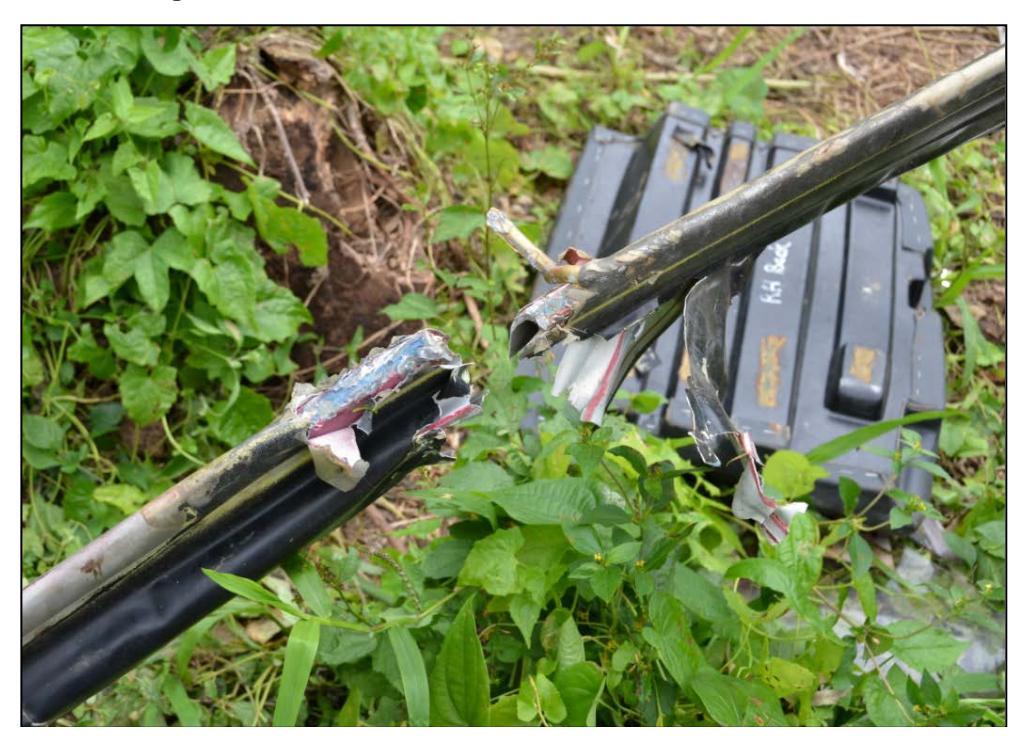
Figure 8: Indications of wire rope contact with a main rotor blade leading edge
