In-flight breakup – Cessna Aircraft Company C210M VH-WBZ

100 km NNW Roma, Queensland | 7 December 2011

ATSB Transport Safety Report Aviation Occurrence Investigation AO-2011-160 Final

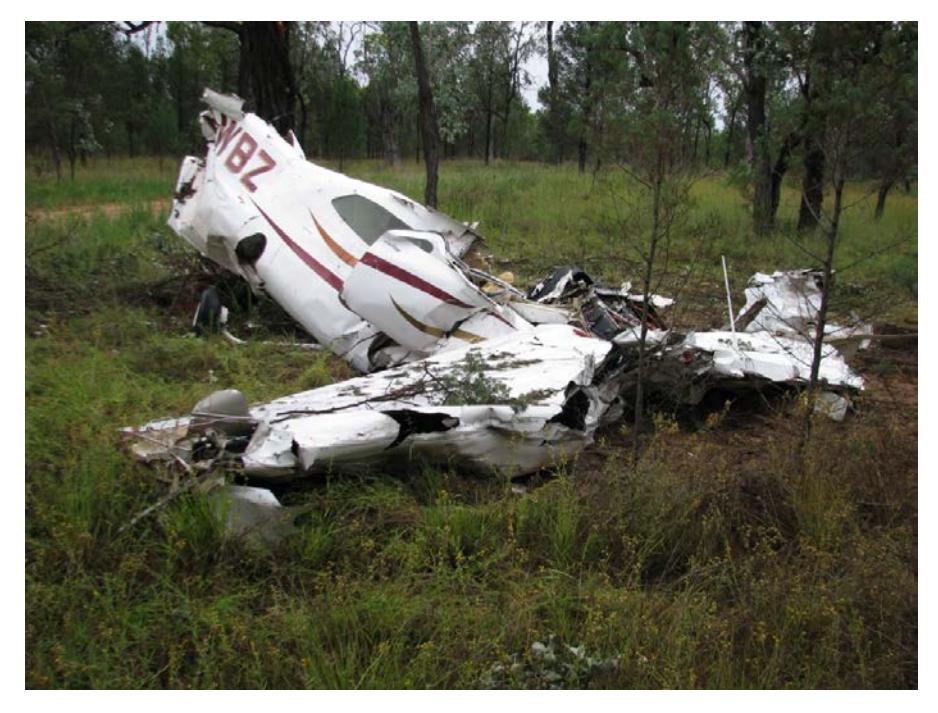
At the main wreckage site, the fuselage was generally upright in a nose-down, left-roll attitude with the rear fuselage bent around an upright tree. The forward cabin area and nose of the aircraft were severely disrupted from ground and/or tree impact.

Above the forward cabin area and still loosely connected was the remaining wing section, comprising the main spar carry-through with the right wing outboard to the flap/aileron junction and left wing spar attachment fittings. The vertical stabiliser and rudder were still attached.

Figure 1: View to the north of the main wreckage (remnant wing section displaced forward and right from the as-found position)
