Collision with terrain – Schweizer 269C-1 VH-LTO

Redcliffe Aerodrome, Qld – 18 June 2012

ATSB Transport Safety Report Aviation Occurrence Investigation AO-2012-082 Final Report No. AO-2012-082

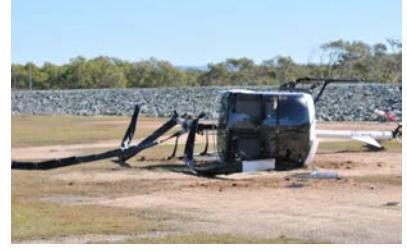
VH-LTO

The tail rotor struck the ground and the helicopter pitched forward. The skids then contacted the ground before the helicopter became airborne again and immediately entered a rapid rotation to the right. The crew closed the throttle in an attempt to recover from the uncommanded right yaw, however the helicopter impacted the ground before the rotation could be arrested and the helicopter rolled over. The helicopter was seriously damaged. Both instructor and student reported soft tissue injuries and some minor cuts and bruises.

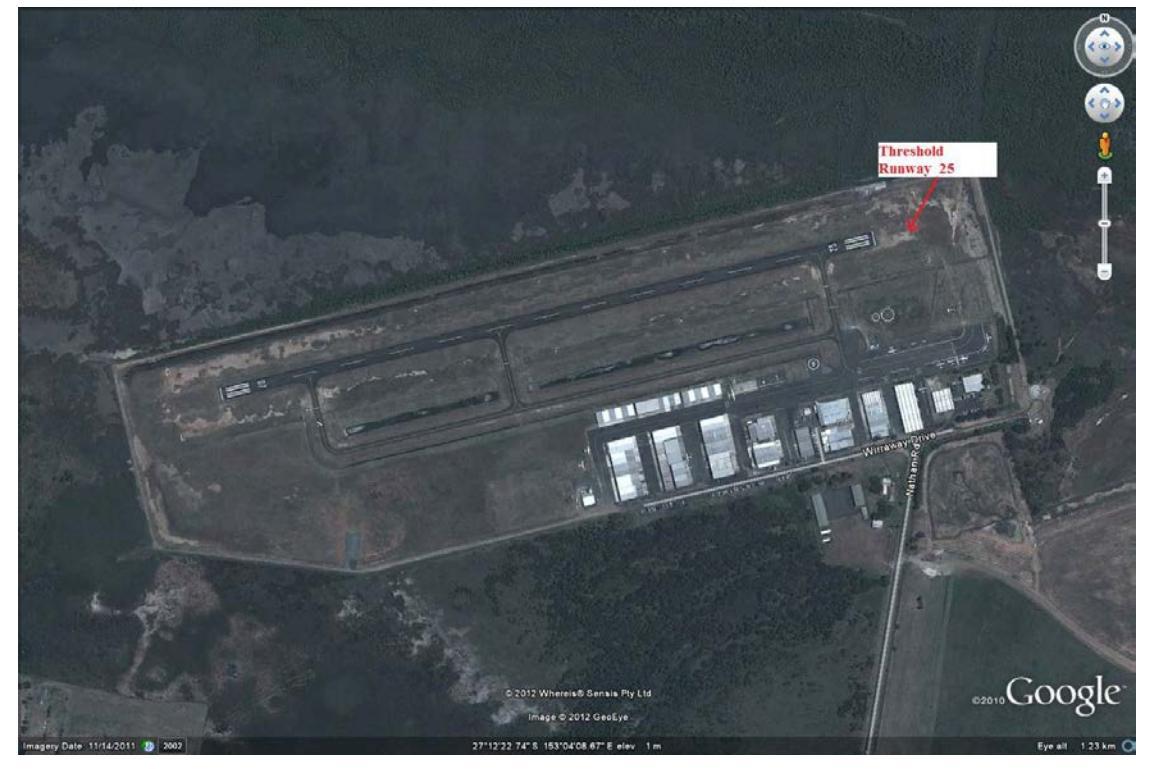
Figure 1: Redcliffe aerodrome

- **Rotor RPM**. It was considered that rotor RPM would have been high at the time of the flare as power had been reintroduced in anticipation of a power termination.
- Forward airspeed. The airspeed at the time of the flare could not be conclusively determined.
- Wind shear. Both instructor and student reported the wind as being light and variable both instructor and student commented that the wind may have shifted at the time of the flare. The student also added that it is common to get mechanical turbulence off the hangars at the threshold of runway 25 where the practice autorotation was to be conducted.
