# Collision with terrain – Robinson R22, VH-STK

near Miranda Downs (ALA), Queensland, 6 July 2012

ATSB Transport Safety Report Aviation Occurrence Investigation AO-2012-091 Final Report No. AO-2012-091

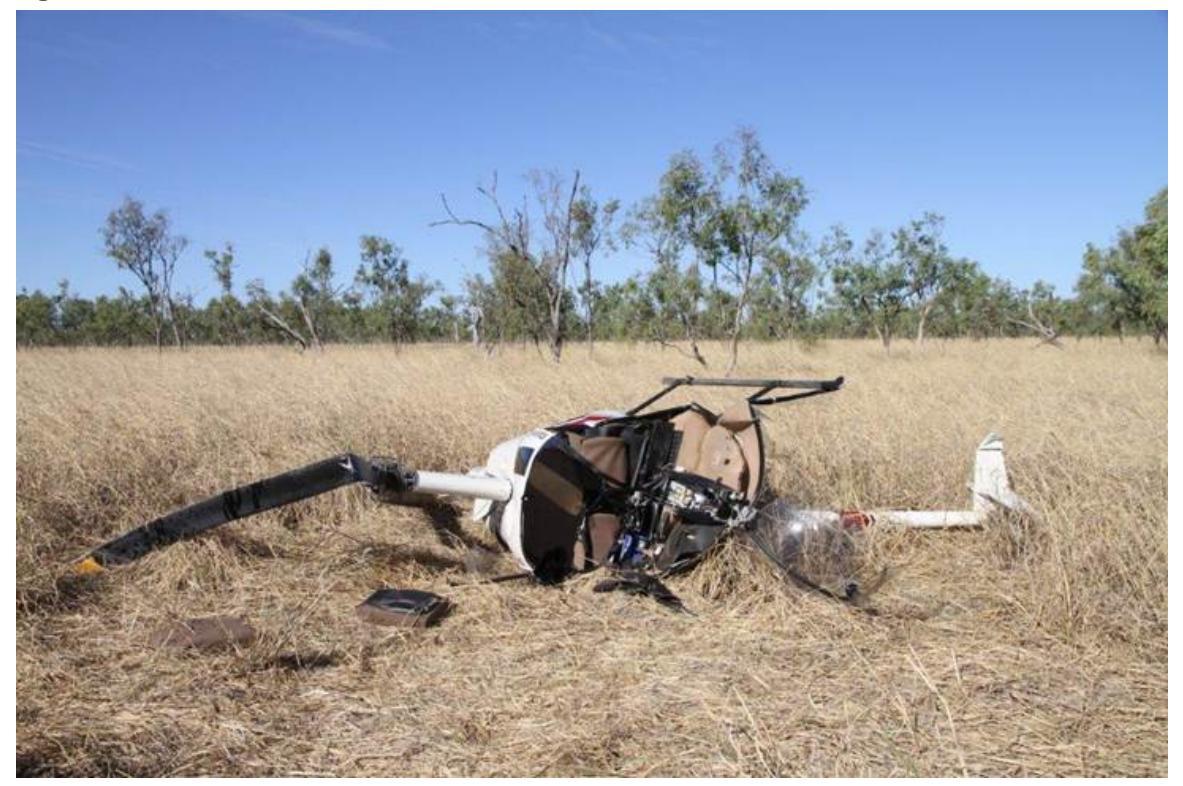
Figure 1: Accident site

At 0840 Eastern Standard Time<sup>1</sup> on 6 July 2012, during mustering operations near Miranda Downs aeroplane landing area (ALA), Queensland, the right skid of a Robinson R22 Beta (R22) helicopter, registered VH-STK (STK), struck a tree, causing the aircraft to collide with terrain (Figure 1). The pilot, the only occupant, was seriously injured and the helicopter sustained substantial damage.

The operator conducted an investigation into the accident and, using Global Positioning System (GPS) data, determined that STK had been operating at an average altitude of about 310 ft above ground level (AGL). Tracking for the dam, STK climbed to 2,308 ft AGL with a ground speed of 24 kt before commencing a spiral descent to the left to an altitude of 283 ft AGL at a ground speed of 42 kt. The last recorded data was an altitude of about 83 ft AGL and ground speed of 57 kt.

Bureau of Meteorology data indicated that the temperature was 14.7° C and the dew point 1.3° C. The operator determined that the combination of temperature and dew point would indicate a moderate carburettor icing<sup>2</sup> risk at cruise power and a serious icing risk at descent power.

The aircraft operator reminded all pilots of the content of the Robinson Safety Notice SN-25 – *Carburettor Ice*, and to be familiar with Section 4 of the R22 Flight Manual – *Normal Procedures*, particularly page 4-11 – *Use of carburettor heat* and *Use of carb heat assist*.

The aircraft operator also advised their pilots to be aware of the details in Robinson Safety Notice SN-38 – *Practice Autorotations Cause Many Training Accidents*, and also cautioned them that auto-rotations should only be practised or used for rapid decent when the pilot is confident that they are over an area where a safe power-off landing can be made in case of engine stoppage.
