# Breakdown of separation -Beech 200, VH-FDD and Beech 350, DINGO 008

Near Cooktown, Queensland, 9 August 2012

ATSB Transport Safety Report Aviation Occurrence Investigation AO-2012-101 Final Report No. AO-2012-101

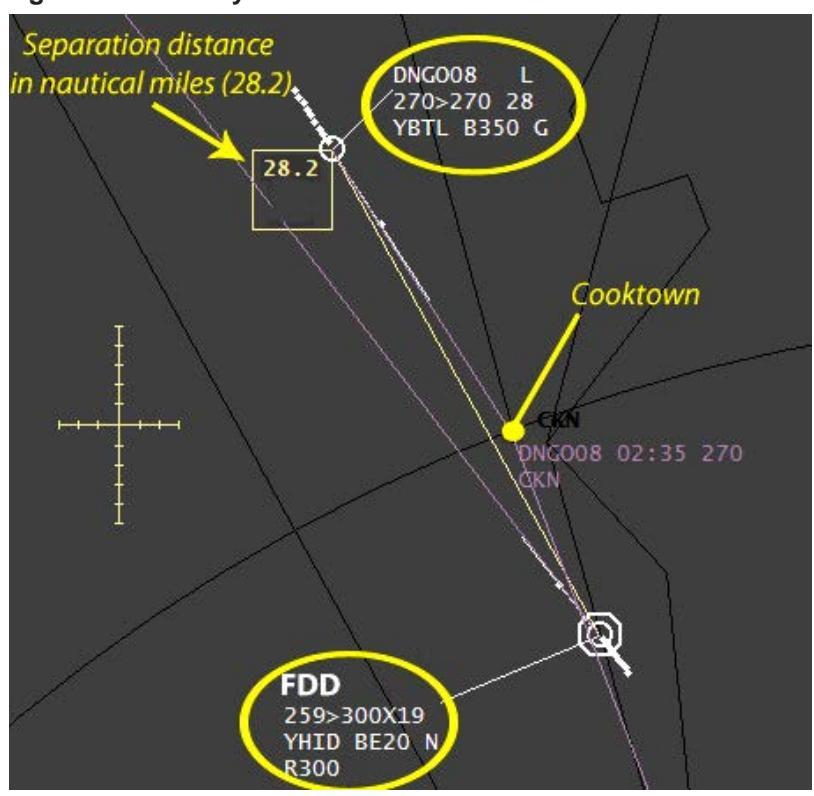
Figure 1: Proximity of the aircraft at 1232:15

At 1231:22, as FDD was passing FL255, the pilot requested further climb to FL300. The air traffic controller advised the pilot to stand by then commenced the required coordination with the two northern ATC sectors and the associated inputs into the Australian Advanced Air Traffic System (TAAATS). At 1232:15, the controller assigned FDD further climb, which resulted in a loss of separation assurance (LOSA)<sup>5</sup> with DINGO 008. At that time, FDD was passing FL259 and was 28.2 NM (52.2 km) south of DINGO 008, maintaining FL270 (Figure 1). There was about 2.8 NM (5.2 km) between the projected flight paths of the aircraft.

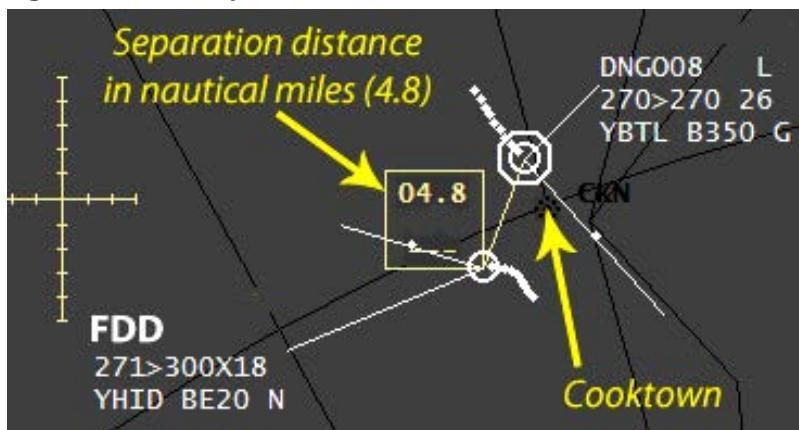
Figure 2: Proximity of the aircraft at 1235:27

At 1235:25, a breakdown of separation occurred as the distance between the aircraft reduced to 4.9 NM (9.1 km) with both aircraft at FL270. The distance reduced further to 4.8 NM (8.9 km) with FDD 100 ft above DINGO 008 (Figure 2), before increasing three seconds later to the required radar separation standard of 5 NM (9.2 km) horizontally or 1,000 ft vertically.
