Fuel Starvation involving PA-34-200, VH-BTW

19 km south of Nowra Aerodrome, 31 August 2012

ATSB Transport Safety Report Aviation Occurrence Investigation AO-2012-112 Final Report No. AO-2012-112

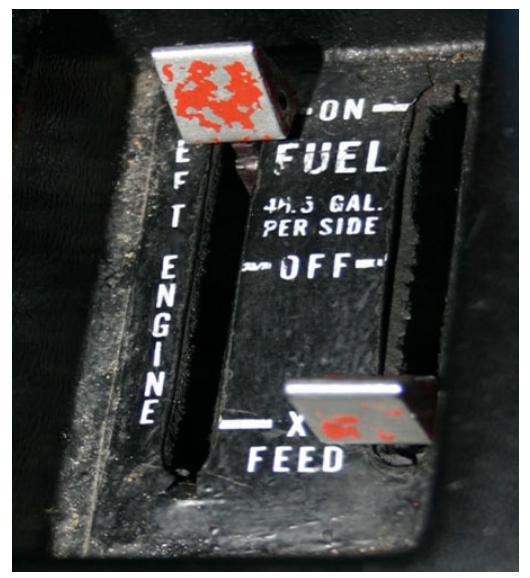
Figure 3: Fuel Selector

propellers, declared a PAN³ and started looking for a suitable landing area. The pilot then proceeded through the memory items on the emergency checklist. While performing the emergency checklist, the pilot discovered that the right fuel selector was in the cross-feed position and the left fuel tank had run out of fuel. The pilot repositioned the fuel selectors and restarted both engines.

The fuel system for this aircraft consisted of two tanks, one in each wing, that were interconnected. The fuel system had two fuel selectors (Figure 3), one for each engine, which were identified as LEFT ENGINE and RIGHT ENGINE. Each selector had three positions. The forward position (ON) allowed each tank to feed its respective engine. The central position (OFF)

cut off the fuel supply. The rear position (XFEED) was for cross-feeding fuel to an engine from the opposite side tank. For example, if the right fuel selector was on XFEED, the right engine would receive fuel from the left fuel tank.
