# Collision with terrain involving Kawasaki 369HS, VH-JWJ

near Inverloch Victoria, 19 August 2012

ATSB Transport Safety Report Aviation Occurrence Investigation AO-2012-104 Final Report No. AO-2012-104

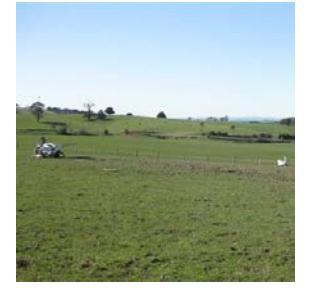
#### Accident site

The pilot aimed for a dry area in a muddy paddock, allowing the helicopter to turn gently left towards his aiming spot. The pilot reported that he flared too late, causing the tail boom and then the left skid to drag along the wet ground. As the left skid broke contact with the ground, the weight of the helicopter was transferred to the right side. The right skid contacted the ground and was torn off, taking the tail boom with it. The helicopter skidded for about 80 m before coming to rest (Figure 1).

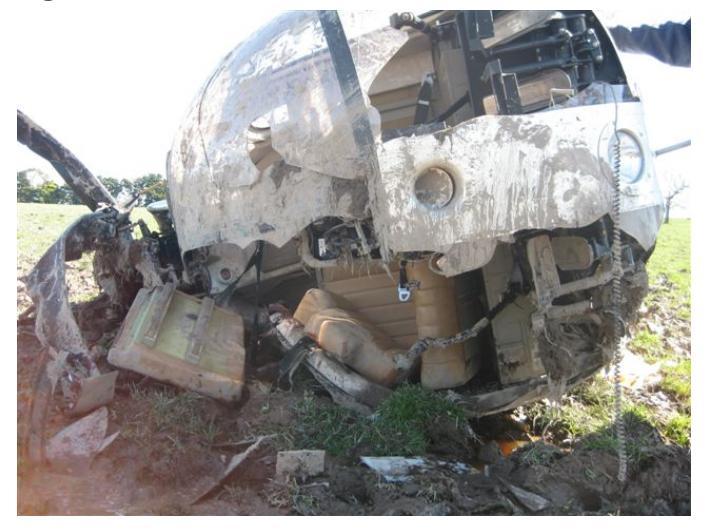
#### Figure 1: Cabin of VH-JWJ

Both the pilot and passenger were wearing a four-point harness and the pilot was wearing a helmet. The pilot was uninjured while the passenger sustained a minor head wound.

The accident highlights the value of occupant restraints and safety helmets for both pilots and passengers.
