Aviation Short Investigation Bulletin

Issue 15

Aviation Short Investigations AB-2013-018 Final – 27 February 2013 Released in accordance with section 25 of the Transport Safety Investigation Act 2003

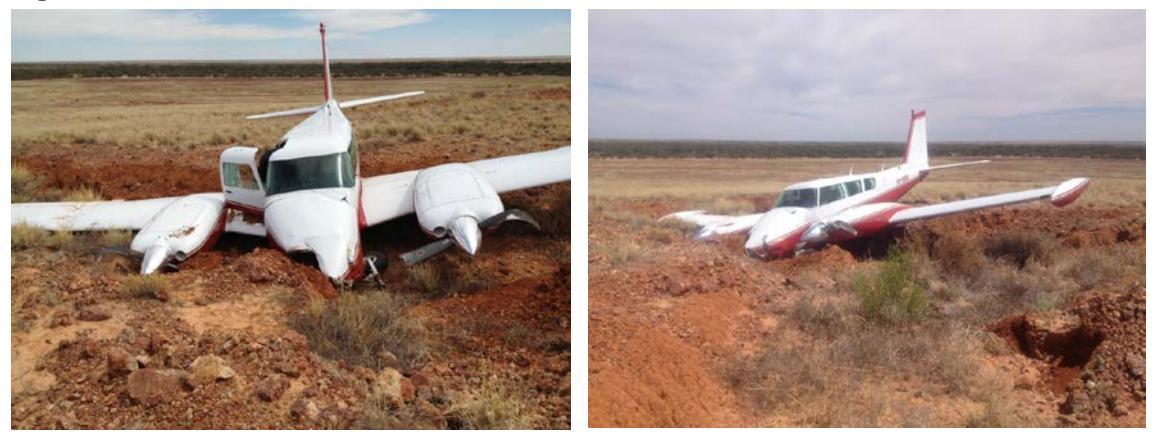
Figure 1: VH-MMN

When the aircraft was about half way along the runway, the pilot realised that the aircraft's speed was too fast and he applied full braking. The pilot determined that it was too late to commence a go-around. He reported that the braking appeared to be ineffective due to the surface of the runway and the aircraft continued beyond the runway end. The left landing gear struck a depression, and then the aircraft spun to the left and came to rest in a 1 m deep gully. The pilot and passenger exited the aircraft and the aircraft sustained serious damage (Figure 1).

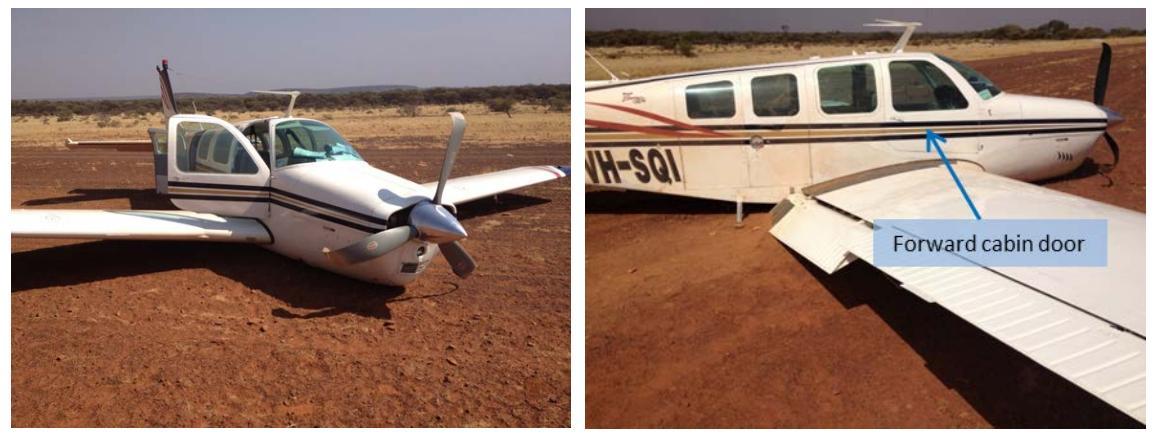
Figure 1: VH-SQI

During the flare², the pilot realised he had not done his pre-landing checks and had forgotten to lower the landing gear. The aircraft landed with the wheels up and skidded to a halt about 200 m down the runway. The pilot and passenger were uninjured, however the aircraft was substantially damaged.

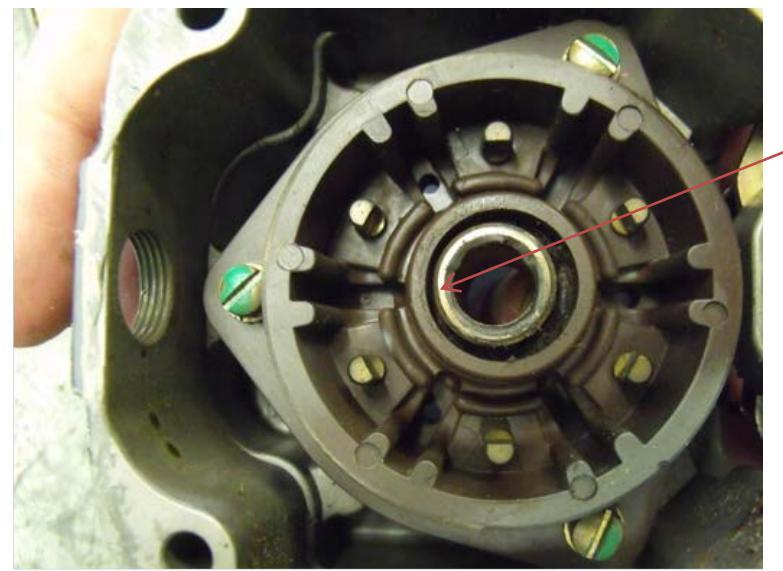
Figure 1: Left magneto distributor block

The aircraft was transported by the insurer to a contracted maintenance organisation for inspection. The magnetos were removed, inspected and checked for timing. The right magneto timing was found to be correct. The timing gear on the left magneto was found to be worn with a large amount of play. On disassembly, the left magneto was found to have a badly worn distributor block, which allowed the timing gear to move and alter the internal timing by approximately 40⁰.

Severe wear of bushing in distributor block.

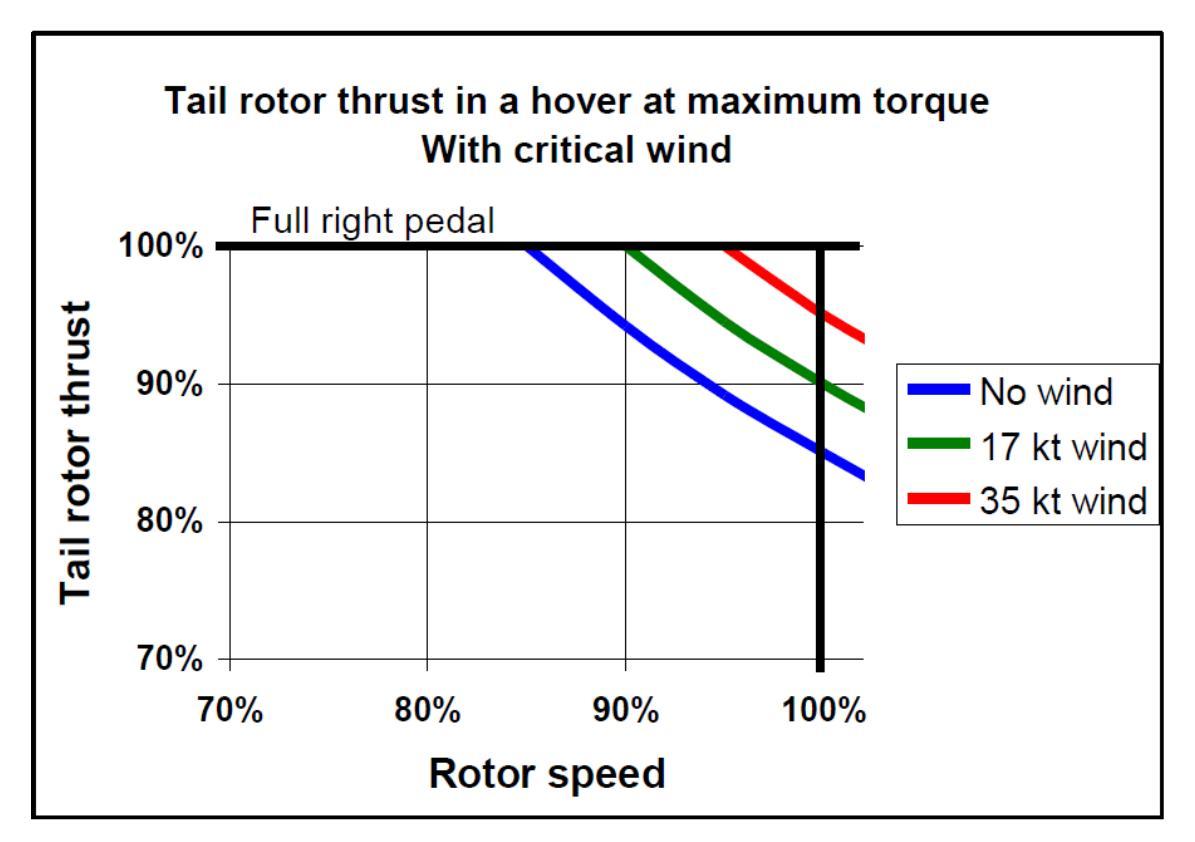
Figure 1: Tail rotor thrust margin versus rotor speed at maximum torque

The Cabri G2's high main rotor inertia will make the yaw departure to the left comparatively quick. Moreover, if the governor is not turned off for the manoeuver, the governor will react quickly in the event the pilot stops overriding it, contributing to the speed of departure in yaw to the left. The manufacturer commented that practising low main rotor RPM recovery in ground effect or at low altitudes poses an unnecessary risk and is not warranted in the Cabri G2 when a similar manoeuvre could be practised safely above 1000 ft above ground level. Such a manoeuvre at low altitude is not described or recommended in the aircraft flight manual.
