# Fatality while storing the products tanker *British Beech*

in Brisbane, Queensland | 15 December 2011

ATSB Transport Safety Report Marine Occurrence Investigation 291-MO-2011-011

Final – 7 March 2013

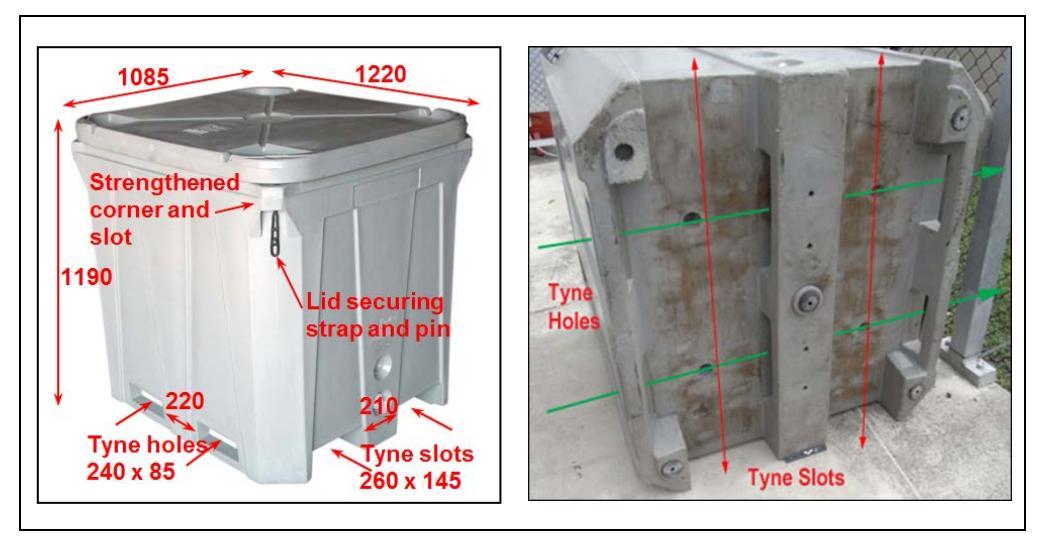
Figure 4: Stores container

The container had a capacity of about 1 m<sup>3</sup> and 1,000 kg. The empty container was weighed after the accident at 98 kg, of which the lid weighed about 16 kg.

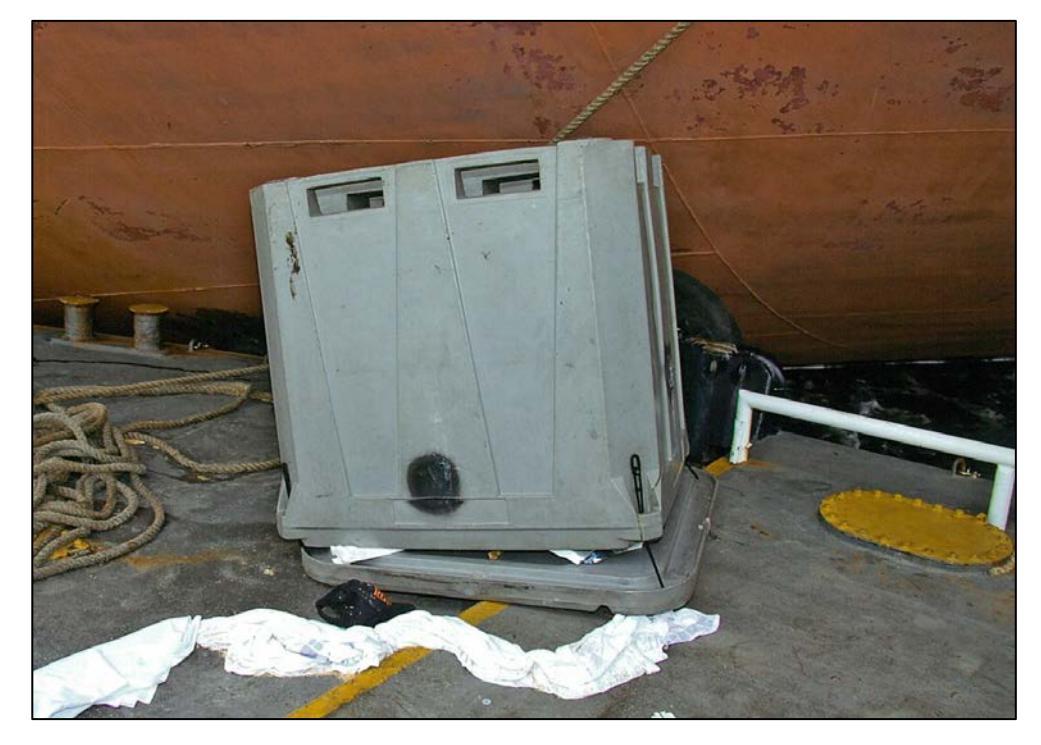
Figure 7: The fallen container lying on the barge's deck

The deckhand in the wheelhouse of the tug heard a bang. He turned and looked forward and could see the container sitting atop the stores pallets on the forward port side of the barge (Figure 6). He then saw the tug master lying on the barge deck with his head on the kick rail at the side of the barge. With a shout of exclamation, he rushed to the tug master's aid.

When the two deckhands reached the tug master, they saw that the container was not lying on the tug master but above him, wedged between the pallets of stores forward and aft of where he lay. The two deckhands moved the container onto the barge's forward deck (Figure 7), away from the tug master, and began providing first aid to the seriously injured man. After checking his vital signs, the second deckhand hurried aft to the tug's wheelhouse to raise the alarm.

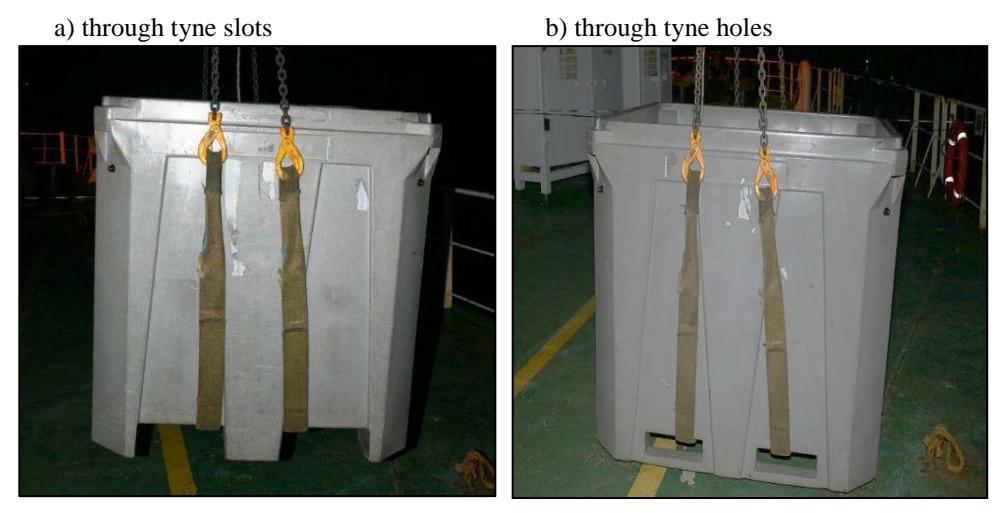
# Figure 8: Possible slinging arrangements for the container with the equipment in use at the time of the accident

The container had been poorly rigged<sup>11</sup> for the lift from the ship to the barge. There were no markings on the container to indicate how it was to be slung and the crew of *British Beech* did not adequately consider how the container should be slung and lifted. This included the weight of the load being rigged, the positioning of the webbing slings and the effect the movement of the loose packages in the container might have on its stability during the lift. Consequently, the slings were positioned through the container base tyne slots (Figure 8a) and the container, when lifted clear of the ship, was easily unbalanced and dislodged from the slings.

An object, like a stores container, remains in balance as long as its centre of gravity<sup>12</sup> remains inside the vertical envelope of its base of support. Once the line of gravity, acting vertically through the centre of gravity, moves outside the base of support, the object will be unbalanced and can topple over.

When the stores container was lifted off the deck of *British Beech*, the base of support was formed by the webbing slings passing under the container. Therefore, the horizontal position of the slings had a significant influence on the width of the base of support. The more widely spaced the slings, the wider the base of support provided by them, the more stable the container and the larger the force needed to generate sufficient turning moment to roll the container out of its supports (slings).

The method used for handling containers of this type in Brisbane has been altered so that the containers are top lifted and slings are no longer used.

The ship's manager, BP Shipping, implemented a requirement to have the lifting point fixed and above the centre of gravity of loads. A thorough review of lifting and slinging processes, practices, procedures and equipment was conducted as well as a review of lifting and slinging job hazard analyses. A fleetwide review and training workshop for lifting and slinging was also completed.

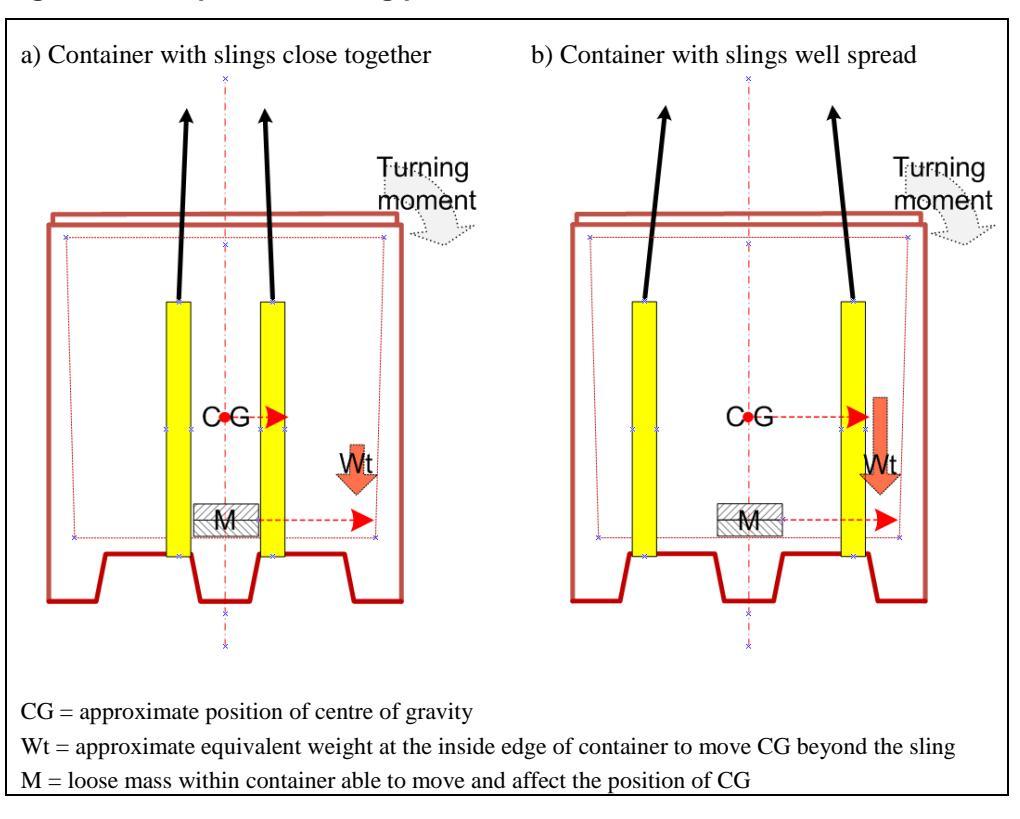
#### Figure 9: Comparison of sling position on stores container

Therefore, when lifted, the container needed a significantly smaller external force to topple it from the slings than if the slings had been positioned to the extremities of the type slots. In addition, the loose packages placed in the container, as they moved about, further reduced the external force needed to topple the container.
