Engine failure involving Gippsland Aeronautics GA-8, VH-AJZ

135 km NNE of Marree, South Australia | 29 September 2011

AO-2011-125 Final – 18 March 2013

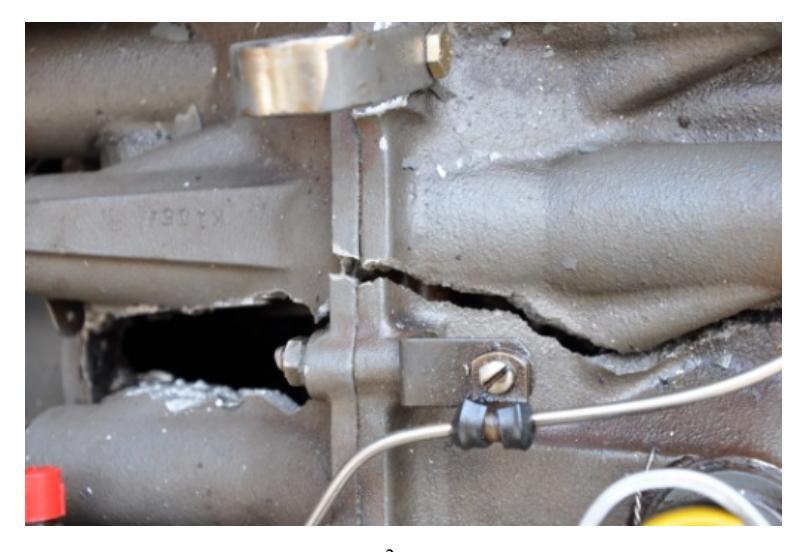
The pilot and passengers were not injured and the aircraft sustained no damage as a result of the forced landing. Inspection of the aircraft revealed engine oil pooling inside the lower engine cowls and covering the underside of the fuselage. Large cracks in the engine crankcase could be seen through the cowling and the propeller could not be rotated by hand (Figure 2).

Figure 2: Cracks in the engine crankcase

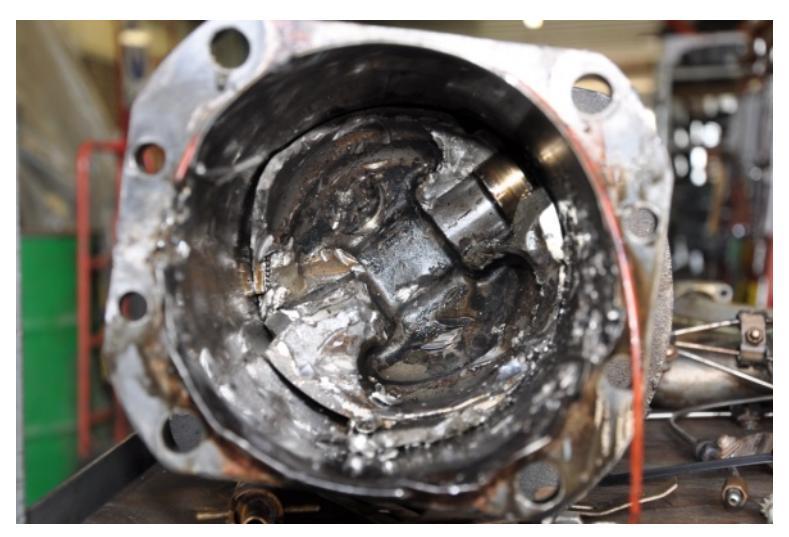
Examination of the engine found significant internal mechanical damage in the vicinity of the No. 5 and No. 6 cylinders, which were located at the rear of the engine. The No. 5 piston had separated from its connecting rod and was fractured in several places around the piston skirt and at the piston pin bore (Figures 3 and 4). Examination of the fracture surfaces found evidence of fatigue cracking originating at the pin bore and separately, through the piston adjacent to the groove of the oil control ring. The remaining damage to the piston was attributed to repeated impacts from the connecting rod and other circulating debris.

Figure 3: No. 5 piston within the cylinder barrel

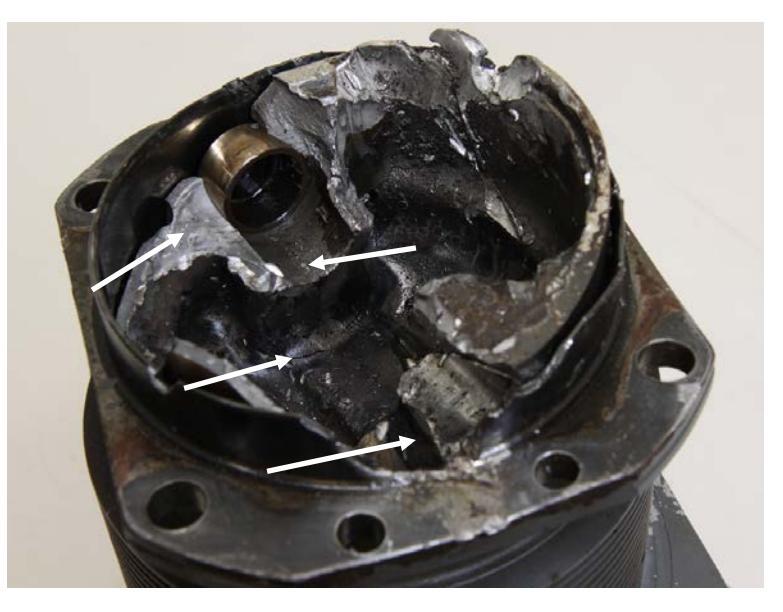
Figure 4: No. 5 piston and cylinder, fatigue cracking arrowed

The fatigue cracking initiated in the No. 5 cylinder piston pin boss and had progressed to the extent that the piston fractured and broke away from the connecting rod. The connecting rod, still reciprocated by the crankshaft, further damaged the engine and all power was lost.

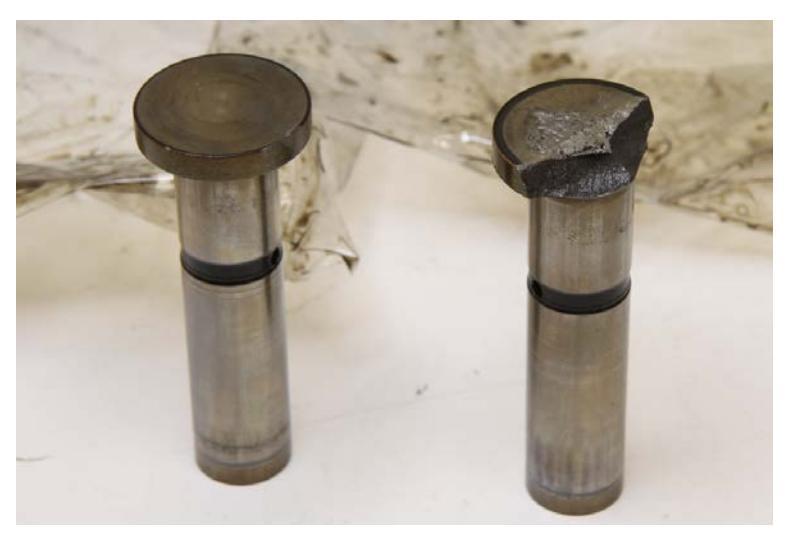
The installed tappets were the original cast iron tappet design (see the discussion in the section of this report titled *Engine tappet (cam follower) information)*. Examination of the engine components found evidence of metal chipping (spalling) to two of the cast iron flat tappets (cam followers). The No. 3 exhaust tappet had fractured through the sliding contact surface (Figure 5). Significant amounts of hard facing material had been spalled from the camshaft lobe contact surface (Figure 6) and there was associated cracking and surface pitting. Spalling of the tappet surface was therefore likely the result of contact fatigue and the wear surface had then been rolled over the adjacent fracture surface by continued operation after the fracture. The No. 6 inlet tappet exhibited similar spalling damage to the hard facing of the sliding contact surface (Figure 7). There was no significant material difference between the tappets exhibiting spalling damage and others from the same engine. Microscopic examination of the undamaged tappets found minor surface pitting that was uniform across the surface, but with no significant loss of material.

Figure 5: Tappets, No. 3 cylinder (inlet left; exhaust right)

The spalling of the tappets was consistent with a progressive failure that resulted from contact fatigue. Given the similar metallurgy of the spalled and unspalled tappets, and the number of operating variables such as lubrication and applied stress to each tappet, no underlying condition was identified.

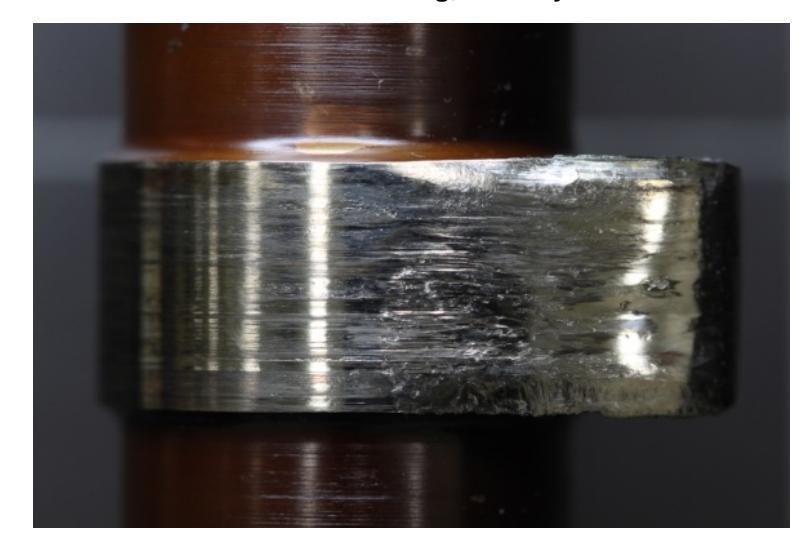
Figure 6: Exhaust camshaft lobe smearing, No. 3 cylinder

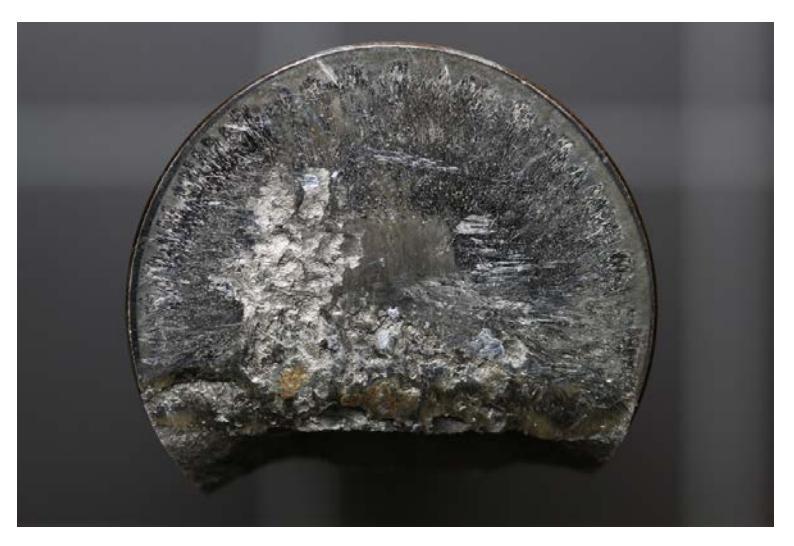
Figure 7: Inlet tappet's sliding contact surface, No. 6 cylinder

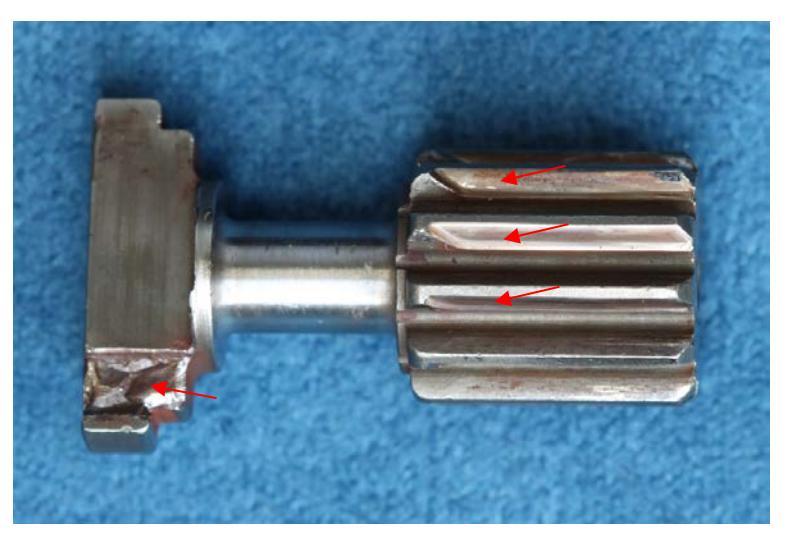
Examination of the shaft and spline gear on the EDFP showed excessive and abnormal wear of the gear teeth but no evidence of cracking or other major defects. Witness marks from the mating gear were also present on the reverse (opposite to drive) side of its splines. The amount of material lost from the drive spline was evident by the rust-coloured dust covering the spline, shaft and surrounding surfaces. Those patterns were likely the result of fretting wear over an extended period of time, both pre and post the EDFP repair.

Figure 7 shows the spline gear removed from the pump and the additional wear/fracture on the load bearing surfaces.

Figure 7: Drive spline as removed from the EDFP – note abnormal wear (arrowed)

Heavy wear patterns were observed on the drive splines from the engine-driven fuel pump (EDFP). These wear patterns were considered abnormal, and are subject to an ongoing study by CASA. If left uncorrected, such wear could have resulted in EDFP failure and a loss of fuel flow to the engine.
