Visual Flight Rules in Instrument Meteorological Conditions and controlled flight into terrain involving Cessna 182Q, VH-CWQ

15 km north of Tooraweenah, New South Wales | 4 June 2012

ATSB Transport Safety Report Aviation Occurrence Investigation AO-2012-076 Final – 4 March 2013

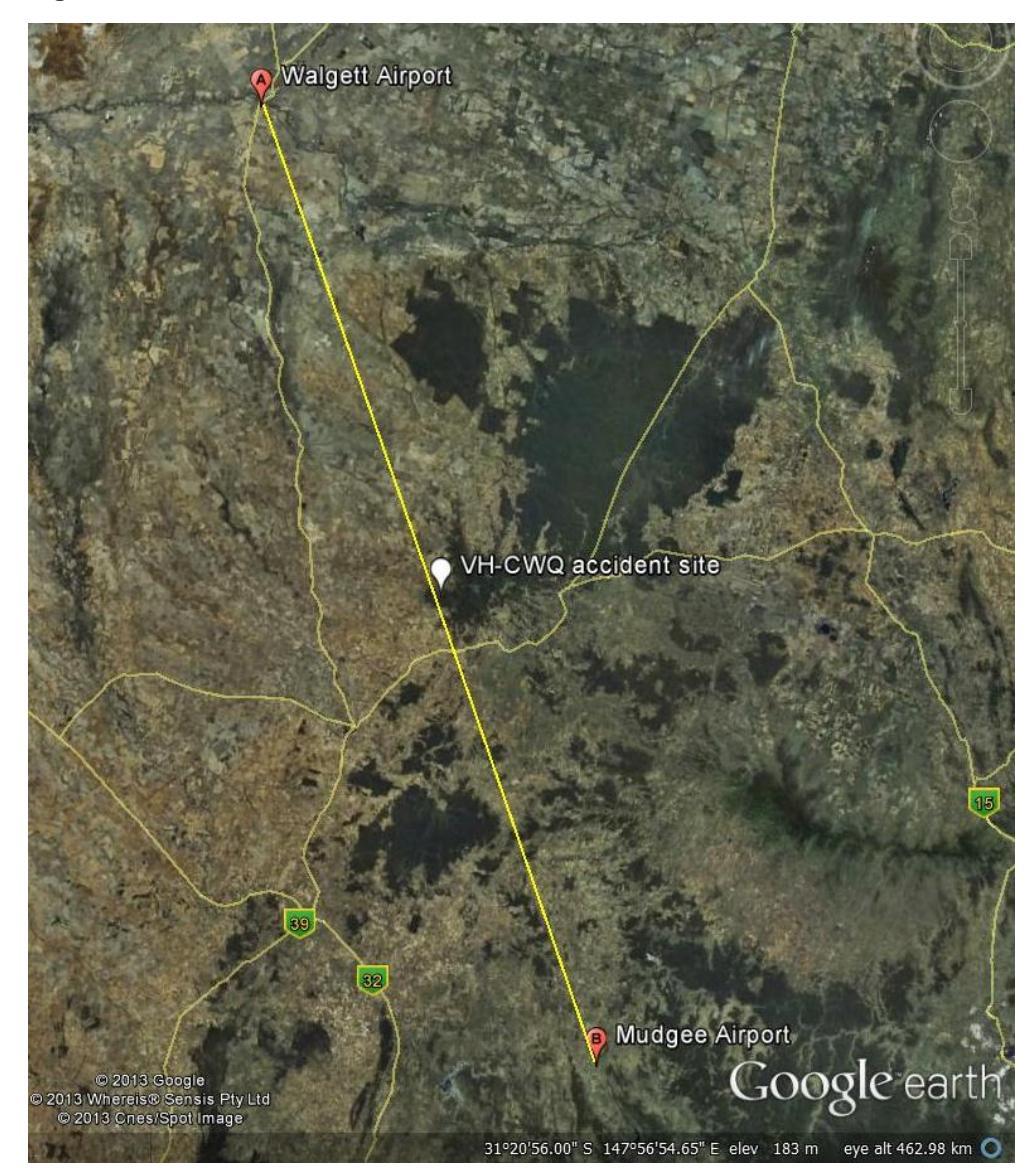
Figure 1: Location of the accident site

At about 1030, the aircraft collided with the side of a hill on the direct track between Walgett and Mudgee Airports (Figure 1), at a point about 100 ft below the top of the hill. Witnesses reported that at the time of the accident, the overcast cloud base was about 100 ft below the accident site.

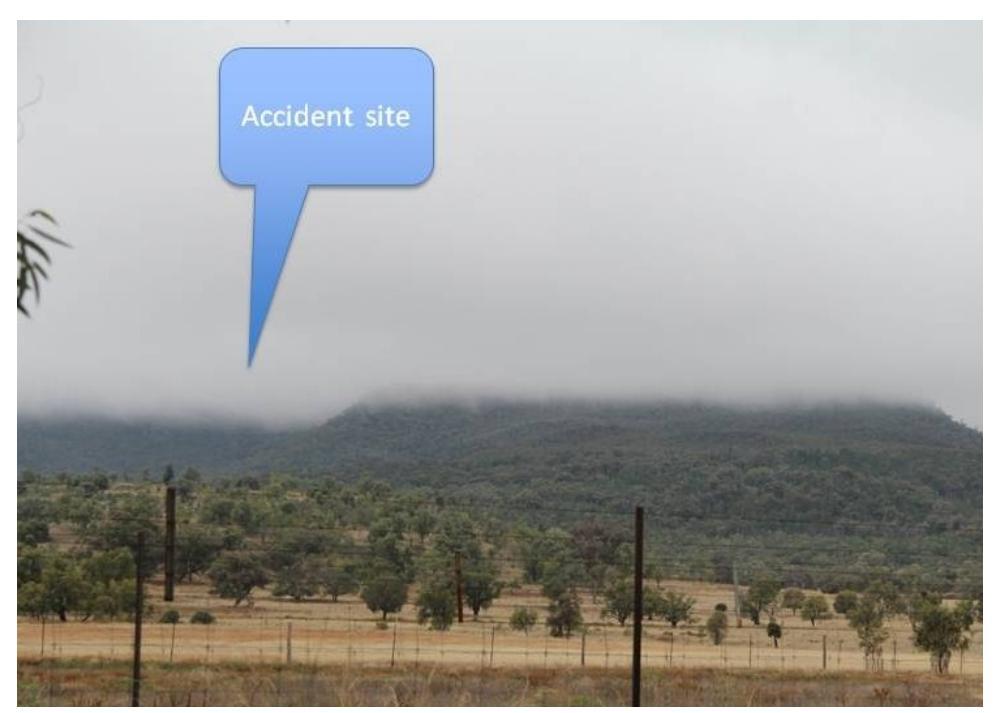
Figure 2: Accident site with similar cloud conditions on the day after the accident

Witnesses about 3 NM (6 km) north of the accident site were interviewed on the day following the accident. The weather in the vicinity at the time of the interviews is shown at Figure 2. The witnesses reported that the cloud base at the time of the accident was similar to that observed at the time of the interview and was described as having an overcast, 'flat' base. Figure 3 depicts the base of the cloud with reference to the terrain in the area of the accident on a clear day. The cloud base was derived to have been about 1,800 ft when looking toward the accident site from the witness location.

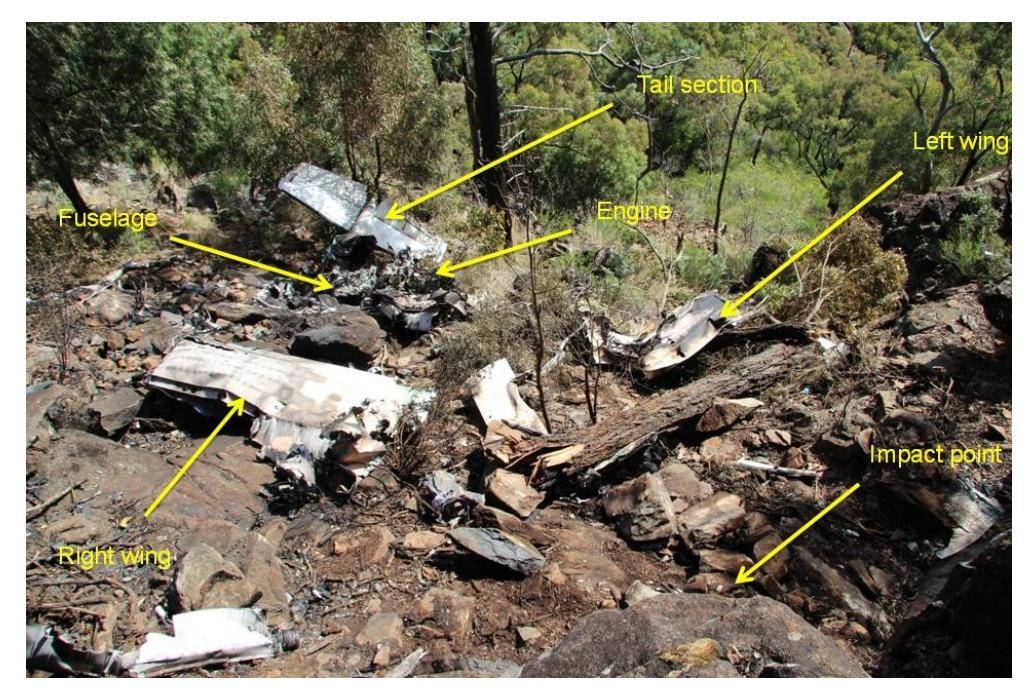
Figure 4: Accident site

The aircraft had impacted a near vertical rock formation with about 35° left bank and 5° pitch up attitude. The terrain below the rock formation sloped down at about 40° , resulting in the wreckage slipping down the slope about 8 m before coming to rest against a tree (Figure 4).

The attitude of the aircraft at the time of impact was consistent with the aircraft being under control. From the observed angle of bank, it is possible that the pilot had initiated a turn away from rising terrain as it became visible, shortly before impact.

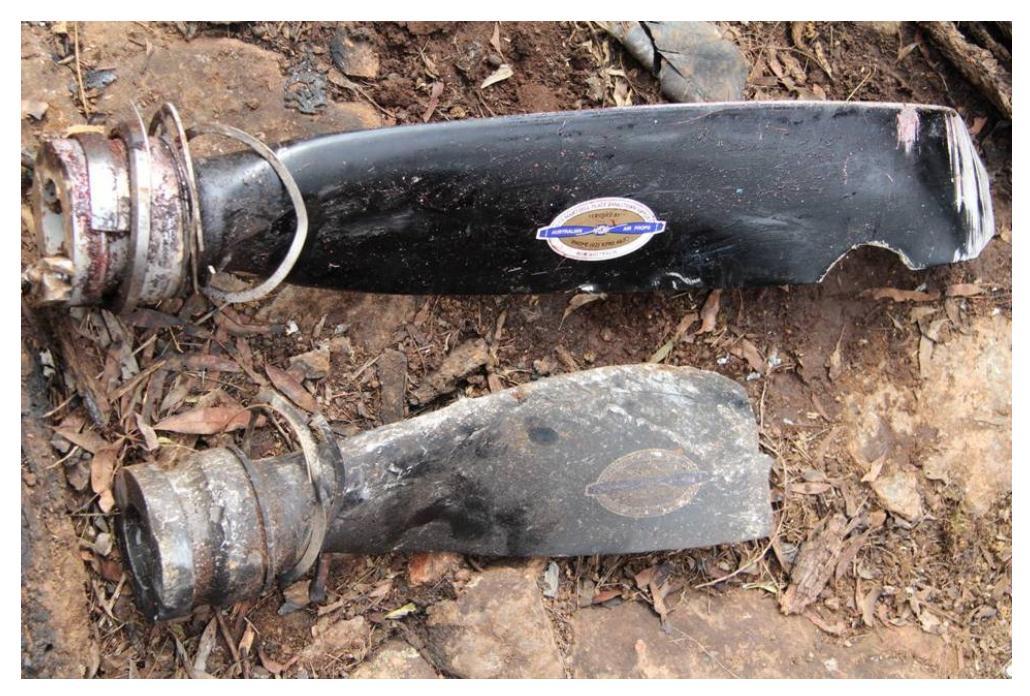
Figure 5: Propeller damage

the parts of the airframe structure that could be examined. Damage to the engine and propeller provided a strong indication that significant power was being produced at the time of impact (Figure 5).
