# **Derailment of train 4DA8**

# Katherine, Northern Territory | 30 January 2013

ATSB Transport Safety Report Rail Occurrence Investigation RO-2013-004 Final – 26 June 2013 Released in accordance with section 25 of the Transport Safety Investigation Act 2003

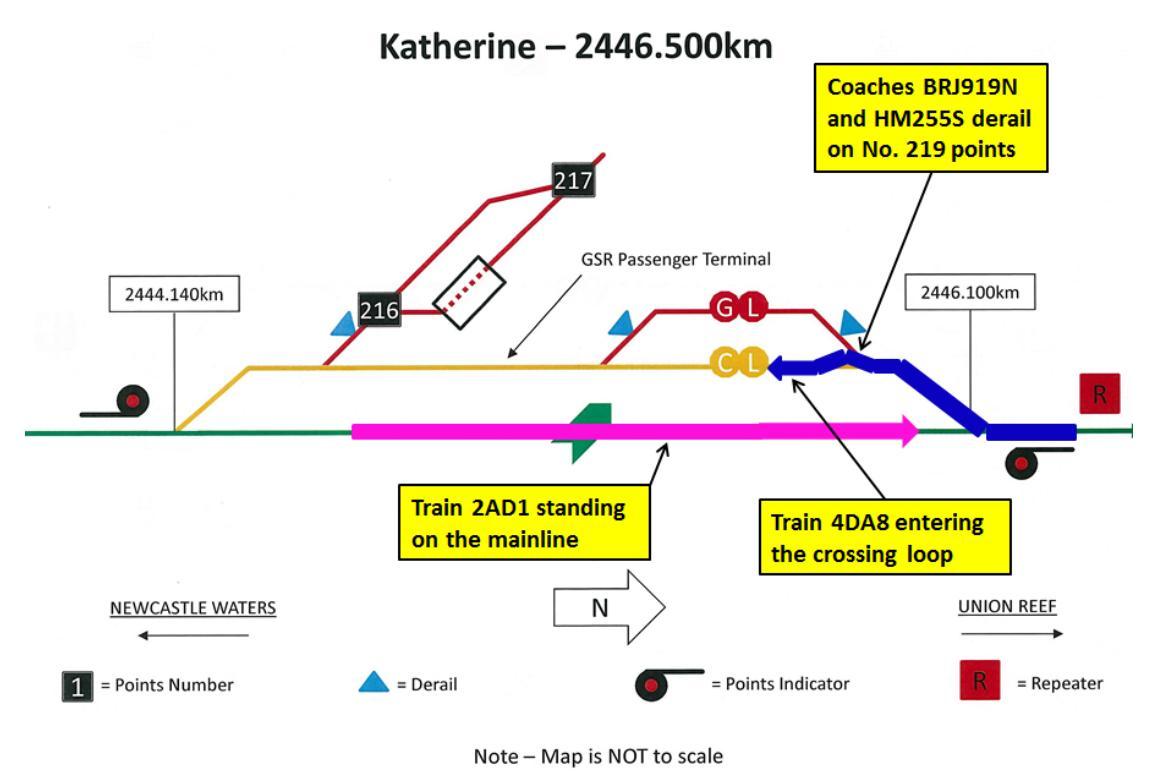
#### Figure 1: Site map

When 4DA8 stopped, the front portion of the train was standing on the crossing loop while the rear portion was standing on the mainline (Figure 1). There were no reported injuries to passengers or train crew.

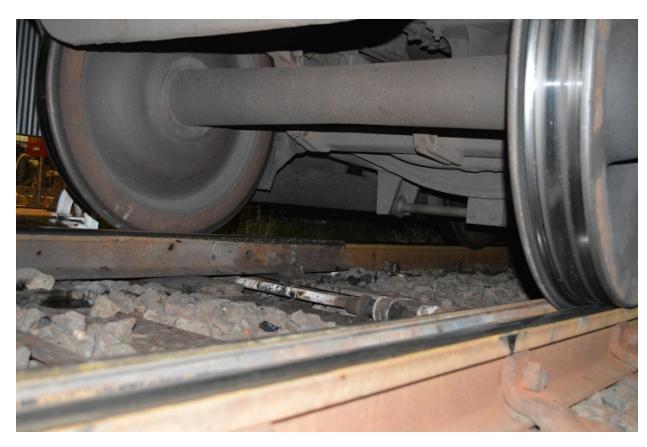
The two locomotives, the first coach and the leading bogie of the second coach had passed through the points correctly following along the crossing loop. The trailing bogie of the second coach and the leading bogie of the third coach derailed into the goods loop. The trailing bogie of the third coach, the fourth and fifth coaches took the crossing loop and remained on track. The leading wheelset of the sixth coach had also commenced to track incorrectly towards the goods loop (figure 2). All vehicles remained upright and coupled.

The GWA investigation established that the right hand wheel of the trailing bogie of the second coach climbed the points blade of No. 219 points and dropped into the goods loop. It was followed by the leading bogie of the third coach. The leading wheelset of the sixth coach came to a stand on No. 219 points and had also commenced to track incorrectly towards the goods loop (Figure 2).

Figure 2: Wheelset tracking into goods loop

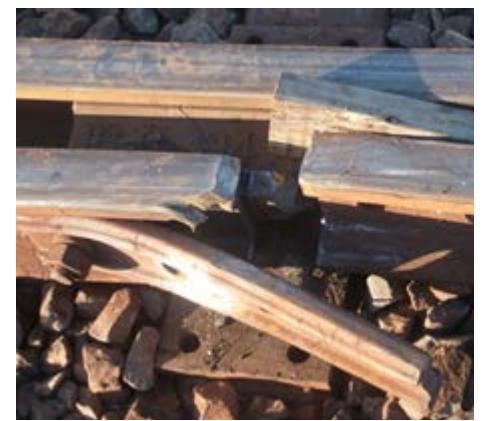
wear. The damage to the heel block,<sup>7</sup> heavy battering to the closure rail<sup>8</sup> (Figure 3), the crippling and disconnection of the point blade (and subsequent gap at the point) were considered to be a consequence of the derailment.

Figure 3: Heavy battering to end of the closure rail
