Breakdown and subsequent drift towards danger of the bulk carrier *ID Integrity*

Coral Sea | 18 to 23 May 2012

ATSB Transport Safety Report

Marine Occurrence Investigation 294-MO-2012-005 Final – 22 August 2013 Released in accordance with section 25 of the Transport Safety Investigation Act 2003

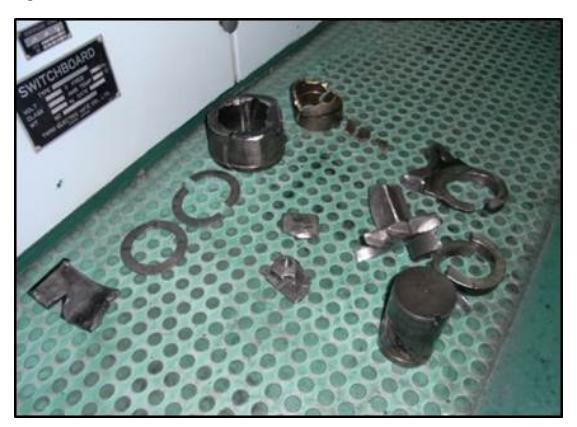
ID Integrity's engineers, in consultation with ID Wallem's technical superintendent, continued to search for the cause of the main engine stoppage. While inspecting the engine, the engineers were slowly turning the engine using the turning gear¹⁰ when the turning gear drive motor overloaded and tripped out. The chief engineer concluded that there was a physical obstruction in the engine that was causing an increased resistance to turning, so he decided to inspect the rotating components of the engine, starting with the camshaft. Upon removal of the camshaft cover from number six cylinder, he found pieces of the fuel pump cam, fuel pump roller and reversing mechanism (Figure 4). Closer inspection showed damage to the cam and engine block surfaces (Figures 5, 6 and 7).

Figure 4: Pieces removed from camshaft space

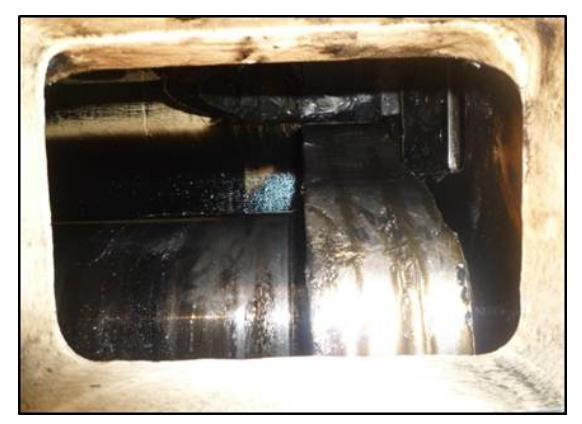
Figure 5: Fuel pump cam and engine block damage

The No. 6 fuel roller guide has failed and caused damage [to] the fuel cam for unit¹³ 6 which has caused the camshaft to slip 190 degrees in the after most coupling. The resulting mistiming of all cylinders rendered the engine unable to be started.

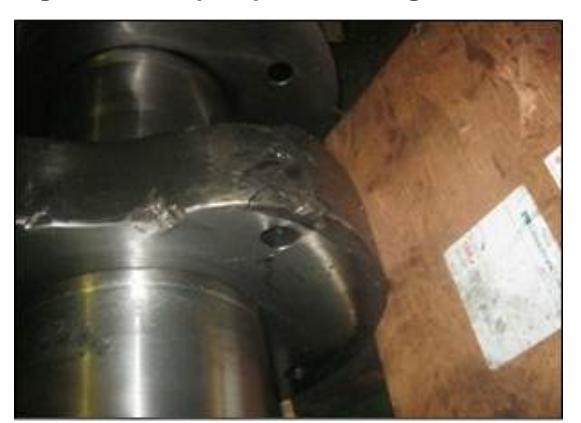
Figure 6: Fuel pump cam damage

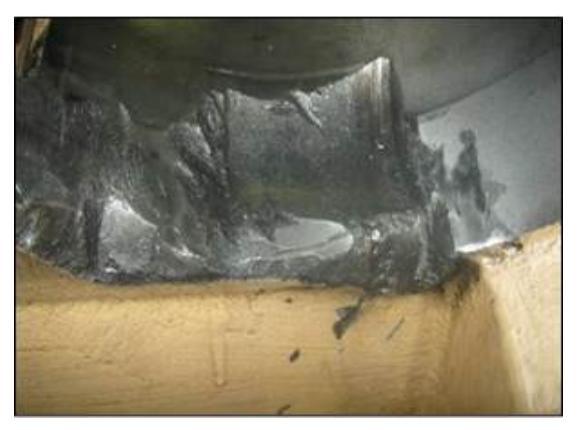
Figure 7: Damage to roller guide housing

The fuel pump guide plate for units 1, 2, 3 and 4 were found loose and the bolts and pins were found broken.

MAN B&W subsequently stated that the engine failure was not caused by the loose number six fuel pump cam follower roller guide block and that, historically, loose guide blocks had not significantly affected the operation and reversing of engines. This opinion was further supported by the discovery that four of the remaining five guide blocks in *ID Integrity*'s engine were also loose but had not affected the running of the engine.

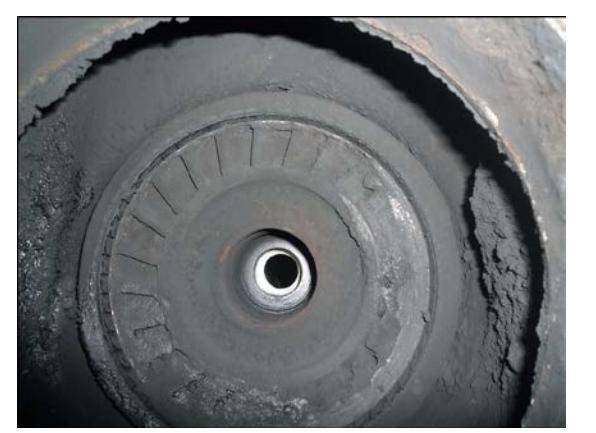
Figure 10: Number 3 diesel generator turbocharger, May 2012

In the following 2 months (to 14 May), both DG2 and DG3's turbochargers were stripped and cleaned twice each. Then, on 14 May, DG2's turbocharger failed due to a broken rotor shaft and, on 16 May, DG1 and DG3 shutdown due to fouled turbochargers.

During this time, the engineers concentrated their efforts on rectifying the symptom, the fouled turbochargers, rather than identifying and rectifying the actual cause of the turbocharger fouling.

It is likely that, as a result of prolonged periods of operation at reduced load, the cylinder bores and piston ring faces had become glazed. This probably led to poor sealing of piston rings to cylinder liner resulting in carry-over of lubricating oil into the exhaust system (Figure 10). Furthermore, operating the engines on heavy fuel at low loads probably resulted in poor combustion and carry-over of unburnt fuel. It is also possible that oil entered the exhaust system through leaking valve guide seals in the cylinder head. Together, these conditions probably led to the fouling of the turbochargers.

a) Fouled turbocharger nozzle ring
