Australian Government Australian Transport Safety Bureau

# Derailment of freight train 3MC1

Locksley, Victoria | 12 February 2013

ATSB Transport Safety Report Rail Occurrence Investigation RO-2013-006 Final – 11 October 2013 Released in accordance with section 25 of the Transport Safety Investigation Act 2003

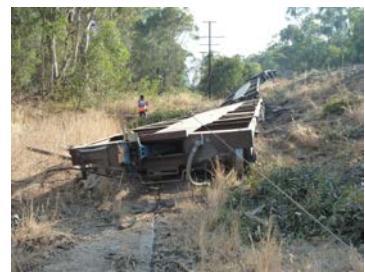
#### Derailed wagons train 3MC1

On 12 February 2013, intermodal freight train 3MC1 derailed at Locksley, near Seymour in Victoria. The train consisted of two locomotives (GL107 leading and GL101 trailing) hauling 33 wagons having a trailing mass of 921.1 t and an overall train length of 885.5 m. There were no injuries but the last eight wagons derailed and about 800 m of track was damaged.

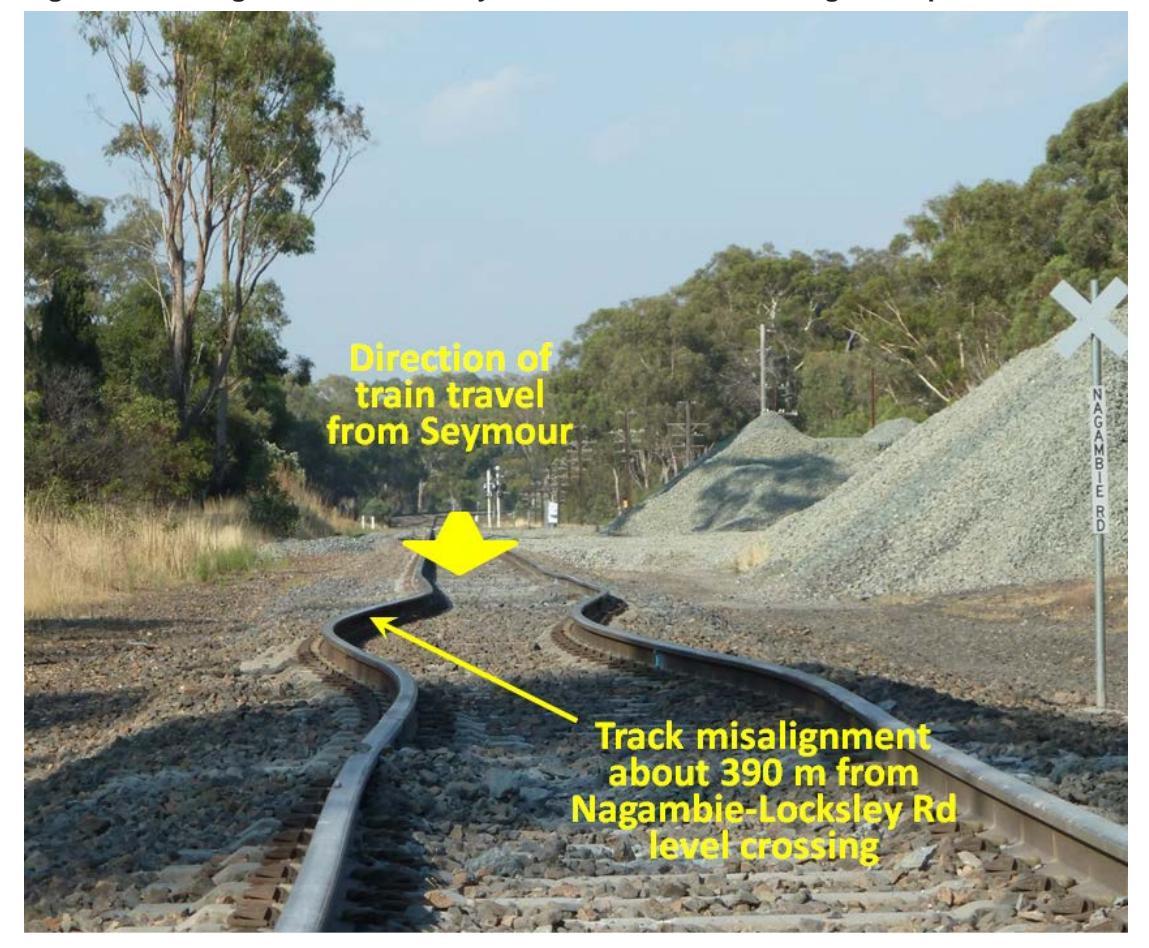
Figure 2: Looking south towards Seymour – Site of track misalignment post derailment

Shortly after traversing the Nagambie-Locksley Road level crossing (127.376 km) both drivers observed a large track misalignment (Figure 2) some distance ahead. The driver throttled off in an attempt to ride through the misalignment (127.768 km). The train continued over the misalignment and travelled a further kilometre at which time the driver assumed the train had not derailed. He was about to communicate details of the misalignment to the NCO when he observed a significant reduction in brake pipe pressure. This indicated a loss of air and the likelihood of a train

Based on the train crew's observations and supported by site evidence, the ATSB concluded that the derailment of train 3MC1 was initiated by a horizontal track misalignment at the 127.768 km location.

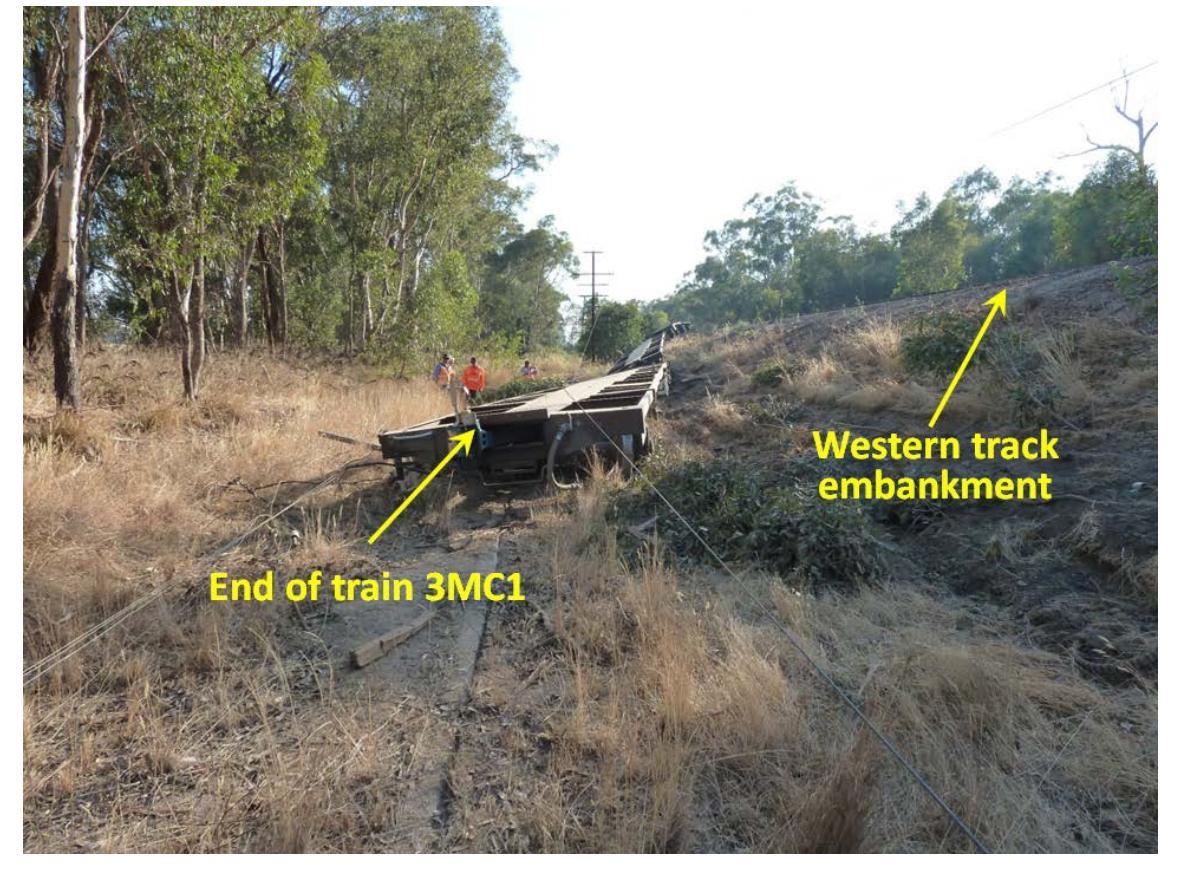
Figure 3: Train 3MC1 – End of train, last wagon in consist

When the train came to a stand both the driver and assistant disembarked and went to opposite ends of the train to protect the train from approaching traffic. The train driver walked to the rear of the train. On reaching the eighth to last wagon he noticed that the leading bogie had derailed. He observed that the next four wagons had also derailed and that either the front or rear bogies had been dragging alongside the track to the left side (western side of West line) in the direction of travel. The last three wagons, though still coupled to the train, had progressively dropped away off the left side of the track embankment with the last wagon (Figure 3) having completely slipped to the bottom of the formation. Although the train remained coupled, air was escaping from air hoses between the third last and second last wagons.

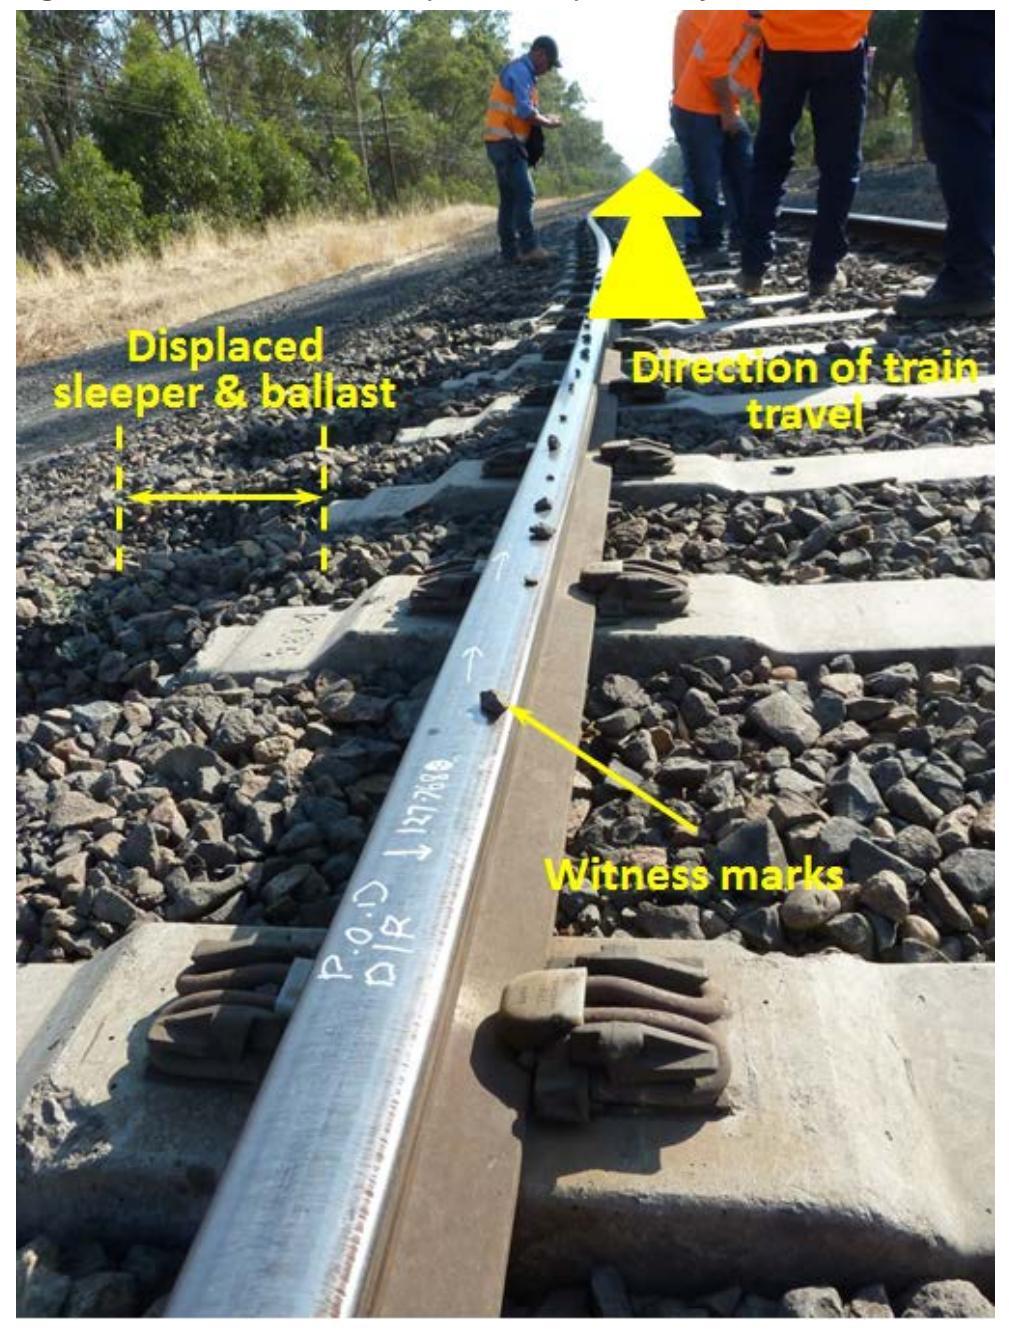
Figure 5: Witness marks at PoD (127.768 km) shown by line of stones on rail head

An examination of the track at the 'Point of Derailment' (PoD) showed evidence of flange climb on the rail running face (western rail/West line) followed by witness marks on the rail head (Figure 5) and damage to sleepers where the wheel(s) had subsequently dropped off the rail head. There was evidence of significant horizontal sleeper displacement within the ballast bed, about 180 mm to the right (Figure 5 and Figure 6). There was no evidence of vertical misalignment.

Damage to sleepers was observed only after the point where the wheel(s) dropped off the rail. Undamaged sections of track were examined for gauge (1435 mm) and found to be within specified limits. Track spread/gauge widening was unlikely to have been a factor in the derailment.

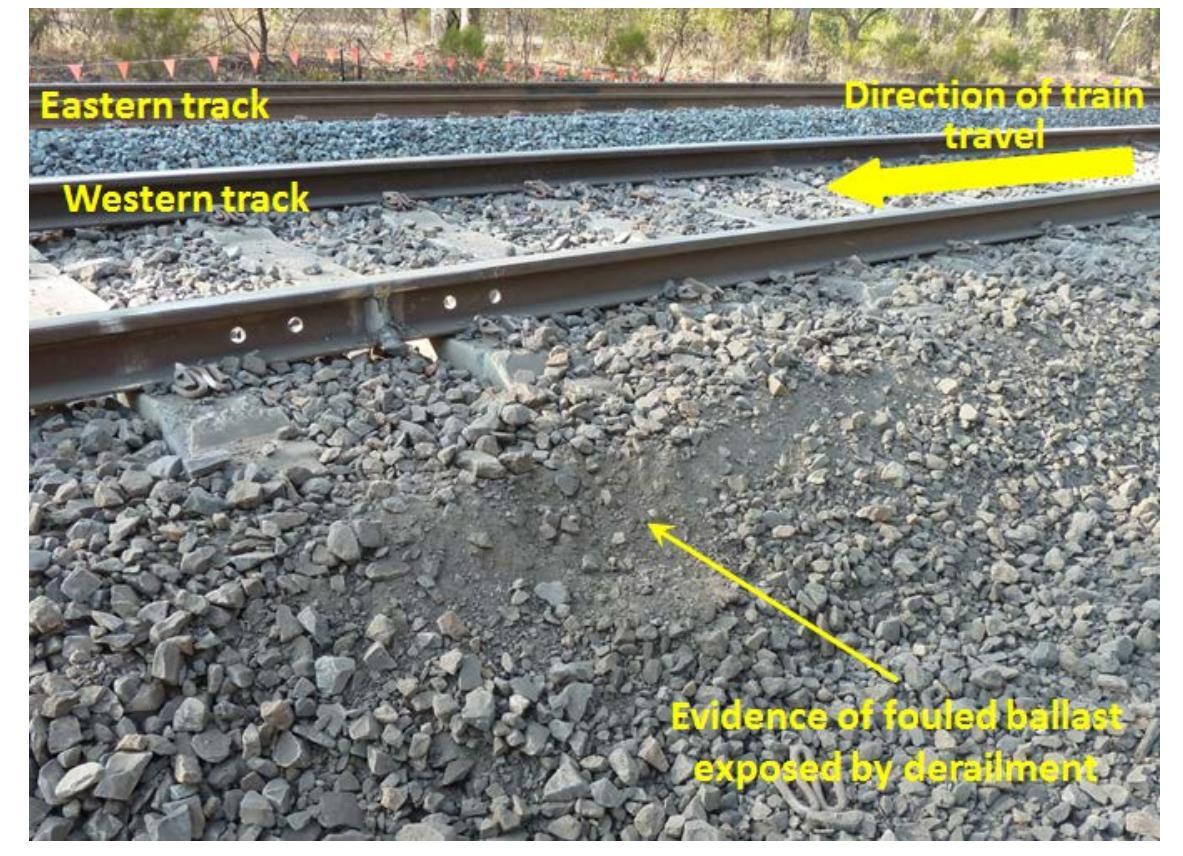
#### Figure 7: Evidence of fouled ballast

During this incident, derailed wagons ploughed into the ballast shoulder along the western (field) side of the West line. The exposed ballast shoulder and underlying formation (Figure 7) was observed to be heavily contaminated/fouled with fine material (fines) along much of the length. The PoD (127.768 km) was located between two track sections (127.751 km to 127.755 km and 127.826 km to 127.830 km) that had undergone undercutting/ballast renewal works associated with identified track pumping/mud-hole damage. As the track at the PoD was not part of this work, it is very likely that this track was structurally weaker than the repaired track and was therefore more prone to buckling.

The Australian Rail Track Corporation has implemented a ballast remediation program on the Melbourne – Sydney rail corridor. This work will continue as programmed until completed, following which further works will be undertaken at sites having identified formation weakness.

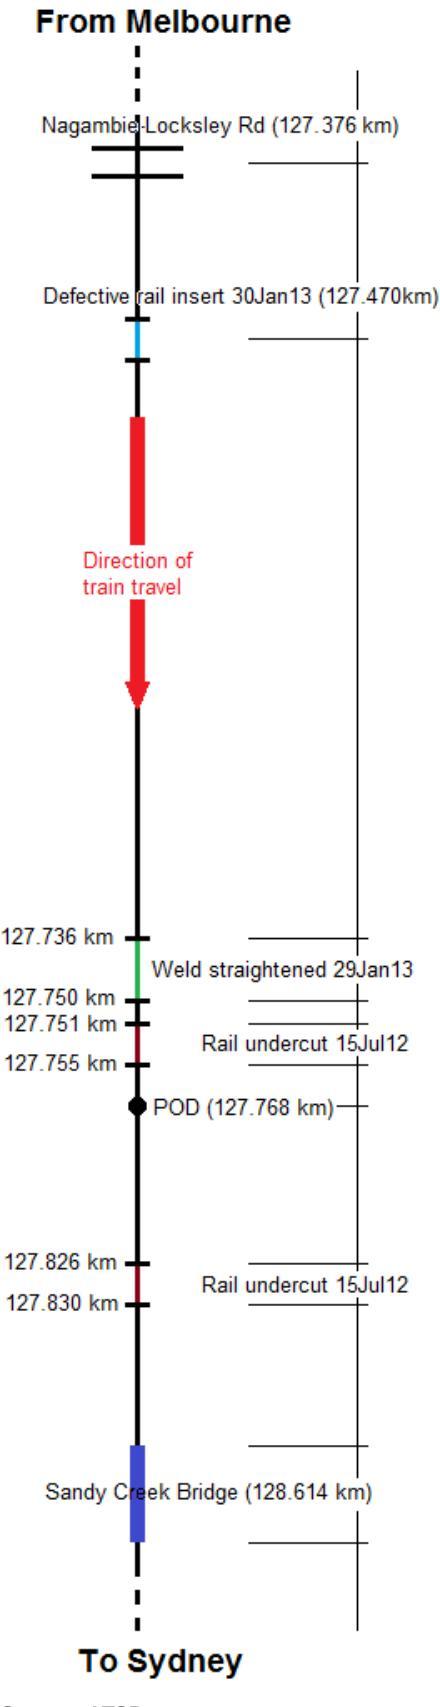
# Figure 8: Schematic showing work near site of track buckle (127.768 km)

During the post derailment site inspection it was observed that work was undertaken about 25 m before the derailment site (Figure 8). The work was identified as weld straightening on the western (field) side of the West line.

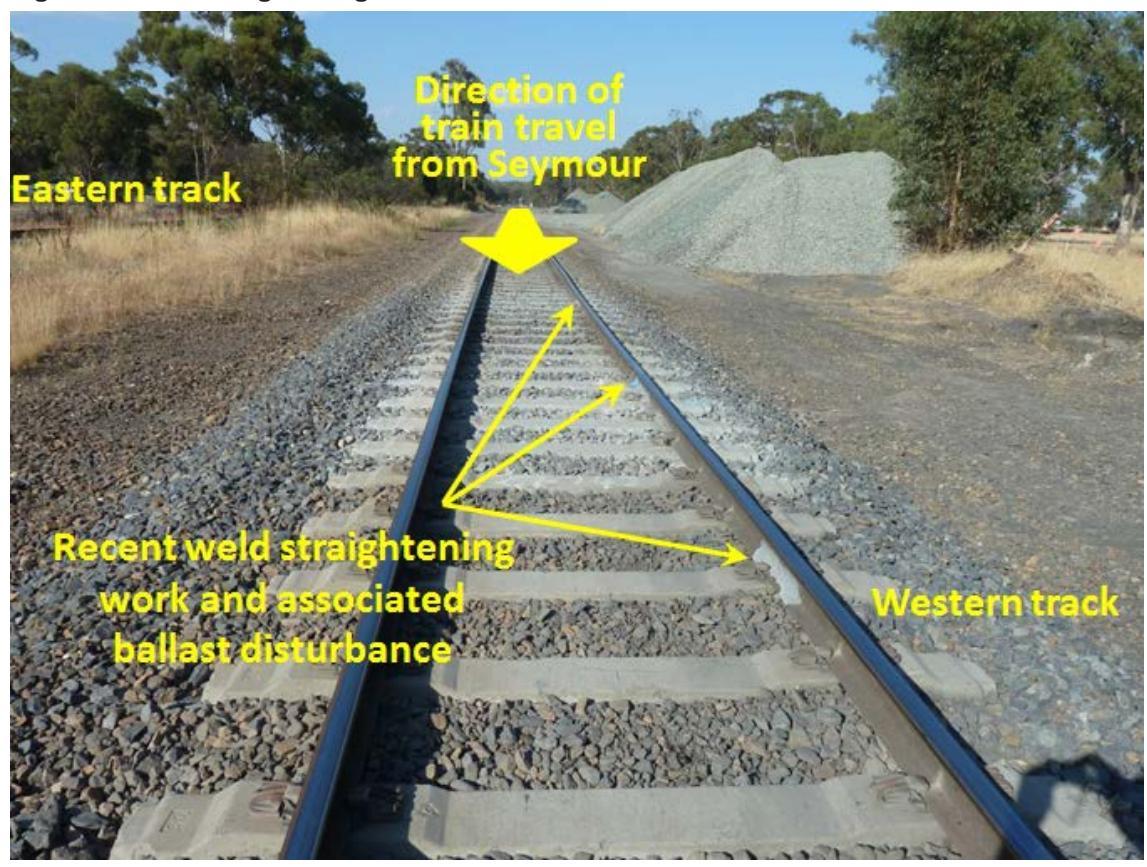
Figure 9: Weld straightening and associated ballast disturbance

The frictional bond between ballast and sleepers will degrade as a result of track maintenance activities<sup>16</sup> such as tamping, track renewal/replacement, weld straightening and associated works. These activities all reduce the track's ability to resist lateral movement until the ballast consolidates under traffic. It may take several weeks for this to occur, depending on traffic volumes/loads. During the consolidation period, the track is particularly susceptible to thermal forces.

The work was undertaken on 29 January 2013, 15 days before the derailment. The photograph (Figure 9) shows disturbance of the track, about 7 m either side of weld straightening activities. It was also identified that work, the replacement of a rail defect, was undertaken at the 127.470 km mark, about 298 m before the PoD on 30 January 2013.

Australian Rail Track Corporation track maintenance staff have been provided with additional training on the consequences of multiple track disturbances altering the stress free temperature of rail track. The training will provide an enhanced level of compliance with the requirements of procedure ETM-06-06 (Managing Track Stability - Concrete Sleepered Track).

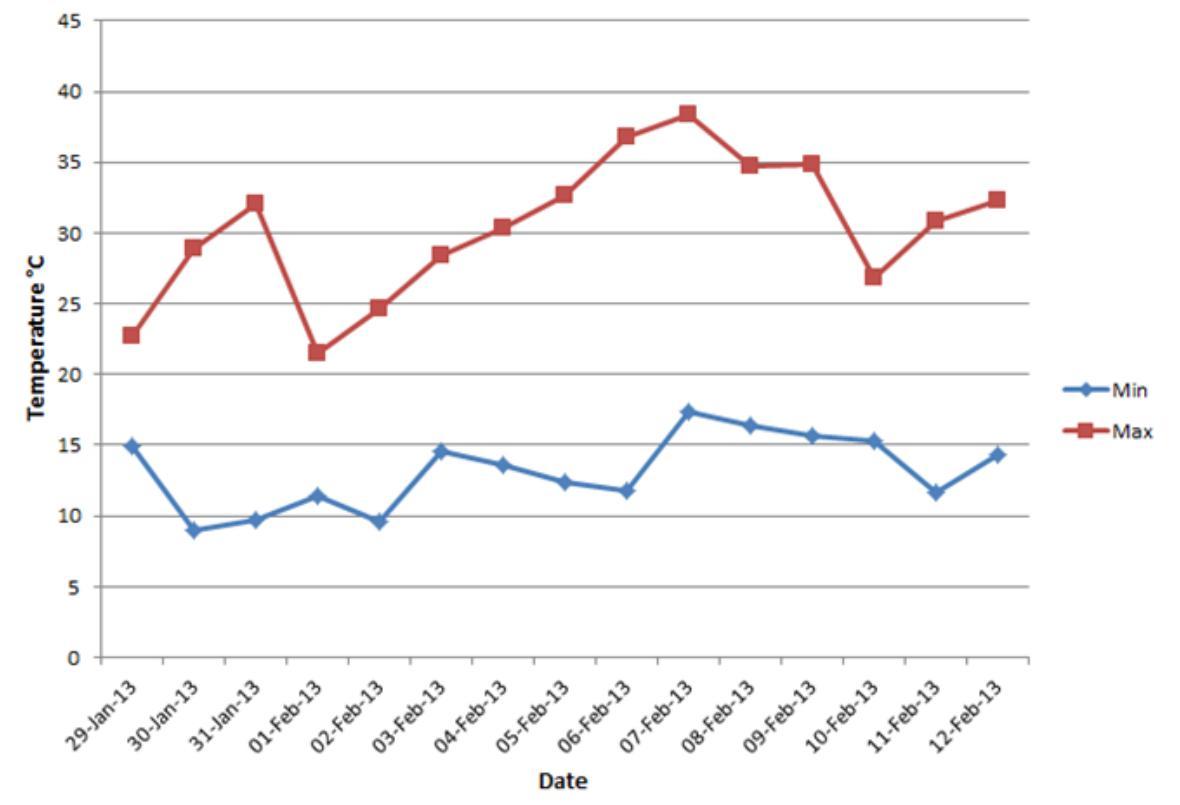
Figure 10: Temperature from 29 January 2013 through to 12 February 2013 observed at Mangalore Airport.

Mangalore is about 14.5 km southwest of Locksley; it is the site of the closest weather station. On the day of the derailment, the maximum temperature recorded at Mangalore was 31.6 °C, at about 1530. At the time of derailment (at about 1640) the temperature was about 30.6 °C. In the period preceding the derailment there was little cloud cover and the track was exposed to full/direct sunlight.

Experience has shown that where rail is subject to full sunlight, the rail temperature may be 15 °C to 20 °C higher than the corresponding ambient air temperature.<sup>17</sup> At some time before the derailment (about one hour) it was likely that the rail near the PoD attained a temperature of between 47 °C to 52 °C. The rail temperature was therefore well above the design neutral temperature resulting in high compressive rail forces. This, coupled with a large cyclic temperature variation (Figure 10) during the preceding fortnight and track disturbance activities, probably resulted in a redistribution of longitudinal stress concentration near the 127.768 km mark, giving rise to the track misalignment.
